Friends of Gumstool Brook is a group of local people interested in Cirencester's Gumstool Brook and its associated streams. Visit our website at <https://gumstool.org.uk>

The following set of monitoring pictures was collected on the 25th of October 2024 to record the status of the Daglingworth Stream and River Churn in the Cirencester area.

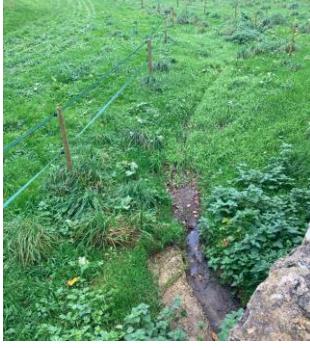
<p>1a. Daglingworth Stream upper source north of Duntisbourne Abbots.</p> <p>The stream channel is muddy and there is some standing water.</p> <p>There is an indication of recent flows from surface water runoff.</p>

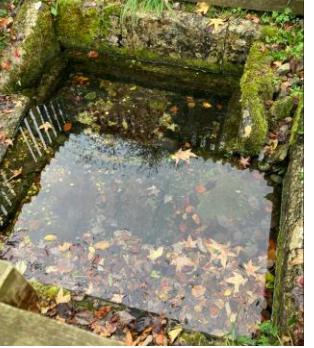
<p>1b. Duntisbourne Abbots village spring.</p> <p>Water is gently flowing.</p>

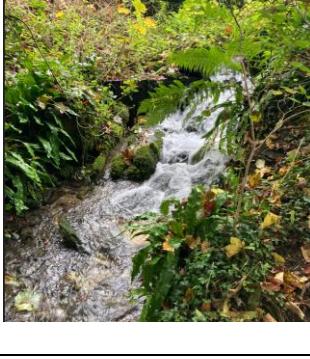
<p>2. Duntisbourne Abbots Daglingworth Stream downstream of inferred confluence of spring sources.</p> <p>There is a normal stream flow in the channel.</p>

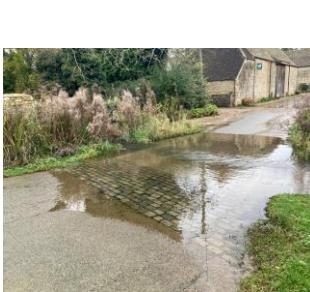
<p>4. Middle Duntisbourne ford, Daglingworth Stream.</p> <p>A normal flow is observed that extends about one foot beyond the cobbled area of the south-west channel edge.</p>

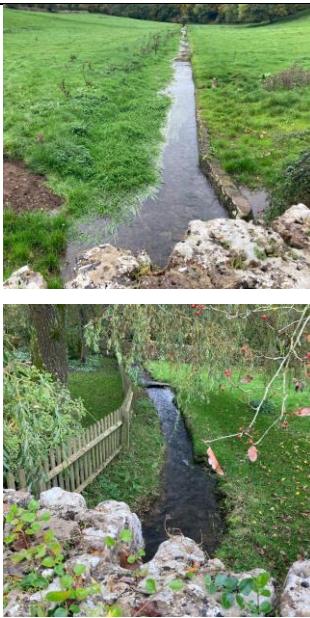
<p>6. Daglingworth Stream Grove Hill bridge.</p> <p>A normal flow is observed that fills one half of the field channel upstream of the road bridge.</p>

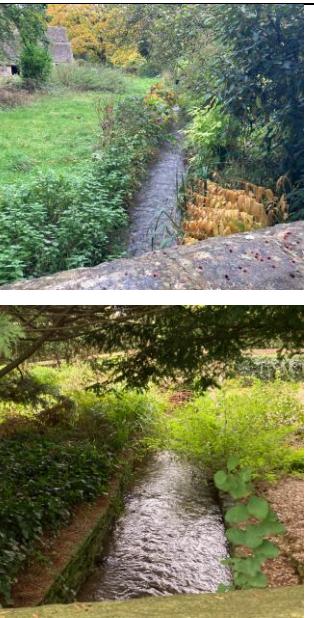
<p>7. Daglingworth Stream at Lower End road bridge.</p> <p>A normal flow is observed in the upstream garden, and the walled channel downstream of the bridge.</p>

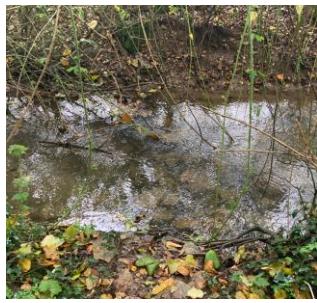
<p>8. Wellhill Copse, Daglingworth Stream.</p> <p>In the fields upstream of Wellhill Copse, the stream is flowing within its banks.</p> <p>At the footpath stile the stream has a normal flow and the water is clear.</p>

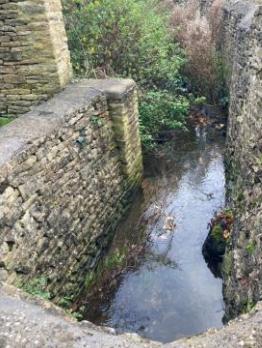
<p>10. Grange Farm bridge, Daglingworth Stream.</p> <p>There is a steady flow into the farm channel.</p> <p>There is still standing water present in the horse fields north of Grange Farm adjacent to the stream.</p>

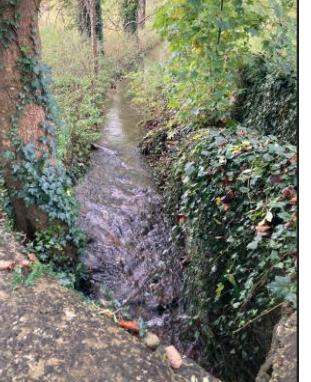
<p>11. School Hill bridge, Daglingworth Stream.</p> <p>The stream has a normal flow similar to that at Grange Farm.</p>

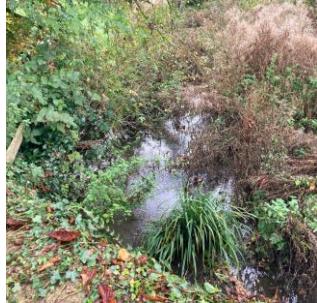
<p>12. Stratton End (private road), Daglingworth Stream.</p> <p>There is a normal flow in the stream. The pool downstream of the bridge is filled with slightly muddy water.</p>

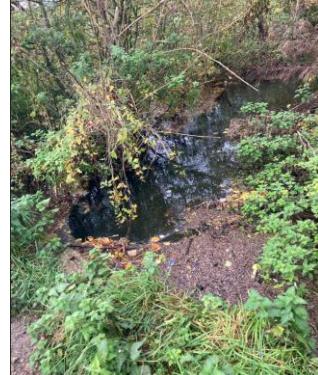
<p>15. Footpath at Lower Stratton, Daglingworth Stream.</p> <p>The stream is flowing at a normal rate.</p> <p>The stream level at this location is very high (close to the footbridge crest). This is believed to be due to heavy undergrowth and debris observed just downstream of this location.</p>

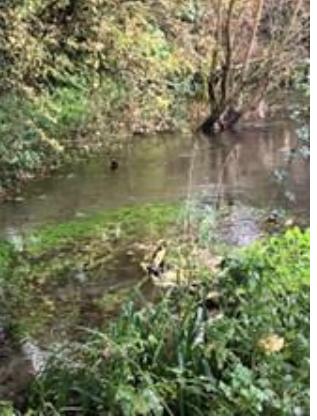
<p>16a. Daglingworth Stream at Barton Lane upstream of Bathurst Estate boundary wall</p> <p>A normal flow of clear water is observed.</p>

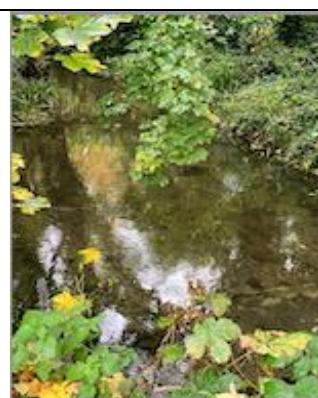
<p>16b. Daglingworth stream at Barton Lane downstream of Bathurst Estate boundary wall.</p> <p>A normal flow of clear water is observed.</p>

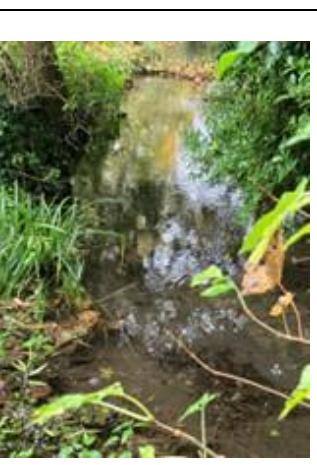
<p>17. Gumstool Brook balancing stream at sluice gate.</p> <p>A normal clear flow is observed.</p>

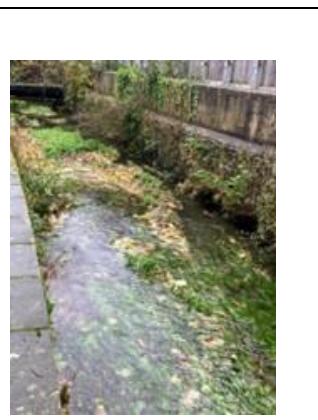
<p>18. Gumstool Brook alongside the Swimming Pool on the Riverside Walk.</p> <p>A normal flow is observed, and vegetation is still very thick.</p>

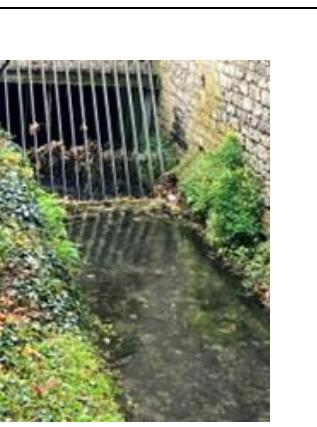
<p>20. Gumstool Brook at culvert trash screen.</p> <p>A normal flow is observed, and there is little debris present at the trash screen.</p>

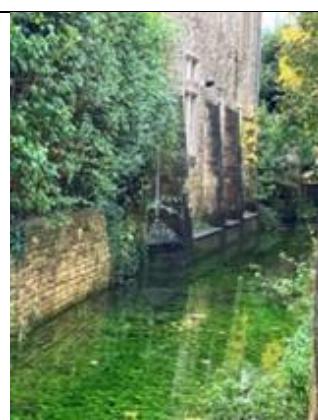
<p>21. Gumstool Brook Balancing Stream at Powell's School</p> <p>There is a normal flow and reduced vegetation</p>

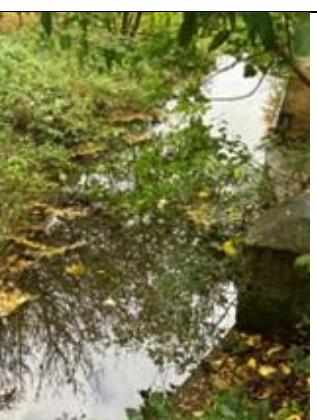
<p>22a. Gumstool Brook Balancing Stream behind Salvation Army.</p> <p>A normal flow is observed.</p>

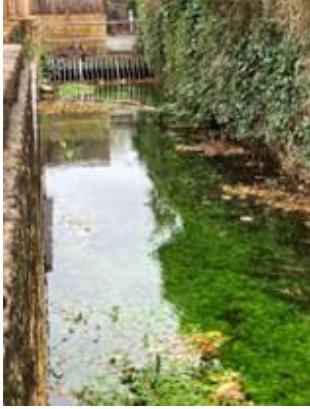
<p>22c. Gumstool Brook Balance Stream at Powell's School at trash screen.</p> <p>There is a steady flow and reduced vegetation</p>

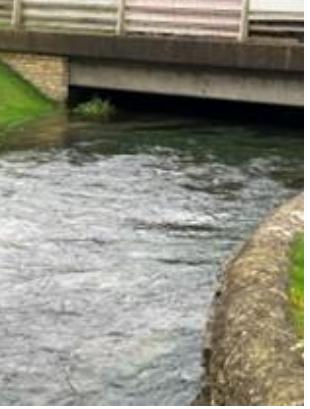
<p>23a. River Churn at Glos St bridge upstream of sluices</p> <p>A steady flow is observed.</p>

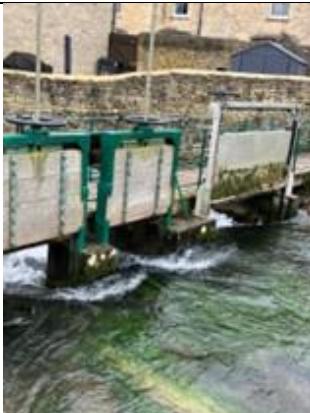
The large sluice gate at the Gloucester Street weir was opened progressively at the end of September and has remained fully open during October. The two small sluice gates also remain fully open. The stream into the Barton Mill Pound is flowing at a healthy rate.

<p>23b. River Churn at Glos St bridge sluices</p> <p>The large sluice gate is now fully open (~105cm).</p> <p>The two small sluice gates remain fully open.</p>

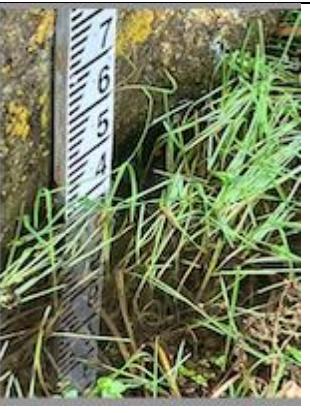
<p>23c. River Churn at the measuring gauge on Glos St bridge.</p> <p>The gauge is showing a level around 3.6 (0.36m) mark</p>

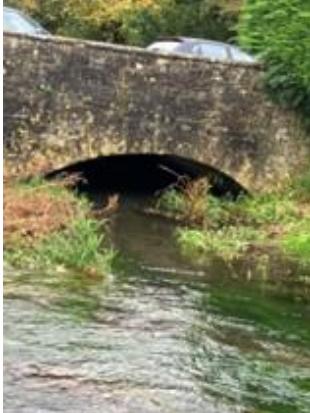
<p>23d. River Churn Glos St bridge view towards the Mill Pound.</p> <p>There is a normal flow entering into the Mill Pound.</p>

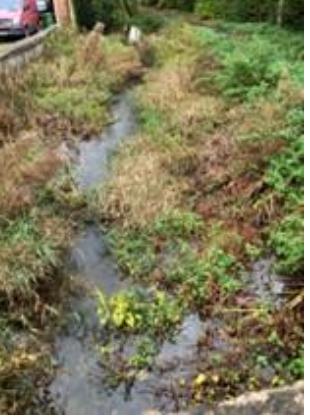
<p>24. Mill Pound looking downstream from Glos St bridge.</p> <p>A normal flow is observed in the central channel.</p> <p>Significant vegetation is present around the stream channel.</p>

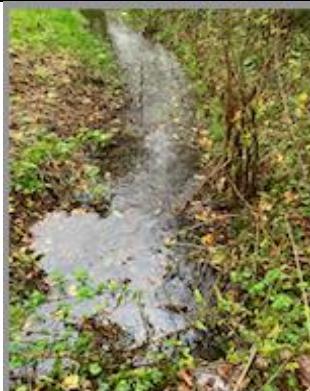
<p>25. Mill Pound Overflow (New)</p> <p>A low flow is observed at the offtake. The Mill pound water level is halfway up the overflow pipe inlet, but leaf debris are partially blocking the flow.</p>

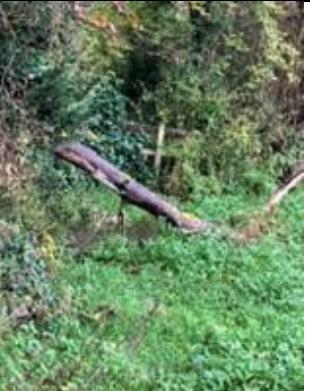
<p>26. Mill Pound Overflow (Old)</p> <p>A steady flow is audible, and water is observed in the field.</p>

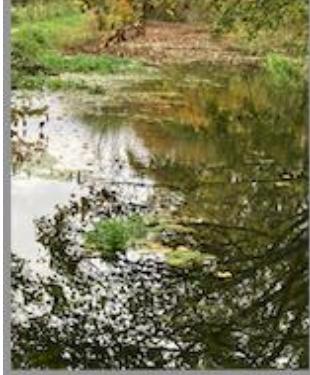
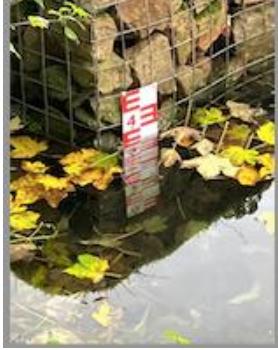
A new 50cm gauge board has been installed on the gabions near to the riverside walk footbridge across the Barton Mill Pound (monitoring location 27).

<p>27a. Mill Pound upstream of footbridge.</p> <p>A steady slow flow is observed.</p> <p>There are still extensive river plants in the mill pound.</p> <p>The new level gauge installed near the footbridge is reading 0.37m.</p>

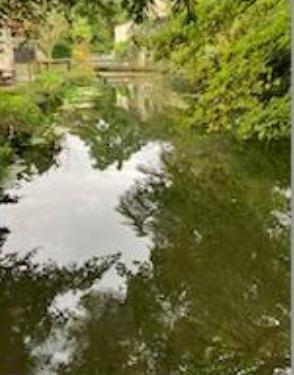
<p>27b. Mill Pound downstream of footbridge.</p> <p>A steady flow is observed. Less algae is visible.</p>

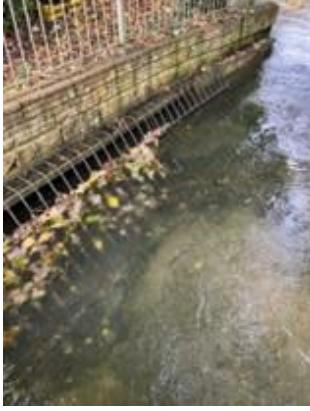
<p>36a. River Churn at Hereward Road trash screen.</p> <p>There is a steady flow entering the culvert</p>

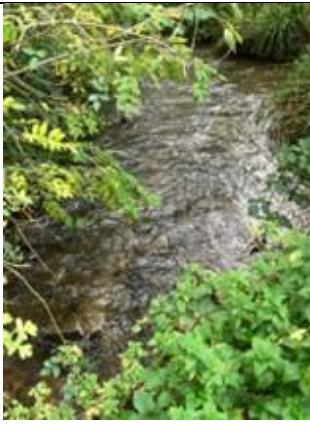
<p>37. Abbey Lake – Churn (West) Inflow</p> <p>There is a normal flow.</p>

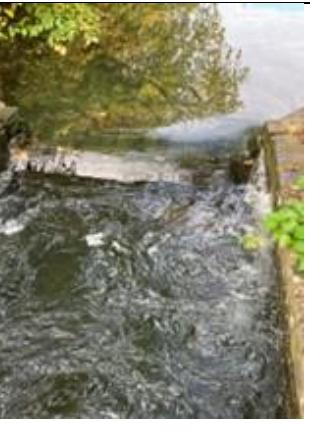
<p>38a. Abbey Lake weir – Churn (West) outflow.</p> <p>View upstream.</p> <p>There is a steady normal flow through the weir.</p>

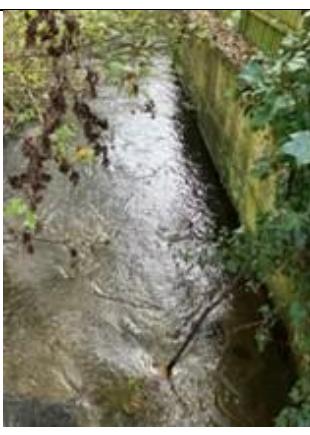
<p>38b. Abbey Lake outflow – Churn (West)</p> <p>View downstream from Corinium Gate footbridge</p> <p>There is a normal flow.</p>

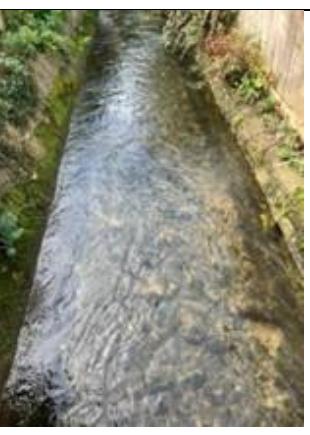
<p>39 Abbey Lake outlet stream at Corinium Gate bridge – Churn (West)</p> <p>There is a normal flow.</p>

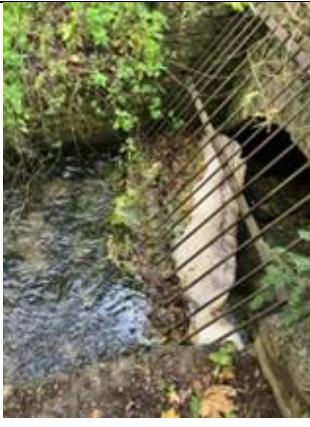
<p>40. Gumstool Brook culvert outlet in Abbey Grounds</p> <p>There is a normal flow.</p>

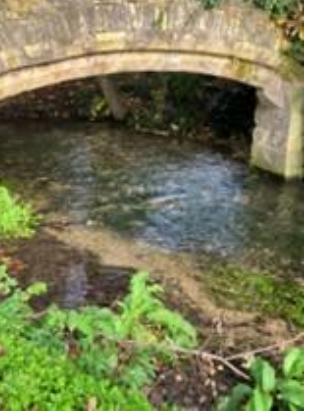
<p>41a. Gumstool Brook - Confluence with Abbey Lake outlet (Waterloo carpark)</p> <p>Further upstream.</p> <p>There is a normal flow.</p>

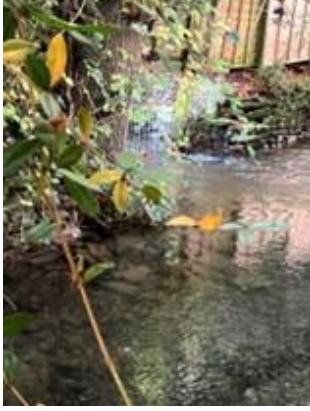
<p>41b. Gumstool Brook - Confluence with Abbey Lake outlet (Waterloo carpark)</p> <p>There is a normal flow.</p>

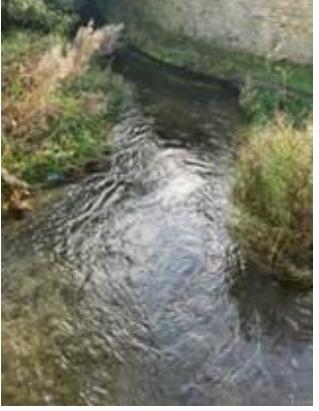
<p>42. River Churn (West) on the downstream side of London Road bridge</p> <p>There is a normal flow.</p>

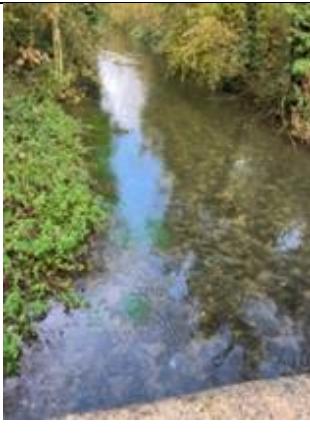
<p>43. River Churn (East) upstream of Old Beeches Road bridge</p> <p>There is a normal flow.</p>

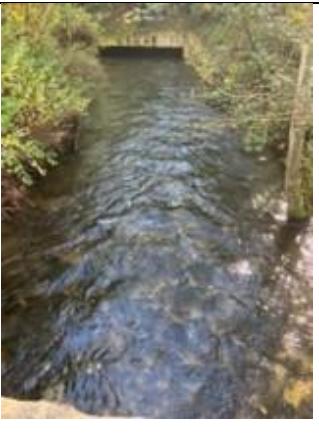
<p>44. River Churn (East) at Old Beeches Road Bridge looking downstream</p> <p>There is a normal flow.</p>

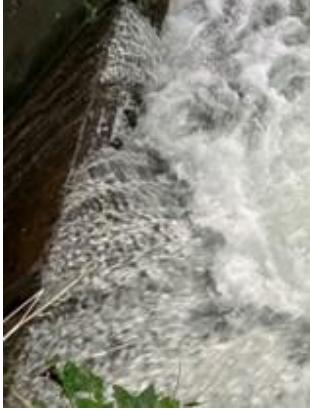
<p>45. New Mills weir discharge – Churn (East)</p> <p>Fast overflow from New Mills</p>

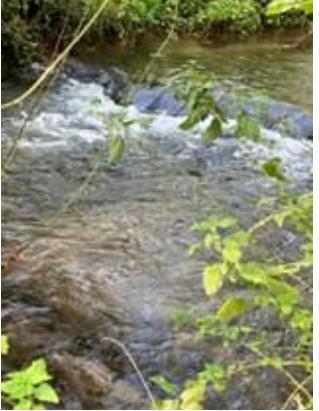
<p>46. River Churn (West) weir in City Bank glade.</p> <p>There is a normal flow.</p>

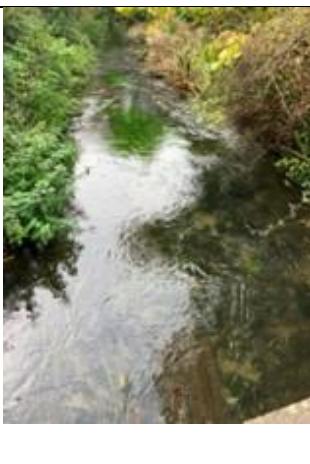
<p>47. River Churn (West) at City Bank Park footbridge</p> <p>There is a normal flow.</p>

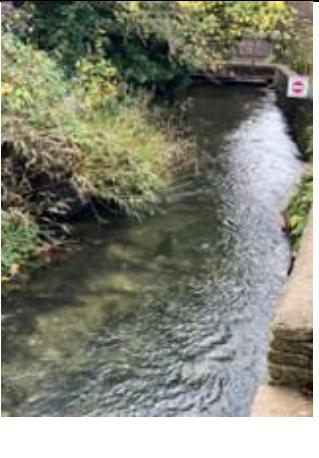
<p>48. River Churn (West) at 161 Watermoor End</p> <p>There is a normal flow.</p>

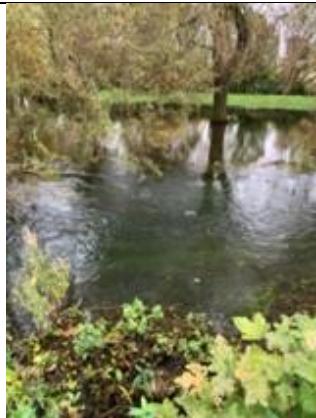
49 River Churn at
Cricklade Road
(opposite Aldi)

The river level remains
high, overflowing the
banks in places.

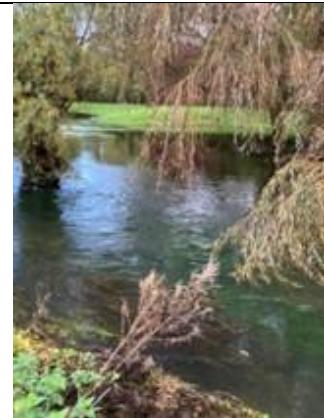
50 River Churn at
Cricklade Road
(opposite Tesco)

The river level
remains high,
overflowing the
banks in places.
