Cirencester Rivers Report: November 2024

By Cirencester Wildlife Group

Based on field surveys in September 2024 by Huw Jones, Melanie Dodd, Peter Newbold and Lyn Newbold

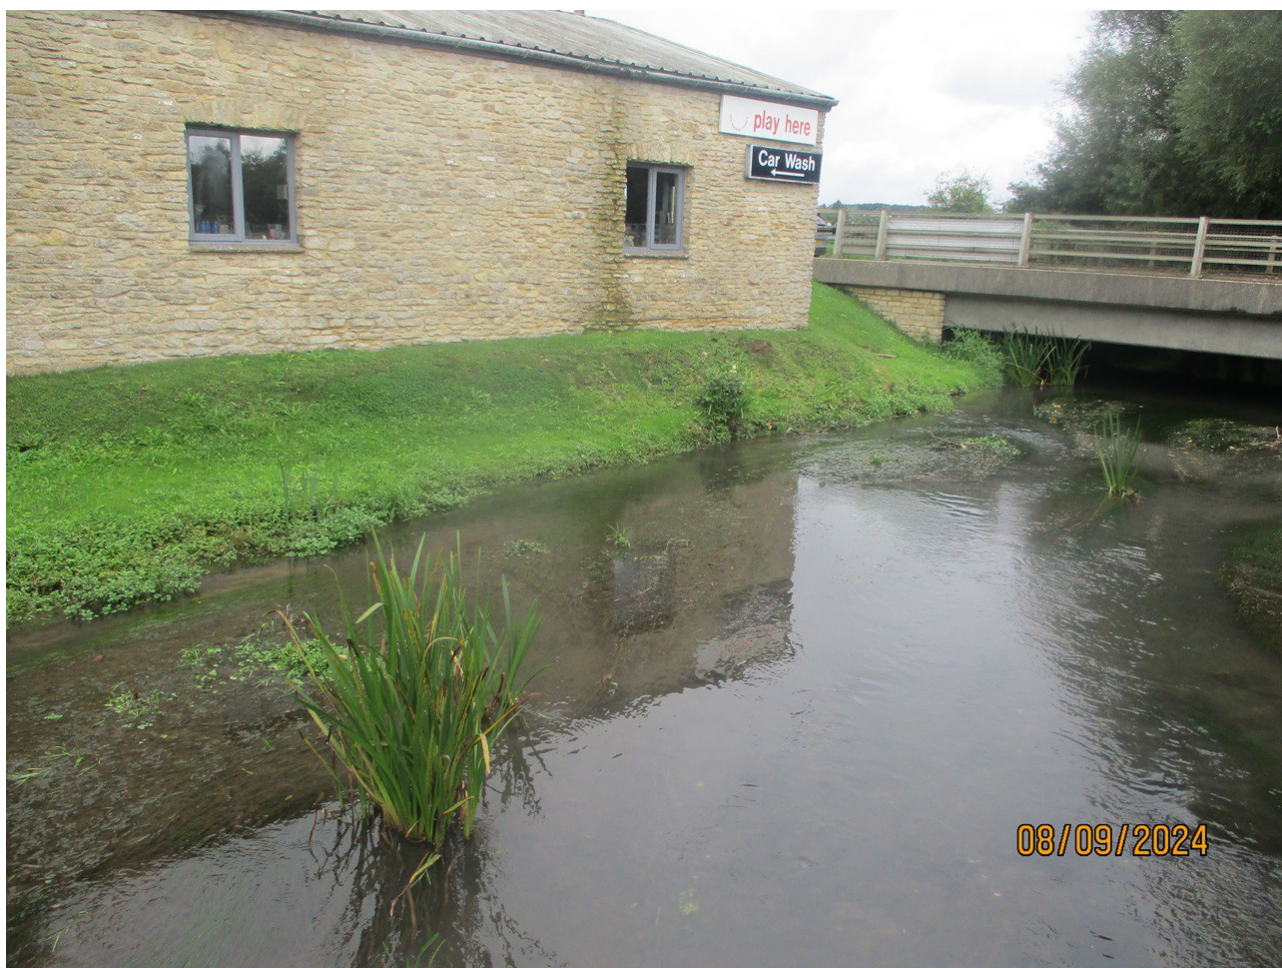
The river bank by the Texaco garage was trimmed in Summer 2024 to ground level.

Illustration 1. A trimmed river bank by the Texaco garage

Recommendation: CWG to contact landowner and request that a vegetative barrier is left to grow along the river bank. This will provide additional habitat for a range of wildlife and encourage marginal vegetation to colonise.

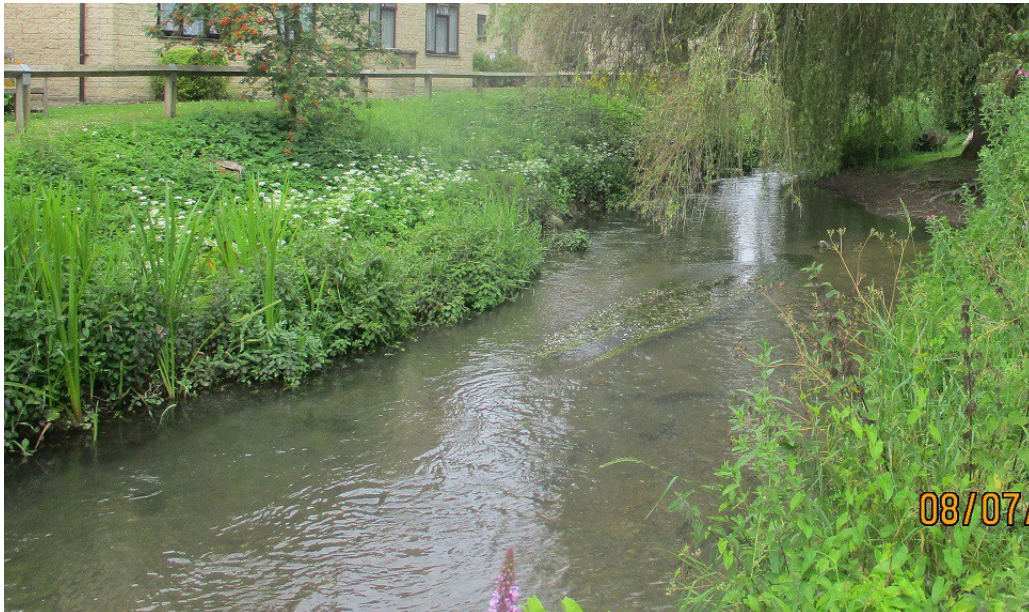
Below the Gloucester Street sluices, the river through Jack Gardeners is in relatively good ecological condition with good flow, a gravel bed, a range of light and shade, and bankside and aquatic vegetation. The river is protected by an uncut barrier of vegetation along the public-facing bank which is left uncut in spring and summer. There is a single dog access point just below Goosacre Lane which is in a shaded area where there is little riparian vegetation. This would be difficult to cut off, and can be left as is.

Illustration 2. Riparian and bankside vegetation at Jack Gardeners

Recommendation to maintain vegetative barrier: Maintain a minimum 2 to 3 metre wide vegetative barrier along left (public-facing) river bank, cutting annually in winter to prevent succession to scrub. Leave riparian and bankside vegetation uncut along right bank below barrier in front of housing where possible.

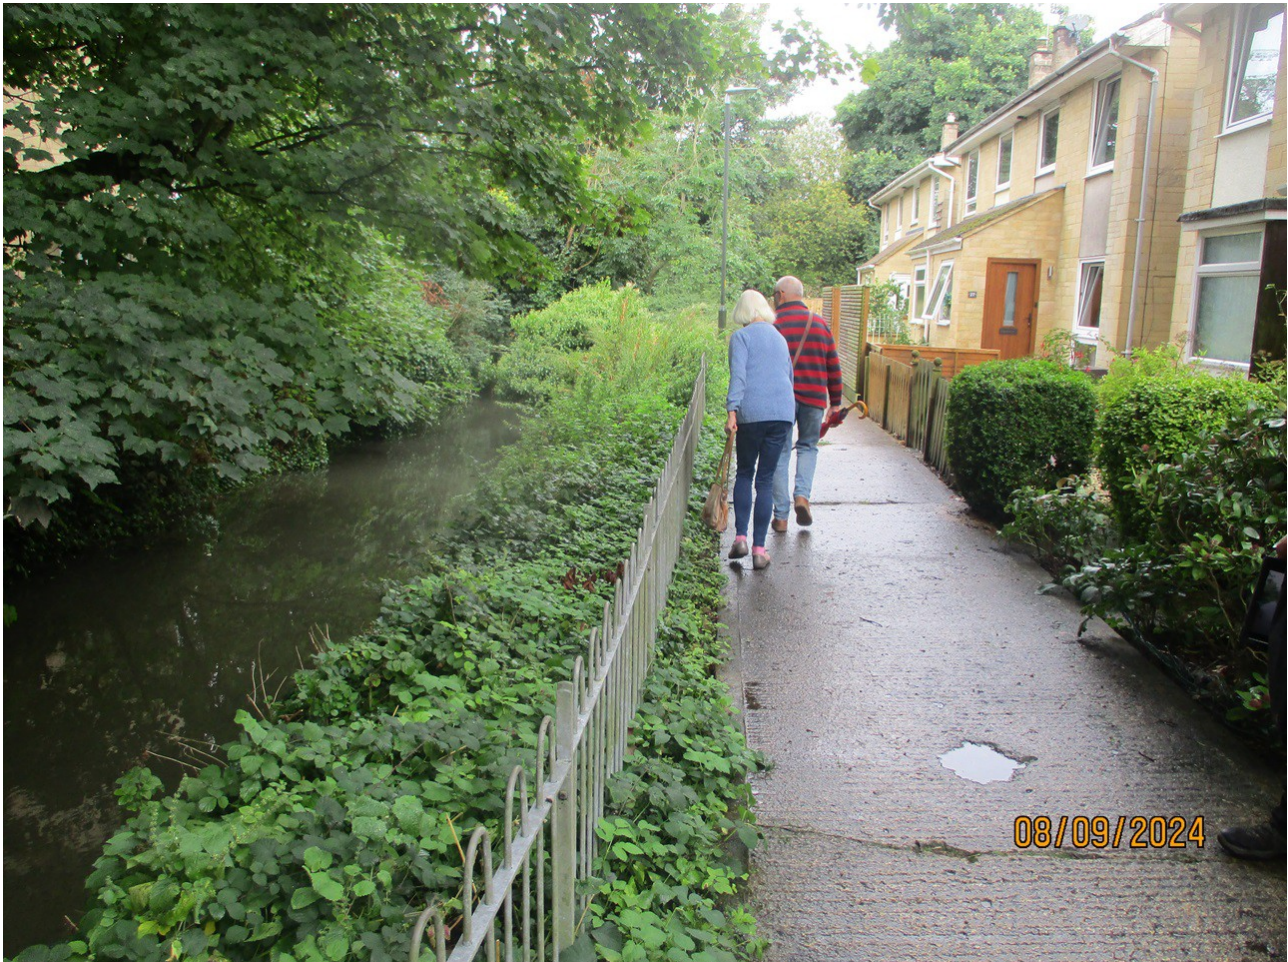
The river channel is in a deep canalised channel with overshadowing but little practical potential for enhancement. No recommendation.

Illustration 3. Canalised river near Hereward Road

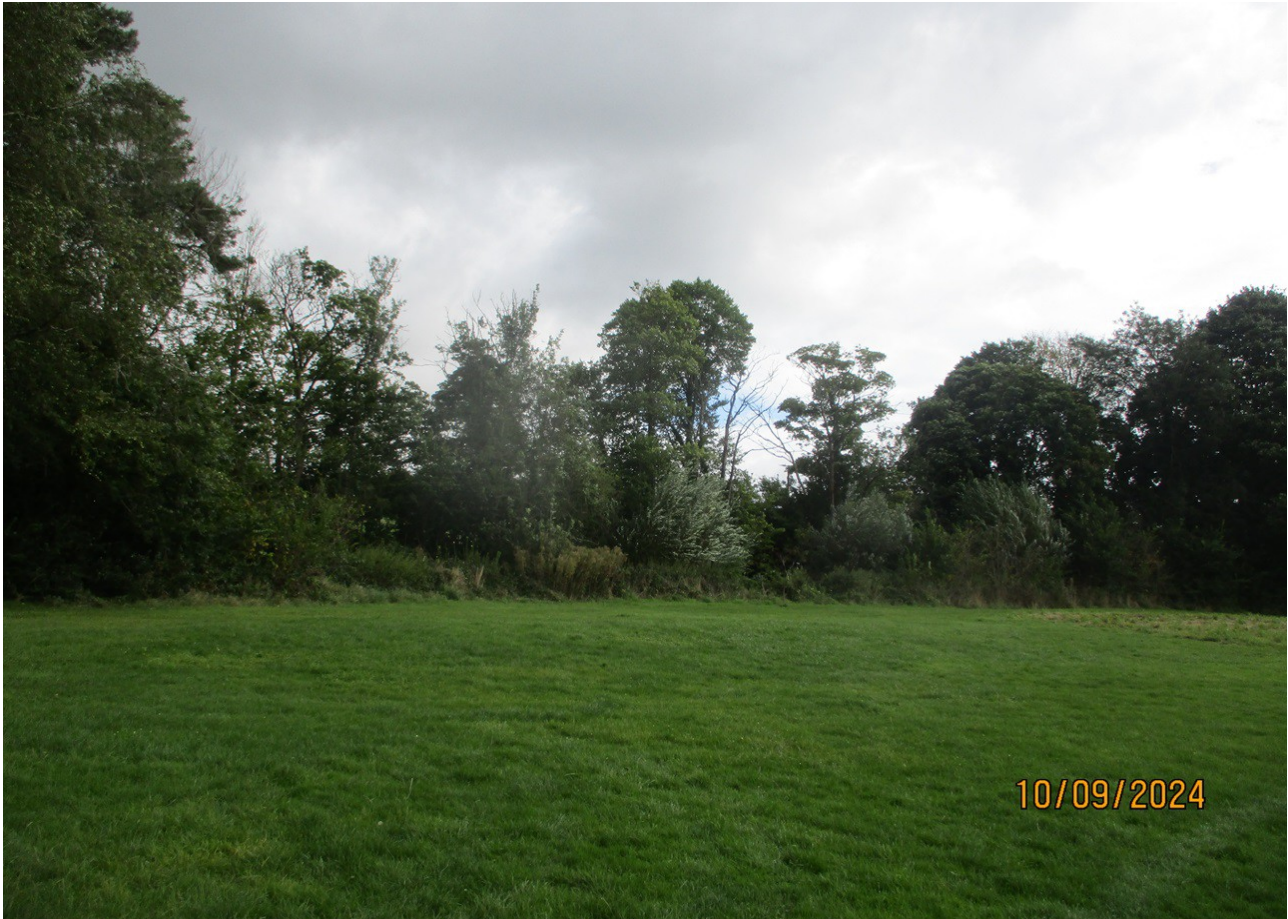
The main branch of the Churn is heavily shaded along the entire length of the Abbey Grounds with little riparian vegetation. There is also some litter including larger items in the river. The river runs roughly west to east and shading is mainly from the southern bank ie the Abbey Grounds side. The trees along the northern bank adjacent to the dual carriageway do not generally shade the river, apart from some overhanging branches. While shading is mostly from mature trees, there are gaps and areas of reduced cover with scrub and previously pollarded willows, where deshading would be much easier. The greatest potential for cost effective deshading is opposite the lake for about 100 metres east from the playground.

Illustration 4. A 100m length of the Churn opposite the Abbey Grounds lake could be opened up where vegetation on the south bank top consists of scrub, saplings and pollarded willows, book-ended by mature trees.

Recommendation for shade reduction: Identify sections of the river along the southern banktop (as in Illustration 4 above) which could be opened up by a combination of removing saplings and scrub, pollarding willows, crown raising of mature trees (including potentially on northern banktop). Given the requirement for monitoring or removal of diseased or dangerous trees, it might be possible to add this work in a cost-effective way.

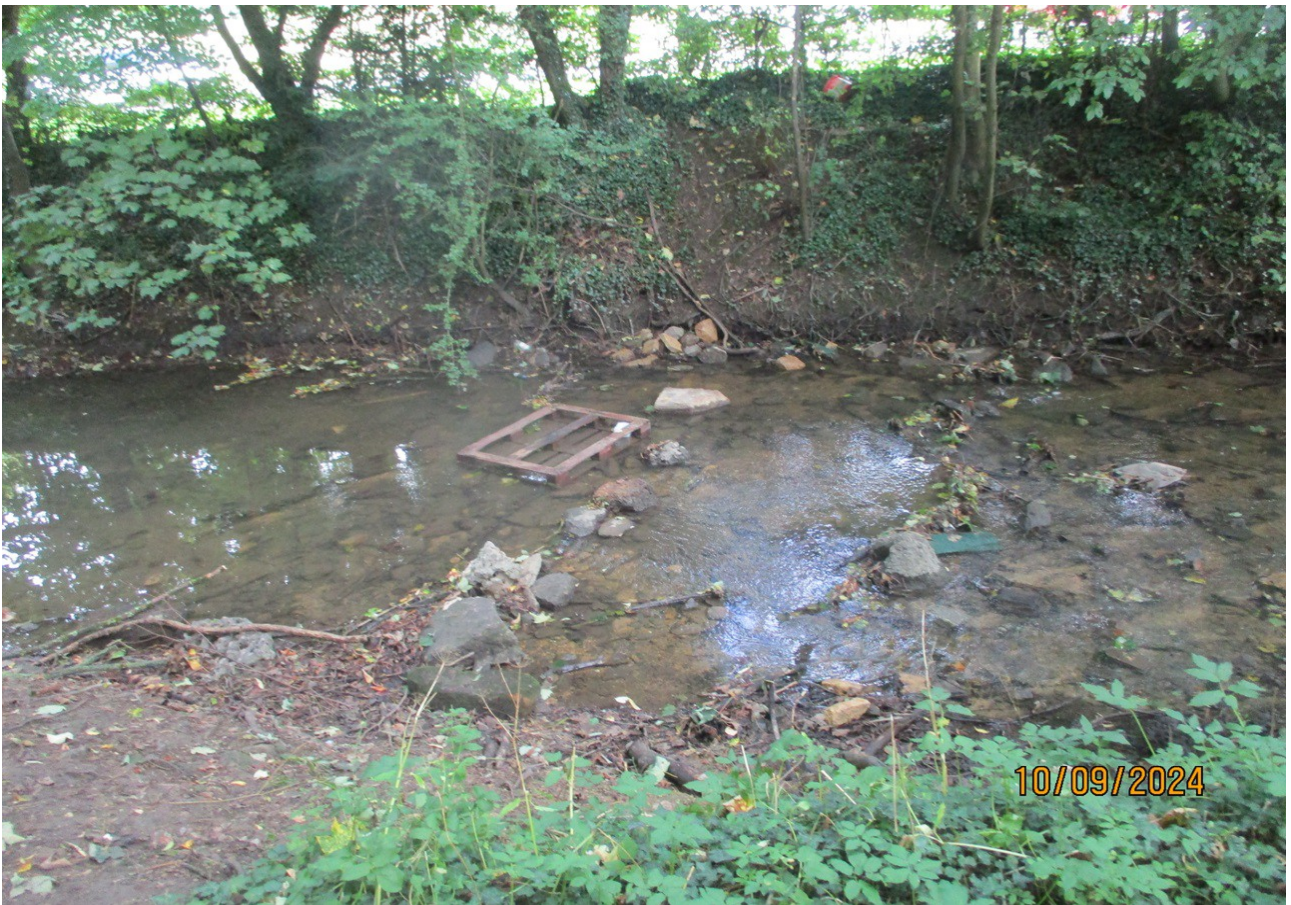
Illustration 5. Debris in shaded lengths of the Churn by Abbey Grounds

Recommendation for clearing debris: The aesthetic benefits of opening up sections of river would be undermined if rubbish and debris was left in the river. Local volunteer groups may be able to clear most of the rubbish but may need help from CTC to remove larger items.

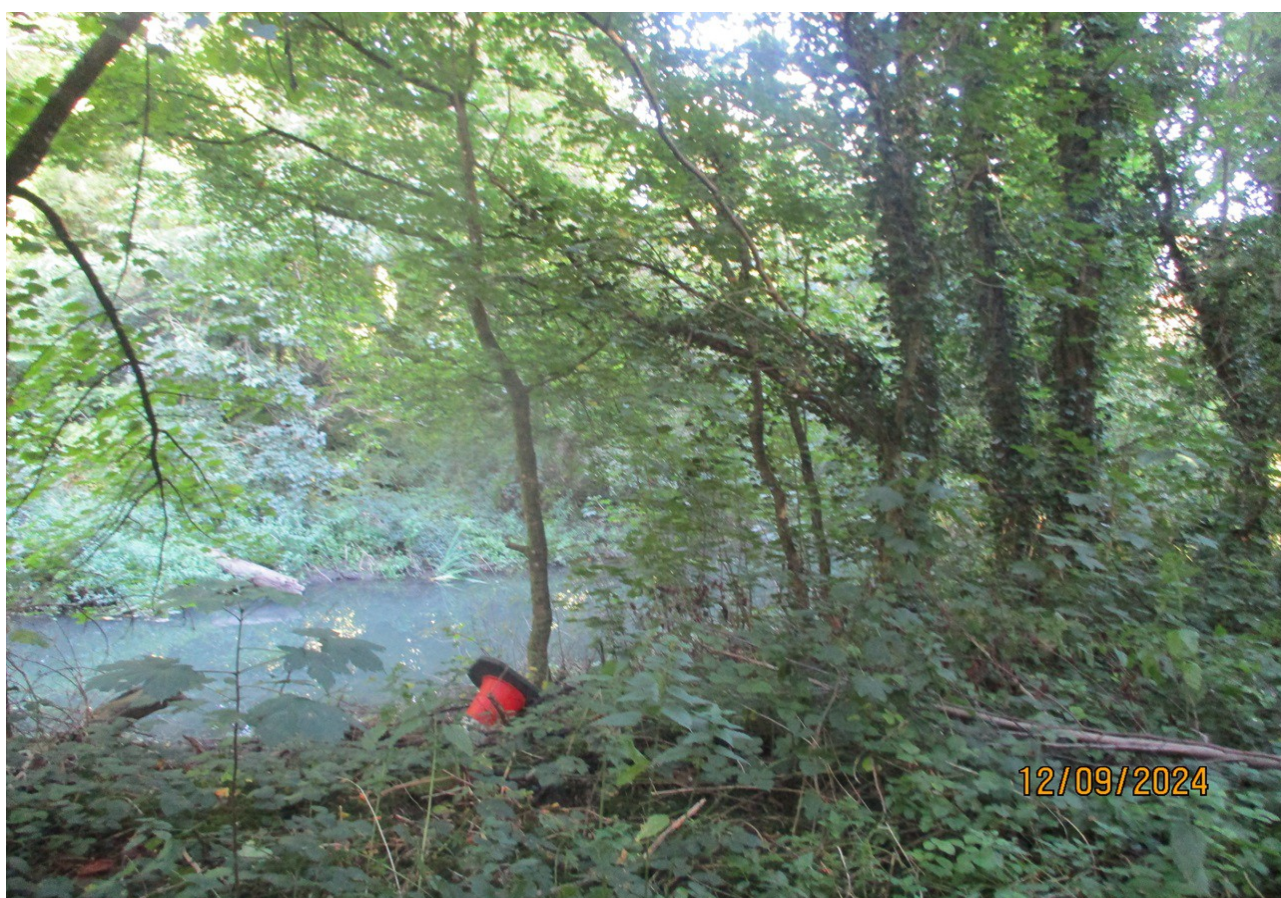
The main branch of the Churn is heavily shaded all the way from London Road (by Barn Theatre) past the weir above City Bank to the Tesco roundabout at Kingsmeadow. There are limited opportunities for shade reduction. Any future tree management to remove diseased or dying trees may however present an opportunity for opening up sections of the river. These should be considered and implemented where possible. This area is thought to be the responsibility of CDC.

Illustration 6. Heavy shading on the Churn between London Road and Tesco roundabout

Recommendation for shade reduction: Look for opportunities to open up stretches of river when planning any tree management work alongside waterways.

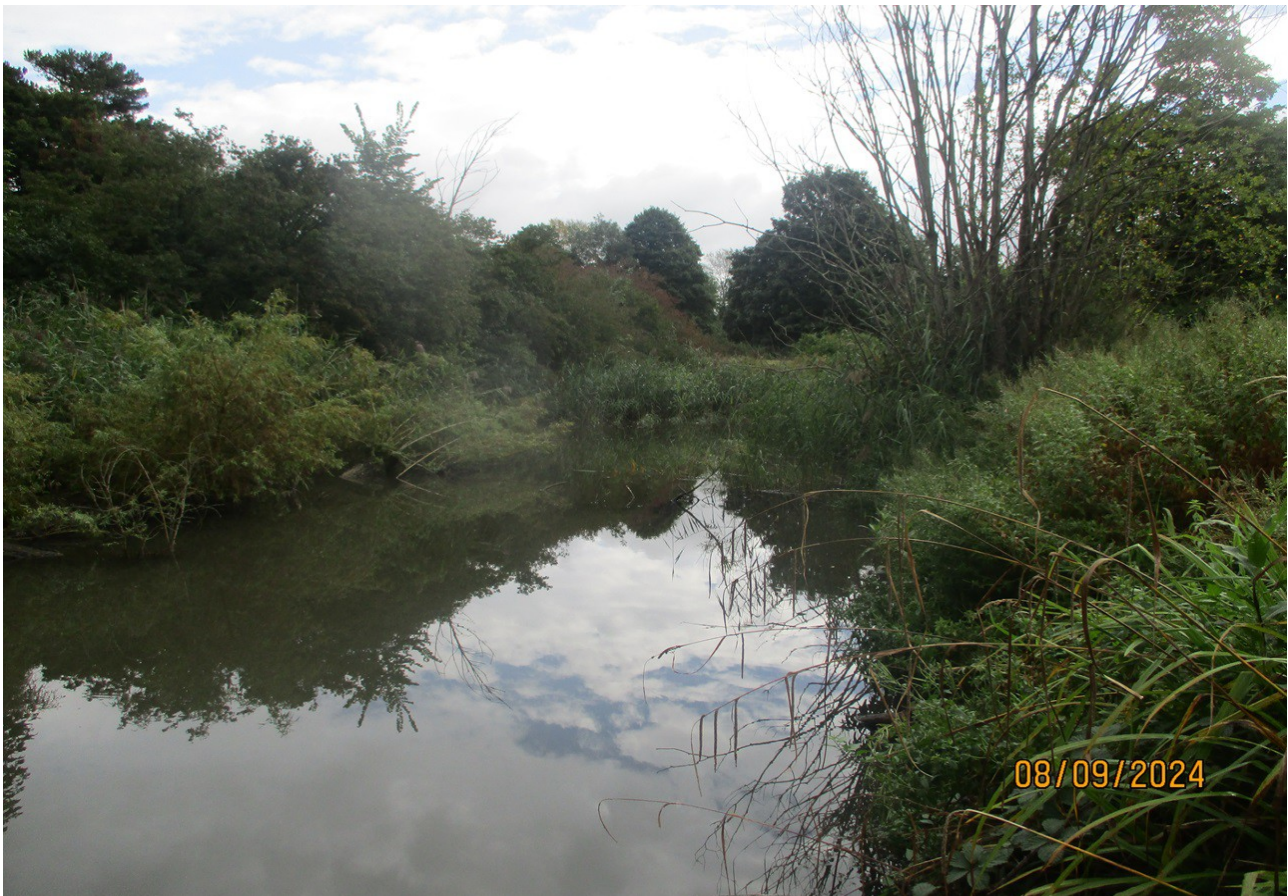
There is a dog access point just below the culverted outflow into the lake at the western end which would be hard to stop-up and is in a shaded area with limited aquatic vegetation, so the ecological impact is limited. A little further downstream on either side of the lake, there are common reeds (*Phragmites australis*) growing on both banks. There is the potential to extend the reedbeds into the lake and along a greater section of bank. This would extend the reedbed habitat used by breeding birds such as warblers, and would also create a filter to help purify flow, by reducing nutrients and sediment.

Illustration 7. A narrow section near the top of the Abbey Grounds lake with reeds on both banks

Recommendation for extending reedbeds: Add faggots along the banks on either side of the lake to help the reedbed extend over a greater area.

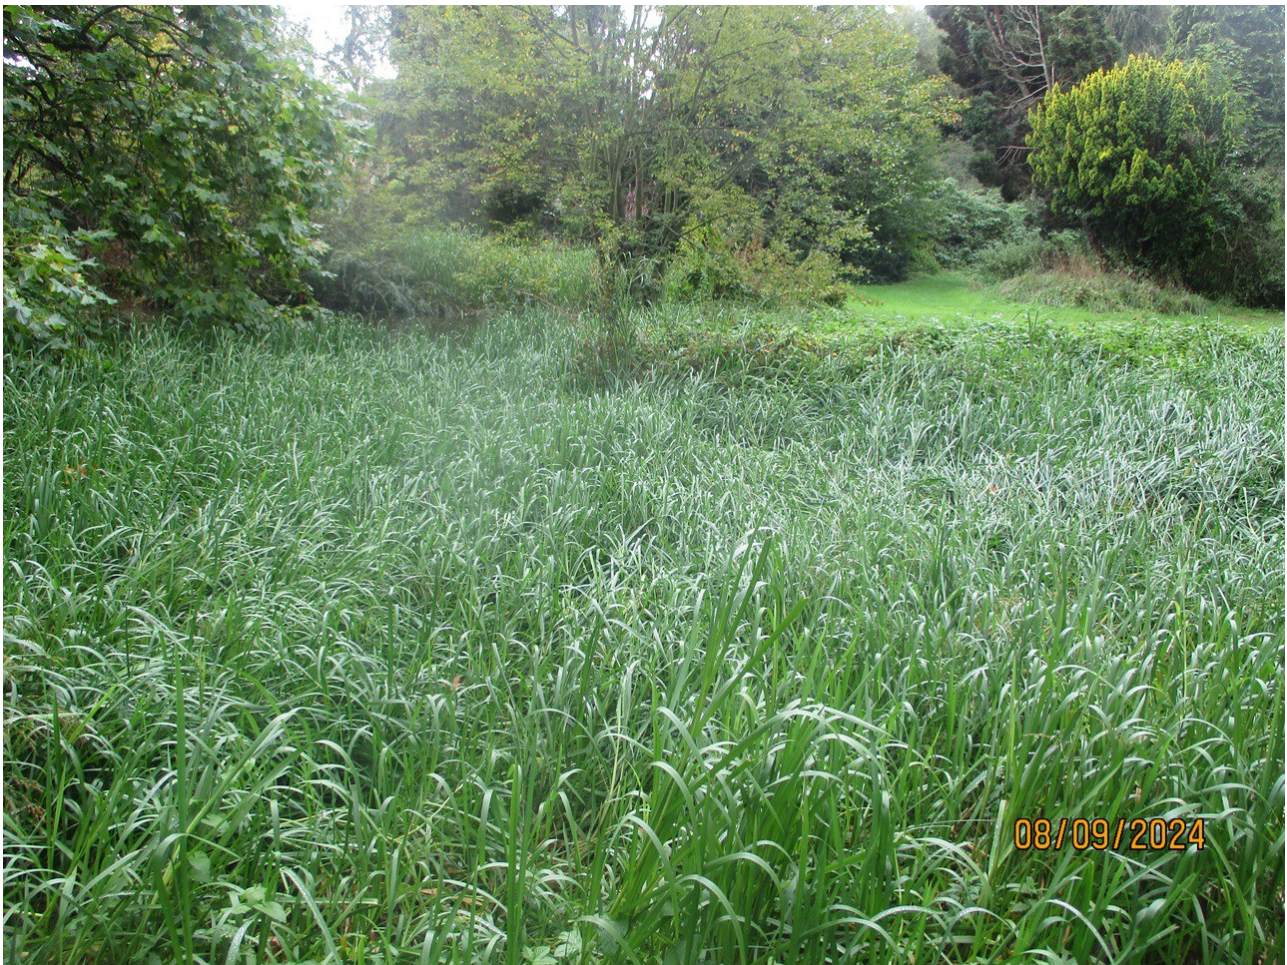
There are two ponds and some connecting channels in an area of woodland at the SE corner of the Abbey Grounds lake. These should be monitored annually to ensure there is some open water maintained in the middle of the ponds while retaining plenty of emergent vegetation.

There is banktop scrub which should be maintained at or below current levels to prevent over-shading

Illustration 8. Ponds near the Abbey Grounds lake with extensive emergent vegetation

Recommendation to maintain ponds: Remove vegetation and silt if necessary from the centre of the ponds to restore open water. No more than 50% of silt and vegetation should be removed in any one year to leave habitat and resources for breeding amphibians and other pond wildlife.

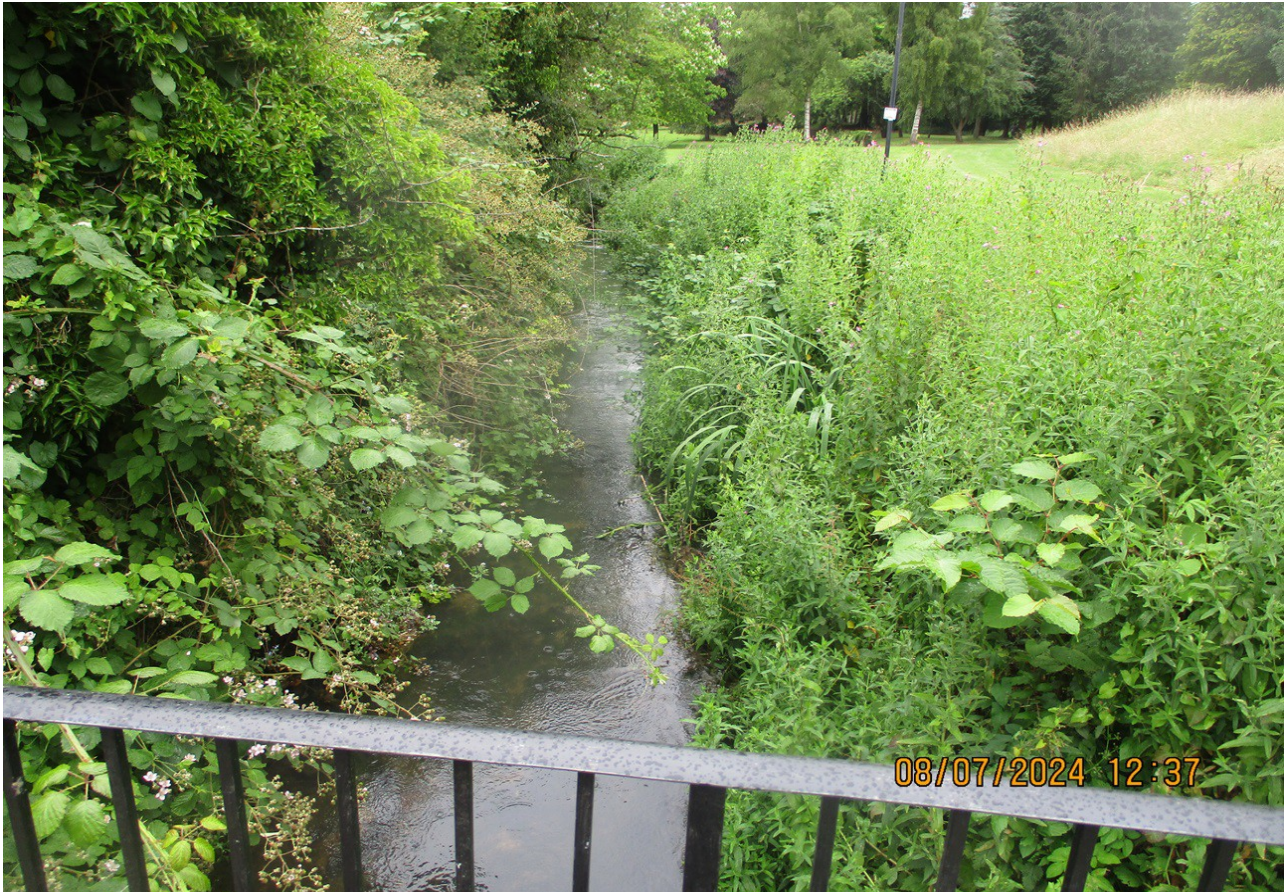
The canalised channel from the weir at the lower end of the Abbey Grounds lake to Corinium Gate has hedgerows and bankside vegetation. While bankside vegetation is welcome, there is a risk of the channel being overgrown and this should be prevented. Japanese Knotweed has been found at this location and treatment is in hand organised by CTC with advice from CWG. Another alien invasive plant, Gunnera is also present.

Illustration 9. Thick vegetation along a channel below the Abbey Grounds lake

Recommendation to maintain vegetation. Inspect every few years and cut back any bramble or other growth out over the channel.

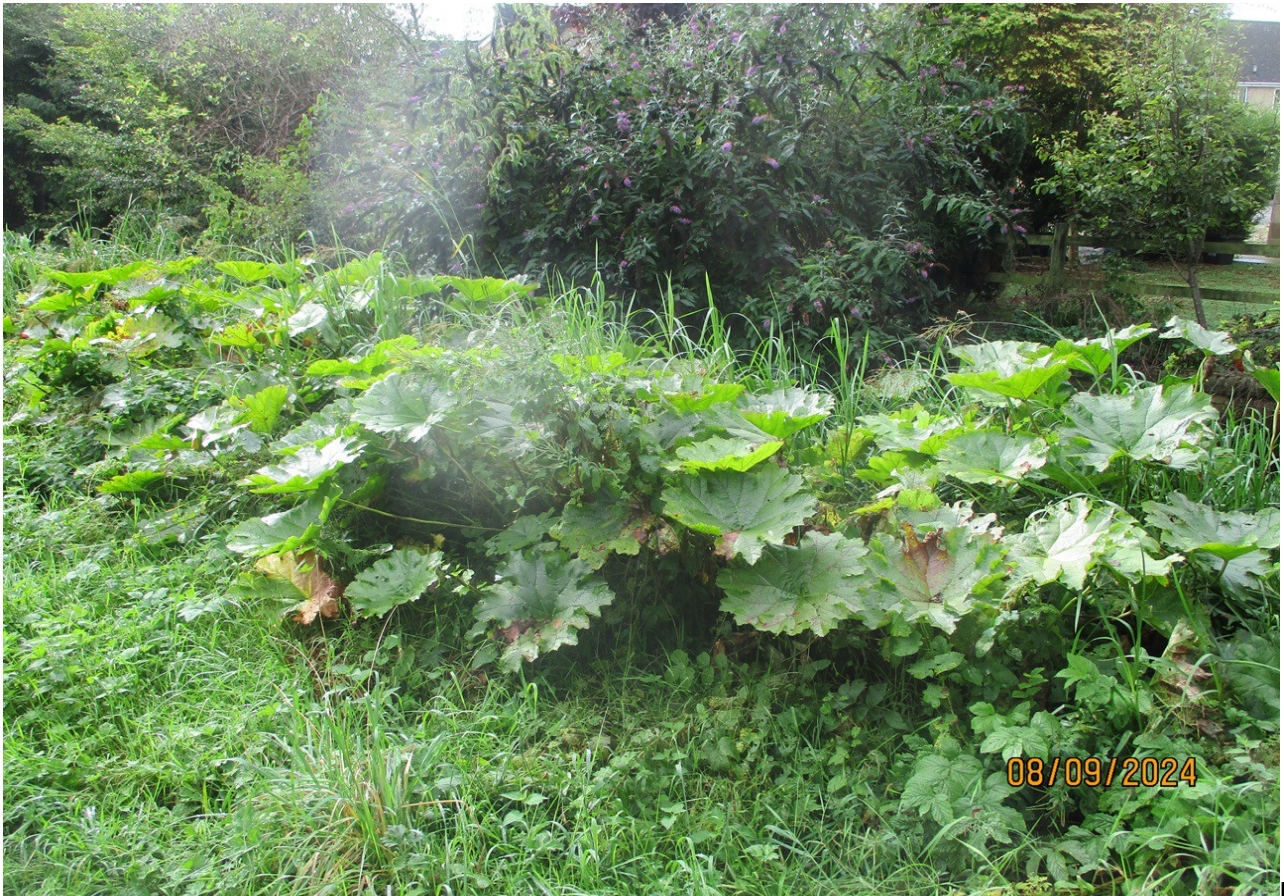
Illustration 10. Gunnera in the Abbey Grounds near Corinium Gate

Recommendation to tackle Gunnera: CWG to investigate practicality of treating or containing Gunnera.

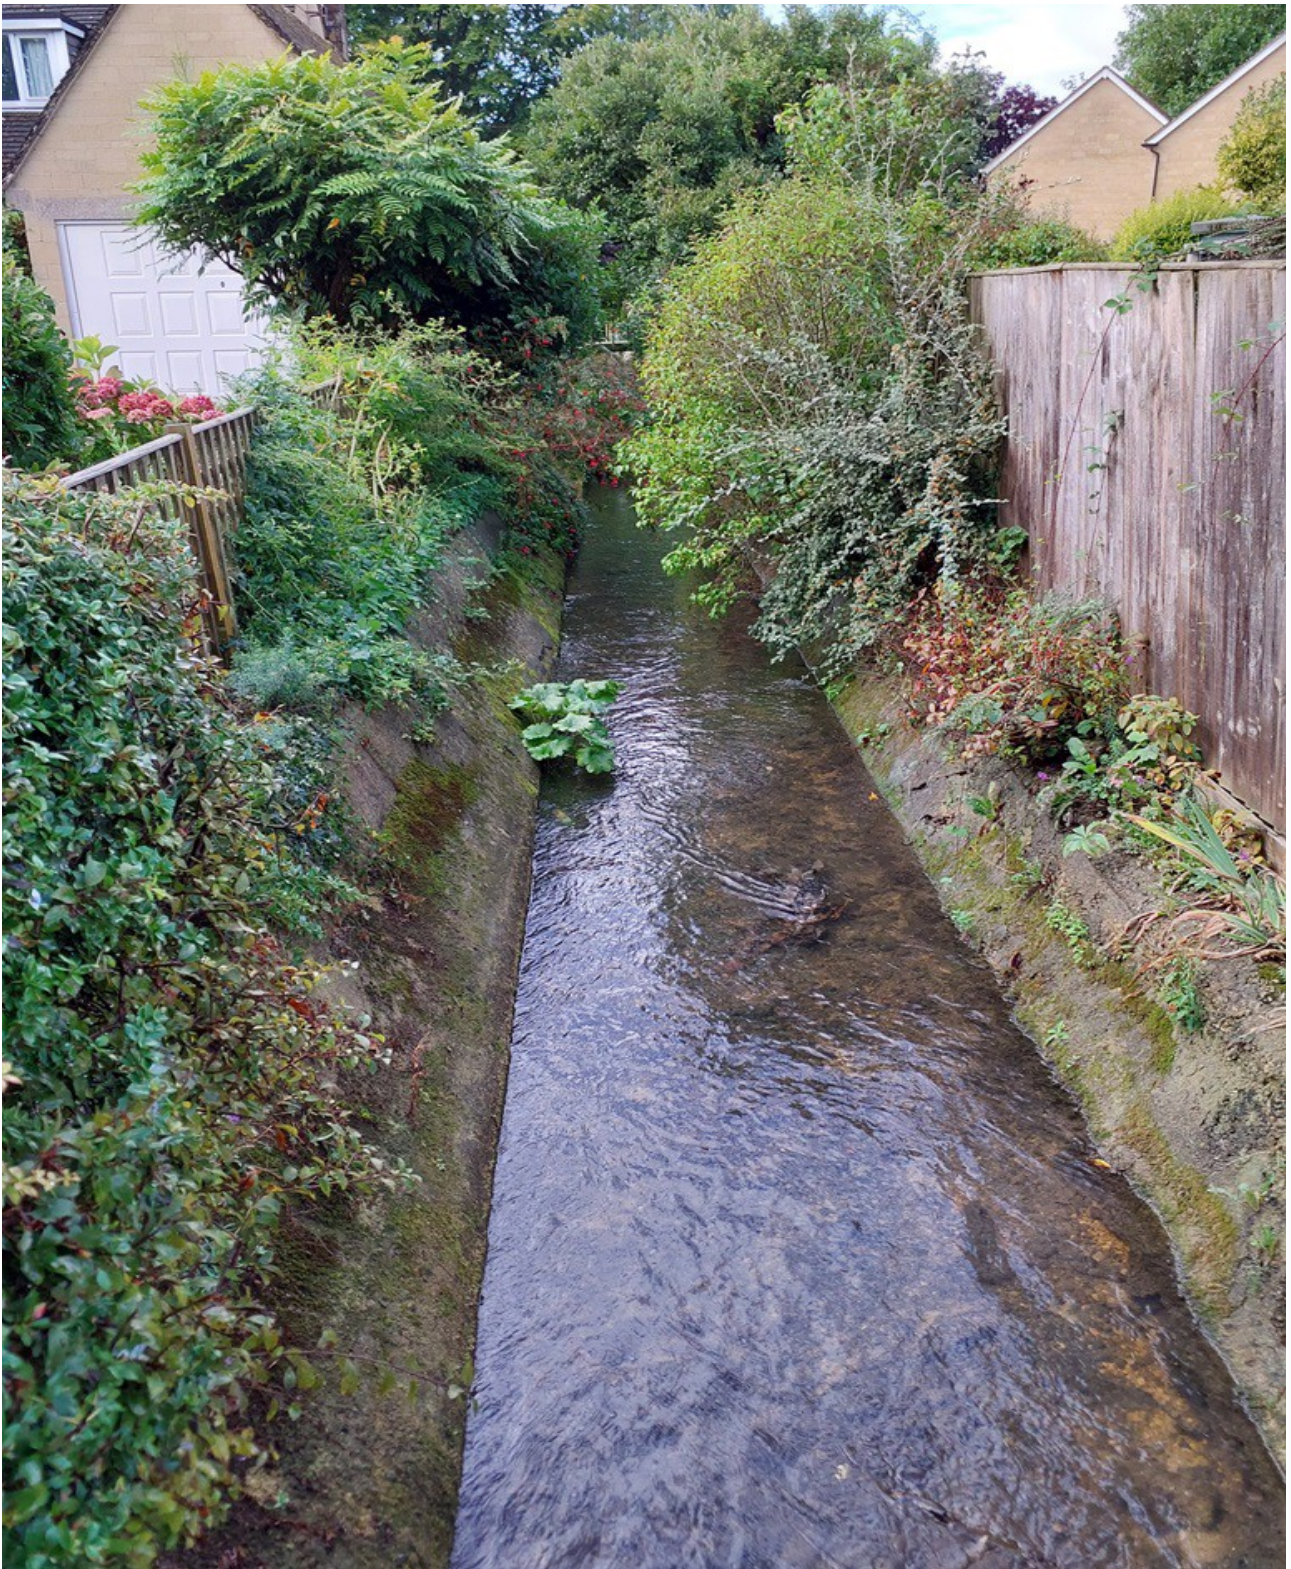
The river is joined by the Gumstool Brook beside Waterloo Car Park and runs behind the gardens of properties on Corinium Gate and below Waterloo car park in a tightly constrained concrete channel. No recommendation.

Illustration 11. Culverted channel between the Waterloo car park and London Road, behind gardens on Corinium Gate

Potential for river restoration if Waterloo car park is redeveloped.

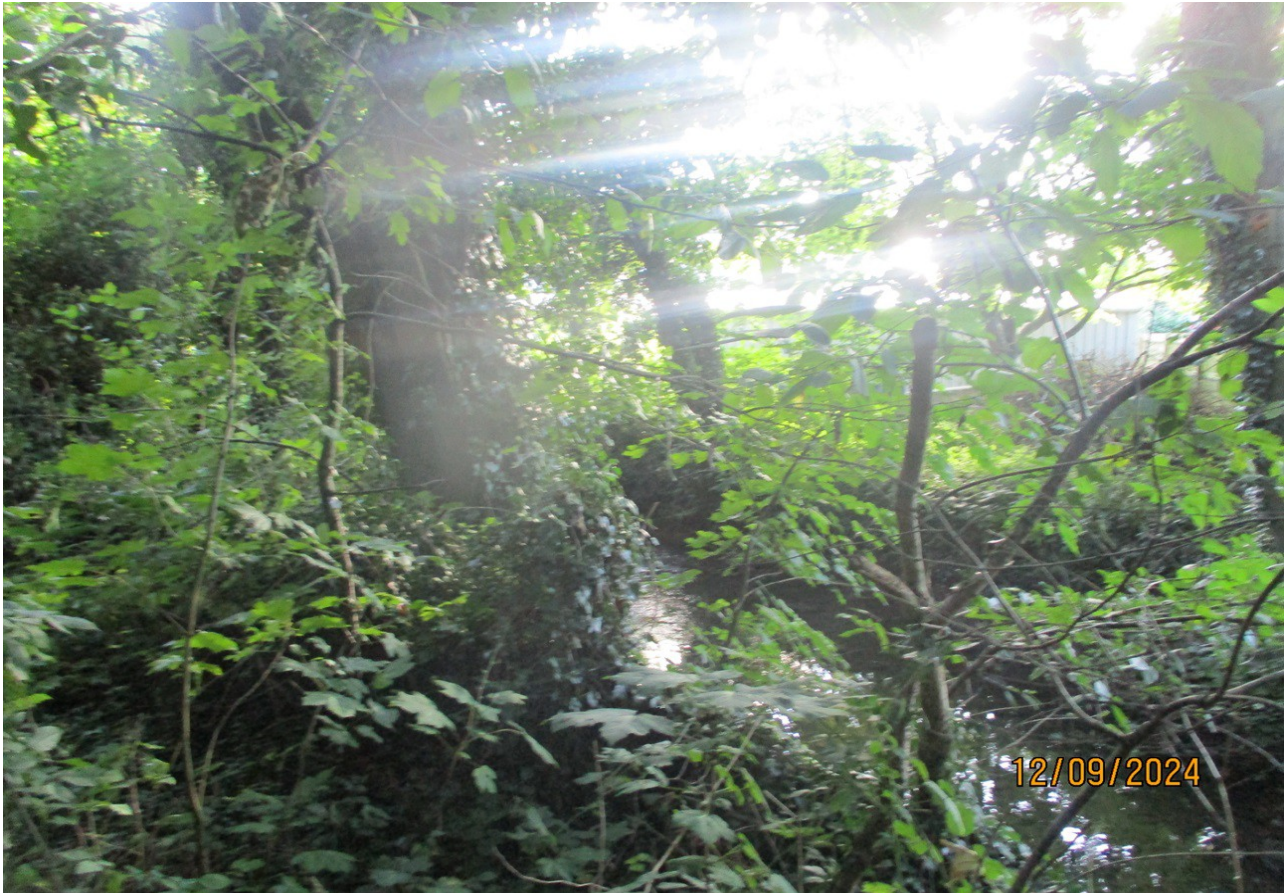
The secondary branch of the Churn runs between Beeches Road Car Park and the gardens at the rear of Purley Road and then on between woodland owned by the Cirencester Opportunity Group and scrub along the rear of Victoria Road Meadow. The river is heavily shaded along this length.

Illustration 12. The channel is heavily shaded as it passes between Beeches Road car park and back gardens on Purley Road

Potential for river restoration if Beeches Road Car Park is redeveloped.

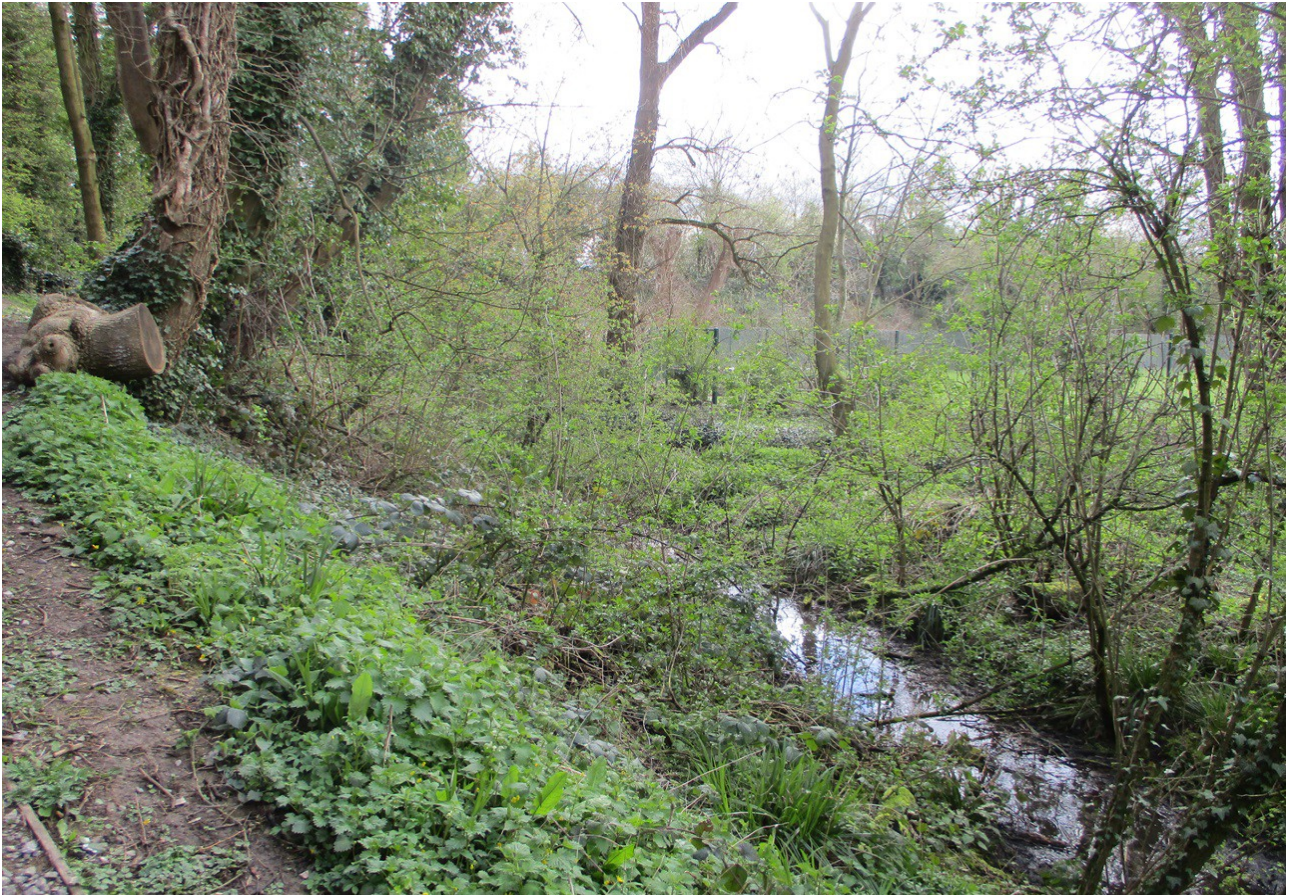
The river continues along the edge of this small woodland area beside Cirencester Primary School playing field. The woodland has a range of native trees and shrubs as well as a small pond and some wetland. This is a valuable habitat for breeding birds and other species which is enhanced by its connection to City Bank Local Nature Reserve immediately downstream. CWG is active in this area, managing the pond and monitoring wildlife. Any management work should be done in conjunction with their advice.

Illustration 13. Woodland at City Bank Glade with the river running along the edge behind Cirencester Primary School playing field.

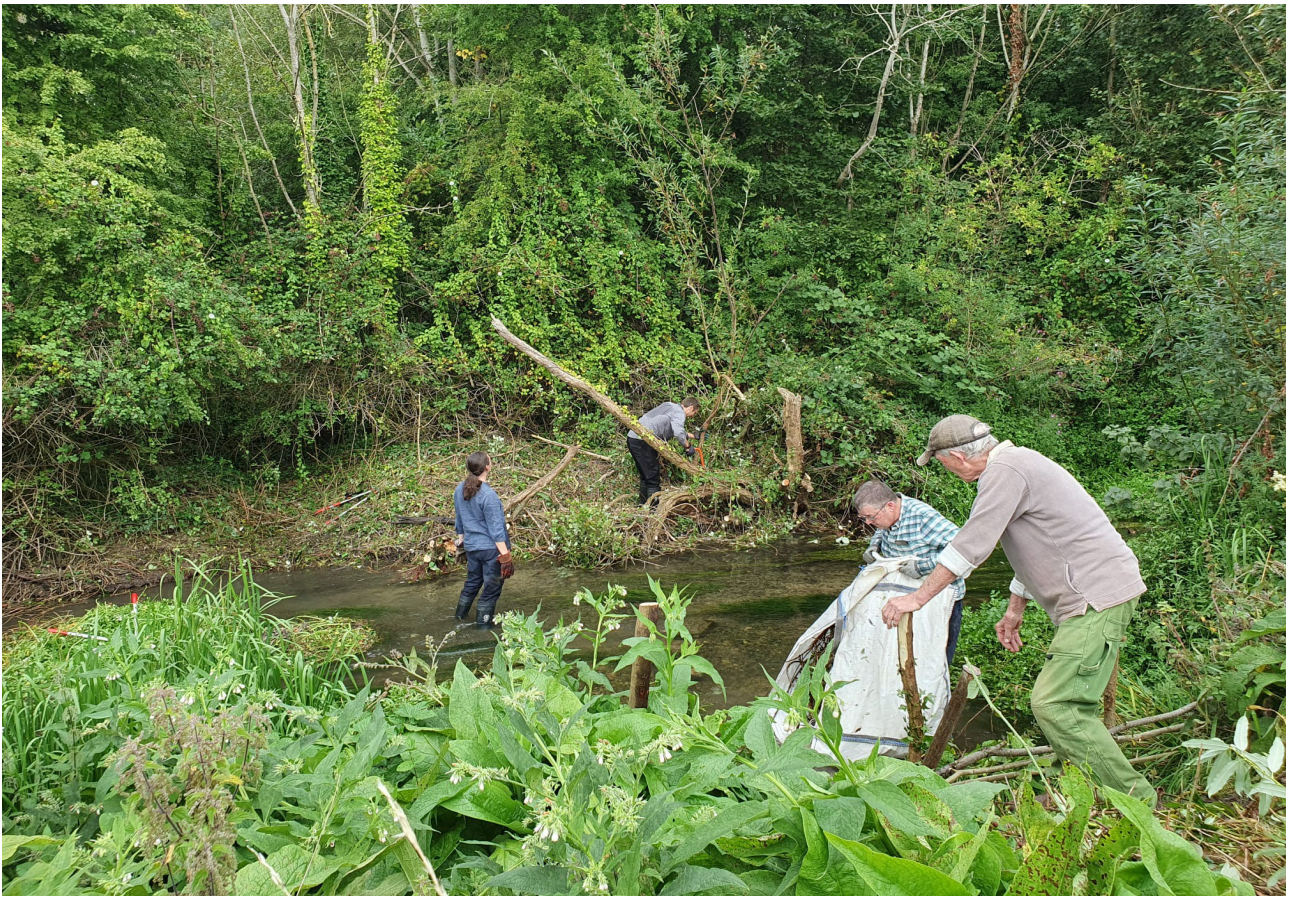
The right bank has become badly overgrown with scrub, including bramble which is growing over the riparian vegetation. CWG has attempted to cut some of this back but with limited success. Work access is limited to September after the end of bird nesting season and before the river rises to winter levels.

Illustration 14. A CWG work party removing scrub from the right bank of the river to restore Water vole habitat.

Recommendation to increase effort to cut back bramble and scrub growing over right bank.

CWG has had limited impact so far in cutting back the bramble and scrub because of the limited time window. Greater effort is needed and this might require better access or help from others such as CTC or other volunteer groups.

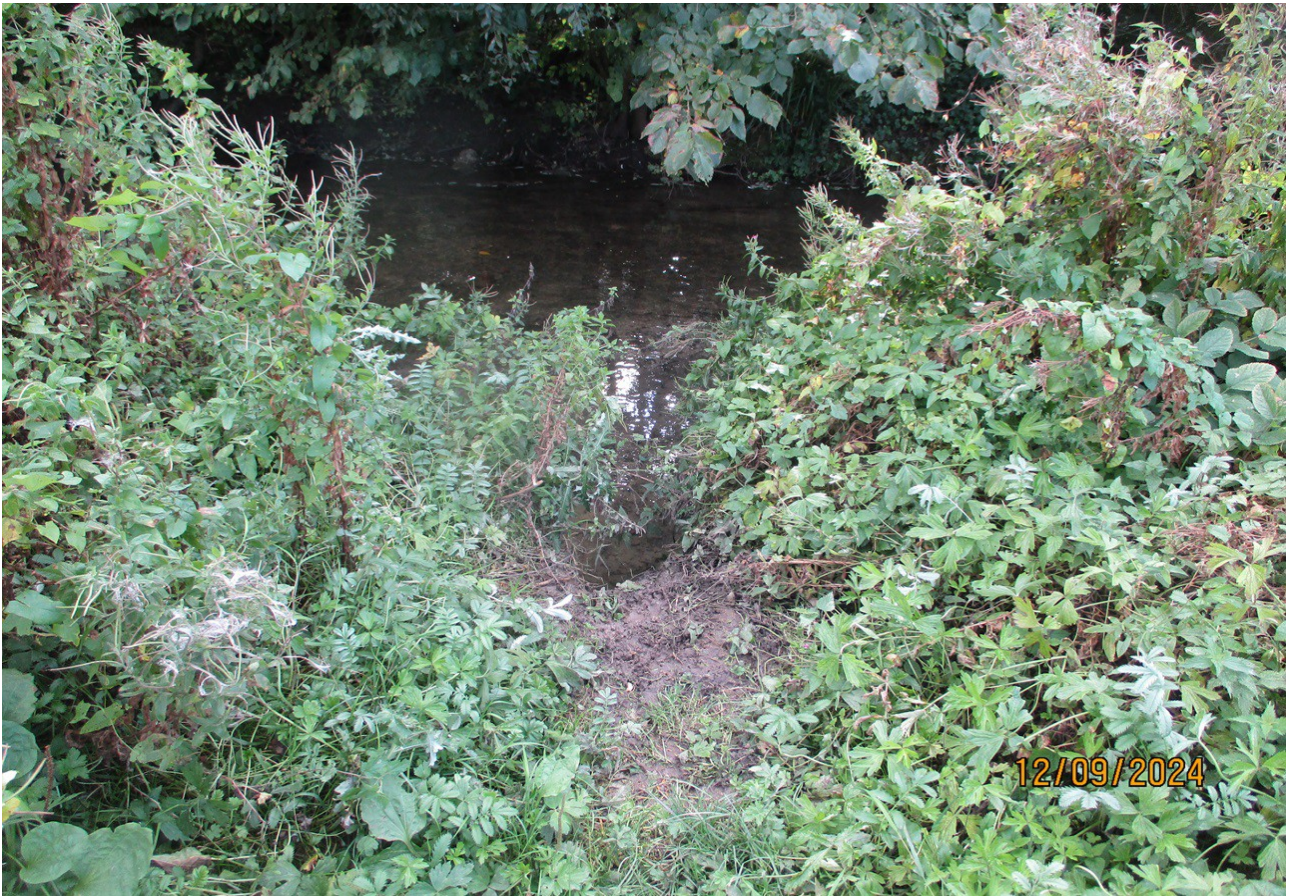
The left bank is supposed to be protected by a minimum 2 metre thick vegetative barrier but this has been ineffective and dogs access the river in numerous places. These are at each end of the meadow beyond the ends of the barrier, either side of the footbridge which is also unprotected, as well as about four points where the vegetative barrier has been breached. Dogs in the river create disturbance which is likely to be a factor in limiting the species present. Water vole surveys by CWG have found only limited signs, which suggests passage only and not occupation and breeding, despite suitable habitat. Another threatened species, Dipper has been recorded regularly within 200m on a secluded section of the main branch of the Churn, but only once in recent years on this branch. A pair of Grey Wagtails, a charismatic river species, are seen regularly, but are also vulnerable to disturbance. Given this is a designated Local Nature Reserve where wildlife should take priority, disturbance by dogs is a serious concern and needs to be addressed.

Illustration 15. River bank damage from dogs finding a weak point in the vegetation barrier and opening up an access channel.

Recommendation to repair river bank at existing dog entry points

This has been the focus of work by FWAG and Cirencester Wildlife Group and remains a priority. CWG/CTC should consider asking for help from FWAG as they have greater experience and expertise.

Recommendation to review protection from dog entry on the left bank. Review the failure of existing protection and how it can be improved or replaced while managing public understanding. Options might include an improved vegetative barrier, fencing, a sacrificial area eg at the bridge where some human disturbance is inevitable. Managing any reduction in access for dogs will want to include public information perhaps in the form of signage about river habitat, species and the threat from disturbance. This is a significant and challenging problem, which will need careful consideration and management by CTC with support from CWG.

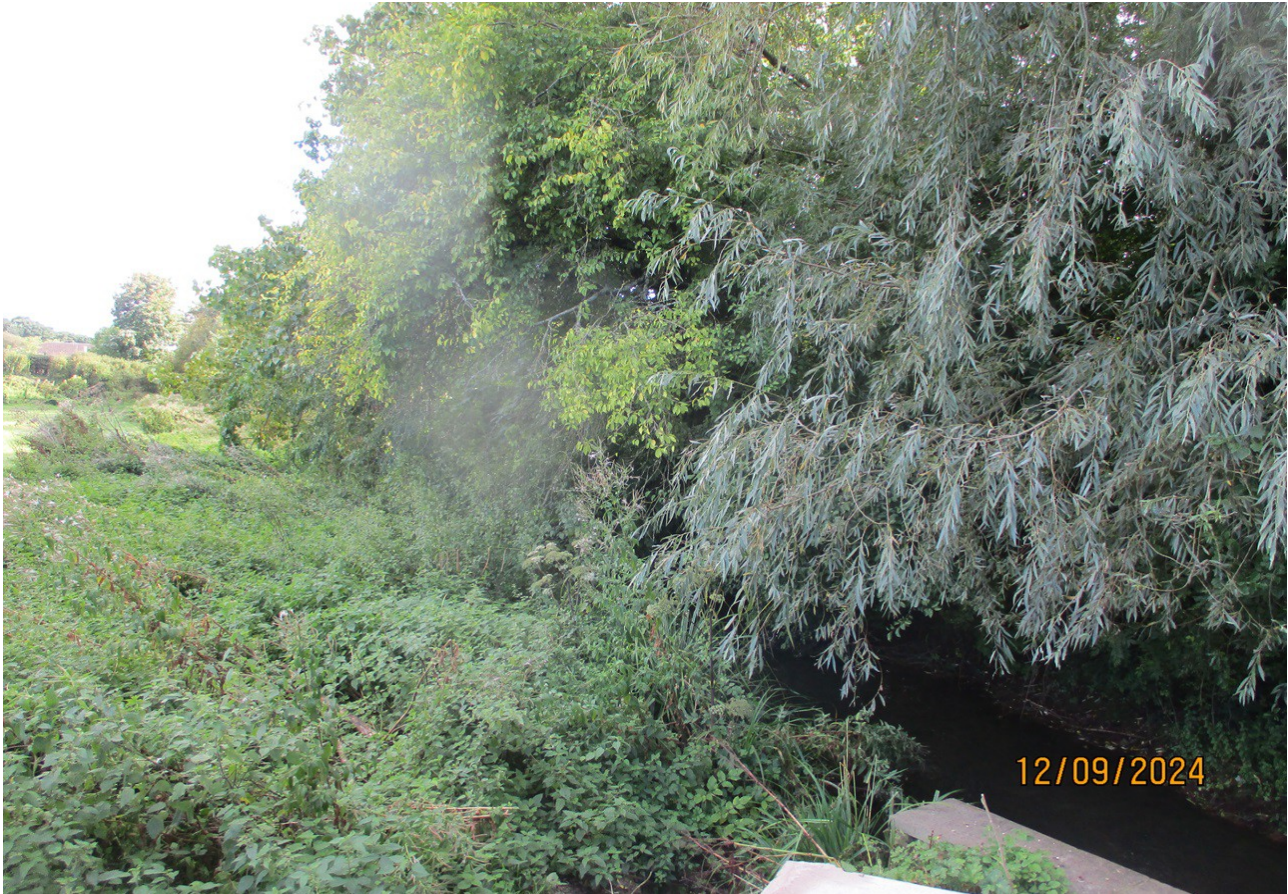
The downstream part of the river below the footbridge has become very heavily over-shaded in recent years by mature trees growing out over the river from the Old Nursery. This threatens to create another dead zone with little riparian vegetation unless deshading is carried out promptly, by end of February 2025 if possible, before the next bird nesting season. A tree management contractor will be needed given the size and height of branches.

Illustration 16. Heavy shading from low branches growing over the river from City Bank Old Nursery

Recommendation to reduce shade below footbridge

Branches growing over the river from the Old Nursery should be cut back. This has been agreed in discussion between Cirencester Town Council and Cirencester Wildlife Group. Action is pending.
