Cirencester Rivers Report: November 2024

By Cirencester Wildlife Group

Based on field surveys in September 2024 by Huw Jones, Melanie Dodd, Peter Newbold and Lyn Newbold

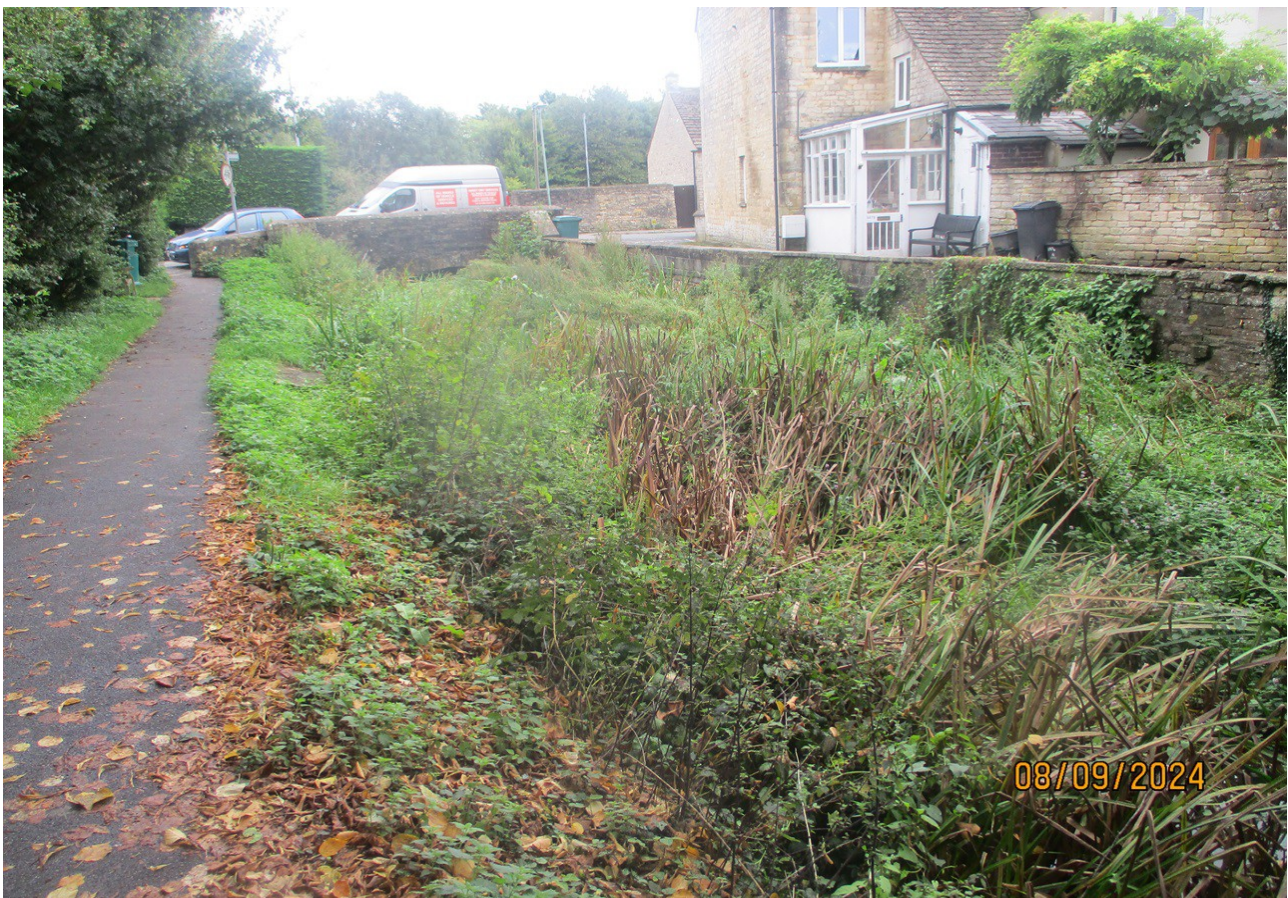
A connector channel runs between the sluices at Gloucester Street and Barton Mill pond. At the Gloucester Street end, there is very low summer flow which has created a narrow channel meandering close to the centre of the relatively broad canalised channel with shallow river banks either side. At the other end, water backs up from Barton Mill pond so that the full width of the channel is in water with no perceptible flow. Shade is variable with dark sections with very little vegetation and well lit sections with abundant growth eg immediately below the sluices at Gloucester Street. Much of the shade is created by mature trees both along the western edge within the Bathurst Estate and along the eastern edge within private gardens. There is also some growth of saplings on the river banks. This section is subject to maintenance by Friends of the Gumstool Brook.

Illustration 17. Heavily vegetated channel just below Gloucester St sluices

Future enhancements: Deshading. Some reduction in shade is desirable and much might be achieved by crown raising in particular removal of lower growth over the channel. As most of the shade is created by mature trees on private land, improvement would depend on liaison with and cooperation of landowners.

Recommendation for FoGB work parties: Remove saplings from river banks to avoid an increase in shading. Encourage development of the meander at the Gloucester St end by not removing woody debris and limiting any channel clearance to the flow channel and not trampling or clearing vegetation on the river banks either side.

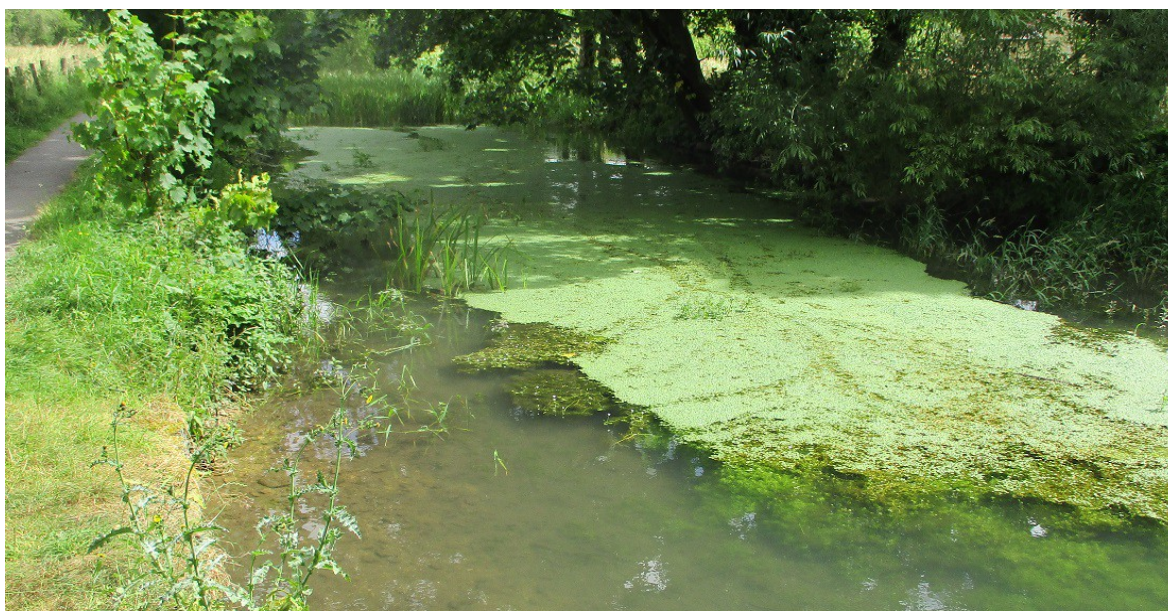
Illustration 18. Stagnant water backing up from Barton Mill pond along the connector towards Gloucester Street

A 'Low Flow' trial is planned (for late summer 2025) to divert more water from the Gloucester St sluices into the connector channel and Barton Mill pond as well as the Gumstool Brook (Daglingworth Stream). This is currently being discussed by FoGB, CTC, the Bathurst Estate and the Environment Agency. This has the potential to increase summer flow in the Gumstool Brook and to prevent it from drying out in summer with ecological benefits, in particular maintaining habitat for Water voles and aquatic invertebrates. Increased flow could also have a positive impact at the top end of the connector channel immediately below Gloucester Street sluices, by increasing the amount of riparian habitat which is currently very limited due to the very low summer flow. It is understood the water level in Barton Mill pond will stay the same so that the rest of the connector channel will be largely unaffected. There is no plan to lower the water level at Barton Mill pond, although this would reduce the length of the connector which is in stagnant water and increase riparian habitat.

Recommendation: The ecological impact of any flow trials should be monitored by CWG in liaison with FoGB and others.

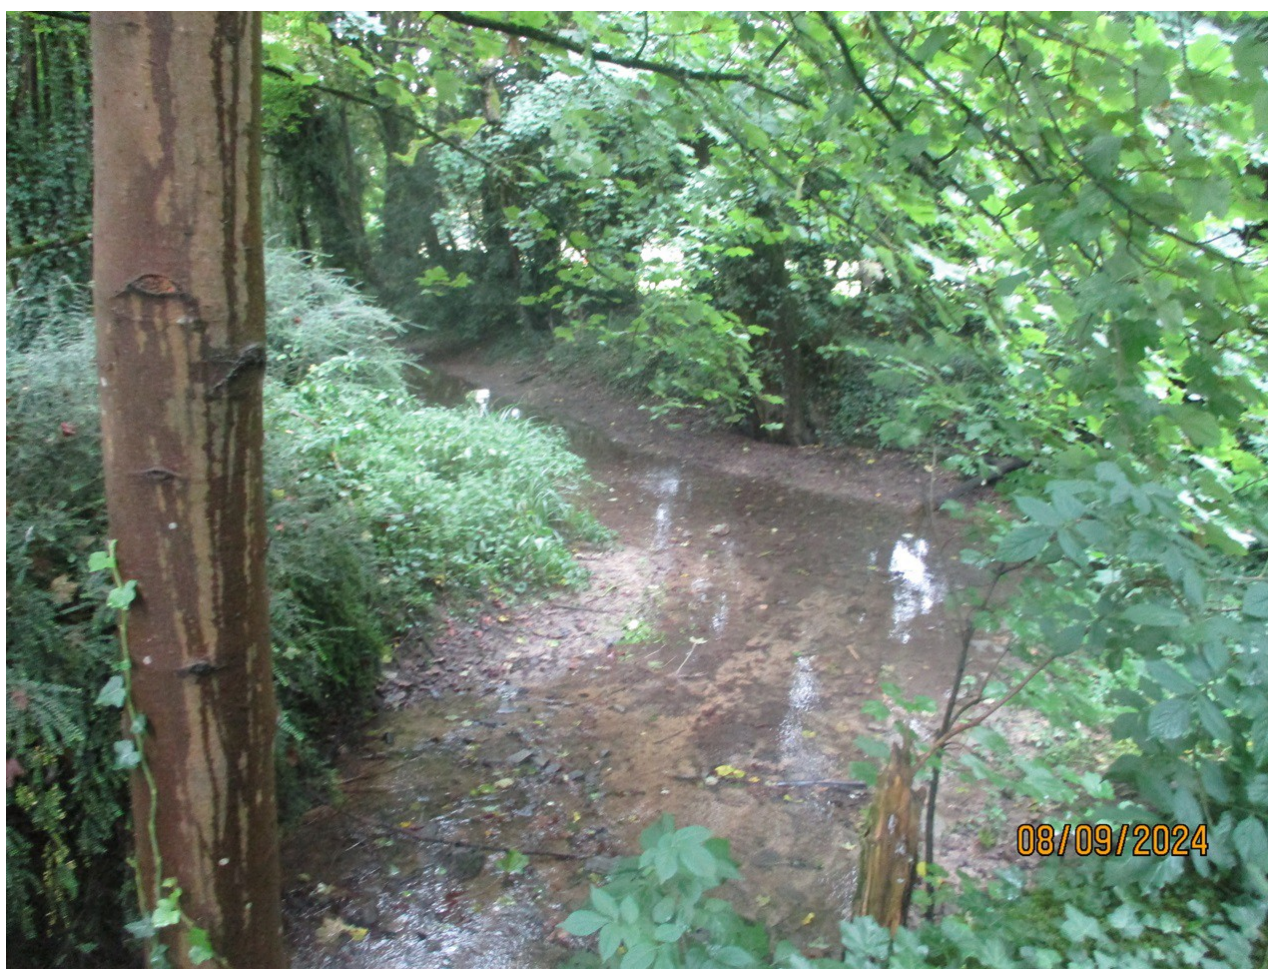
The Gumstool Brook is fed by the Daglingworth stream and any overflow from the Barton Mill pond. The channels converge in a narrow triangle of woodland immediately below the millpond. This section is heavily shaded by mature trees which narrow to become a single treeline just within the boundary of the Bathurst Estate. The shading creates a dead zone with little or no aquatic or bankside vegetation. Shade reduction is desirable but the size and density of mature trees means intervention would be expensive. It might be more practical to suggest a policy of shade reduction over time. Some crown-lifting may be practical.

Illustration 19. Woodland and heavy shade over the river channels below Barton Mill pond

Recommendation for shade reduction: Suggest to Bathurst Estate a policy of shade reduction over time. This might involve not replacing any trees lost to wind or disease, allowing the tree cover to thin out over time with a resulting reduction in overshading.

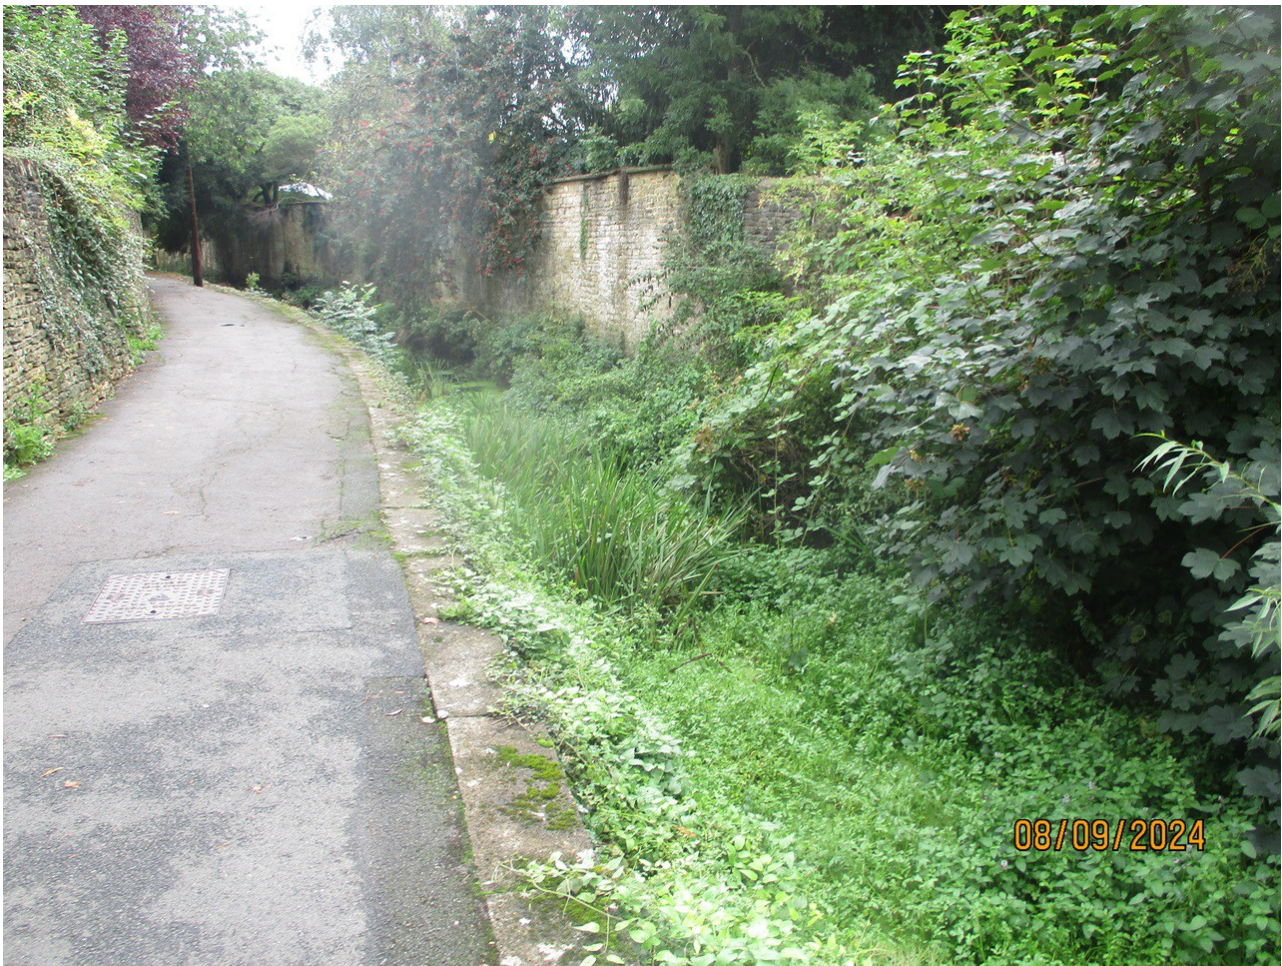
The Gumstool Brook enters a U-shaped brick-lined channel as it passes the open air swimming pool. There is considerable woody and non-woody growth on the channel walls including saplings. The brook has been forming a narrow watercourse within the channel forming a meander between sidebars where silt has built up. This has added to the diversity in the channel which has a range of bankside, marginal and aquatic vegetation. This section is subject to maintenance by Friends of the Gumstool Brook. Water voles have been seen in this area but sightings appear to have stopped in recent years.

Illustration 20. Dense vegetation in and beside the Gumstool Brook as it passes the open air swimming pool

Recommendation for FoGB work parties: Remove woody and other excess growth from channel walls so as to limit and avoid any increase in shading (and damage to structures). Encourage development of the meander by not removing small woody debris and not trampling or clearing vegetation on the side bars, limiting any channel clearance to the flow channel.

Recommendation for Water vole monitoring: CWG should aim to monitor for signs of Water voles, in particular at the time of the 'Low Flow' trial or similar testing.

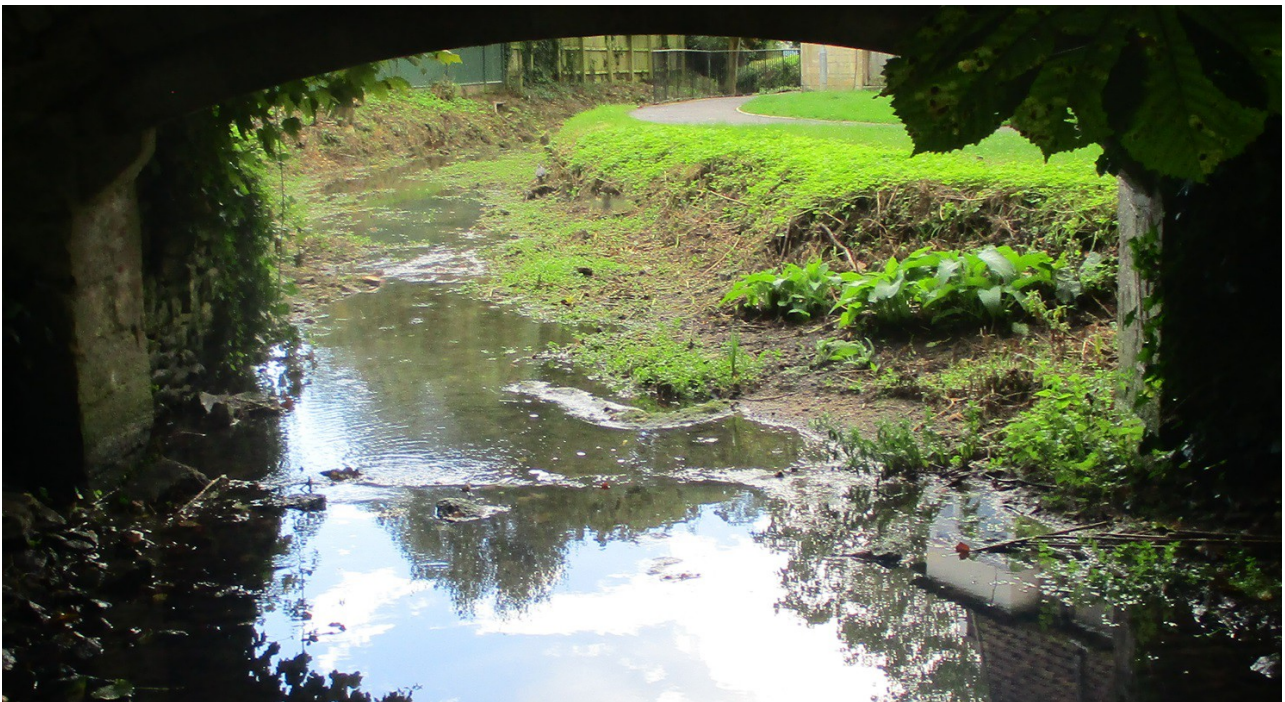
The river bank and channel were strimmed to a couple of inches in Summer 2024 possibly by CDC or by whoever manages the adjacent flats.

Illustration 21. A strimmed river bed and banks in the grounds of flats by the Abbey Grounds near the Waterloo car park

Recommendation CWG to investigate who manages this area and suggest leaving a vegetative barrier and not cutting along the river channel bed.
