# Citizen Monitoring Report

## August 2024

### Friends of the Gumstool Brook

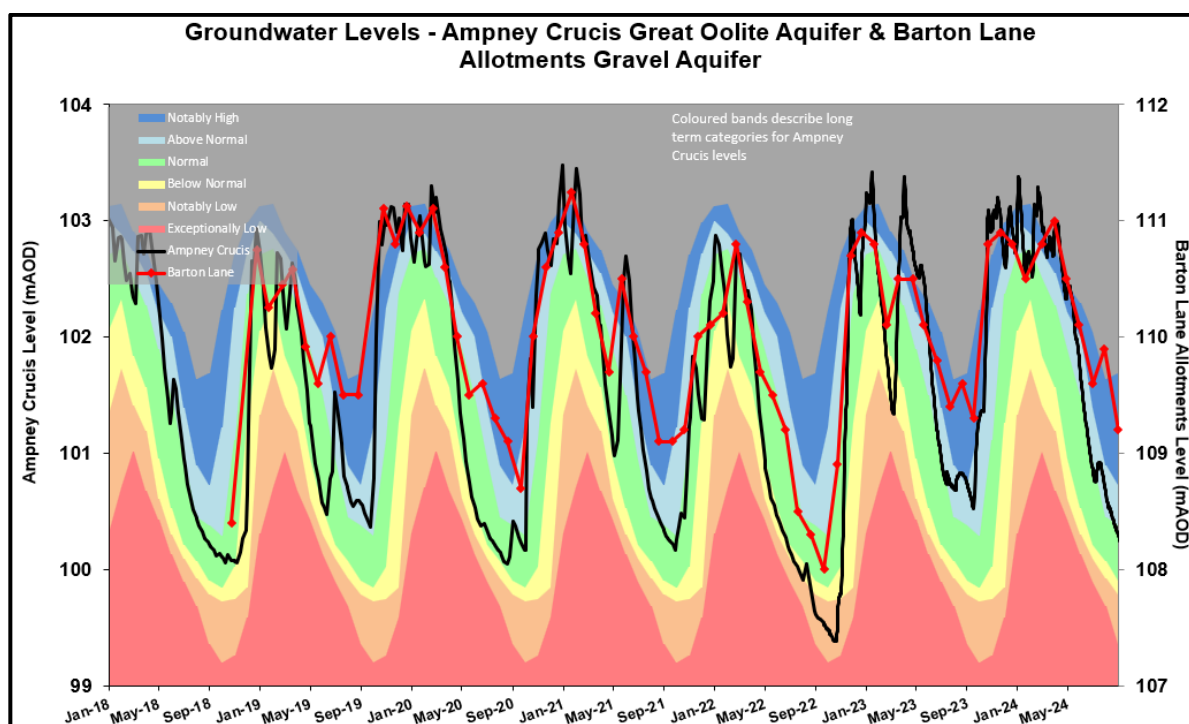
As seen on the graph below, groundwater levels in the Great Oolite limestone aquifer fell progressively from Exceptionally High levels in April to Normal levels for the time of year at the end of June, but with the first half of July being particularly wet, the declining trend was interrupted briefly. The usual seasonal decline then recommenced, with groundwater levels at the end of August being Normal for the time of year. As a result, groundwater levels in the Great Oolite are similar to those seen in August 2021 although noticeably higher than in August 2022. The graph also shows that similar groundwater level trends have been observed in the shallow Gravel aquifer at Barton Lane Allotments.

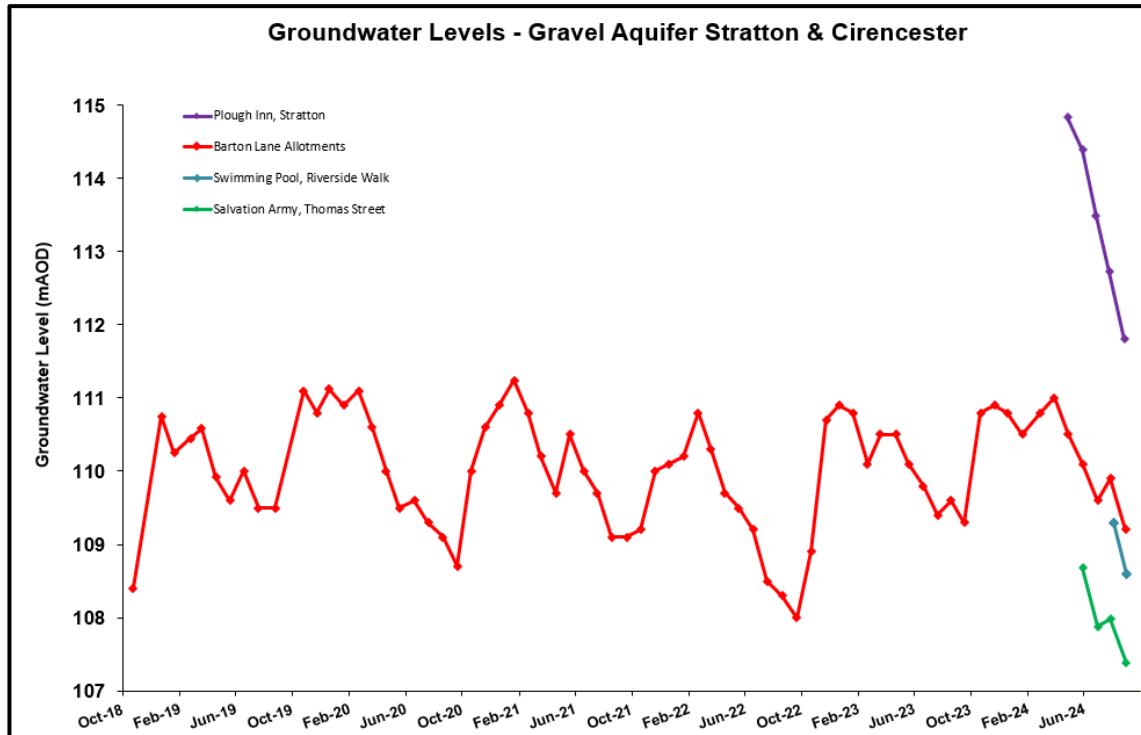
As citizen science has extended to monitoring groundwater levels in the Gravel aquifer using additional wells, similar trends are emerging. This can be seen on the graph below, which shows groundwater levels declining in Stratton and in the northern parts of Cirencester. In these areas, the shallow Gravel aquifer underlies the River Churn and Daglingworth Stream, so continued monitoring is important to help understand the interactions between groundwater and the waterways.

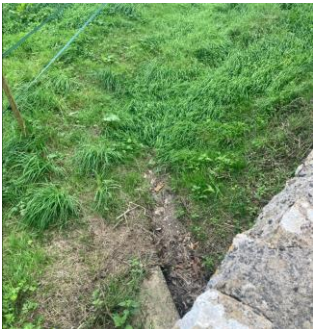
<p>1a.</p> <p>Daglingworth Stream source north of Duntisbourne Abbots.</p> <p>Channel is very overgrown and dry.</p>

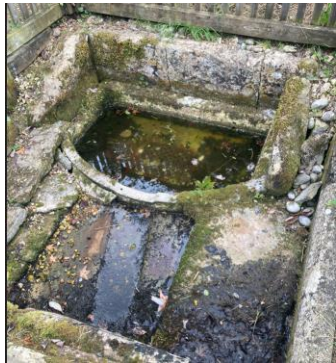
<p>1b</p> <p>Duntisbourne Abbots village spring.</p> <p>Water only in back section, and no flow observed.</p>

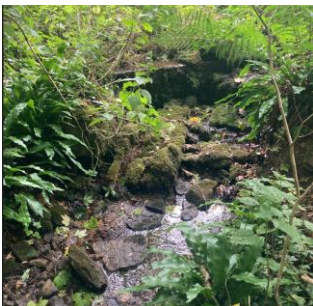
<p>2.</p> <p>Duntisbourne Abbots downstream of inferred confluence of spring sources.</p> <p>A very low flow is observed in the channel.</p>

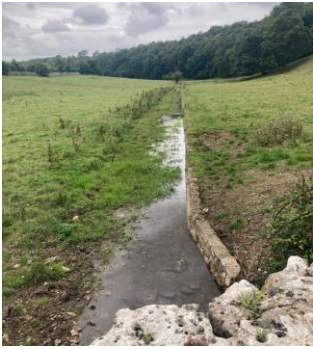
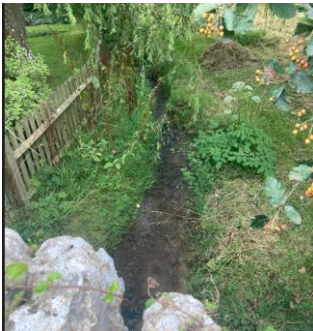
<p>6. Daglingworth Grove Hill bridge.</p> <p>A low flow is observed within the field channel upstream and the garden downstream of the road bridge.</p>

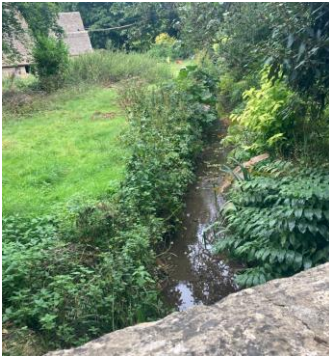
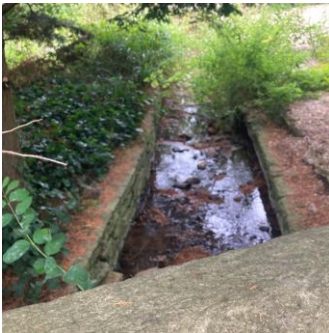
<p>7. Daglingworth stream at Lower End road bridge.</p> <p>The garden channel upstream has been cleared. A low flow is observed in the walled channel downstream of the bridge.</p>

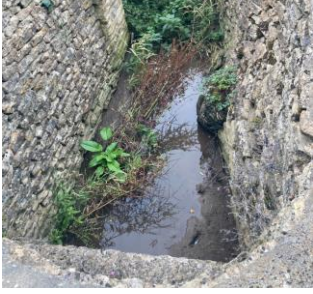
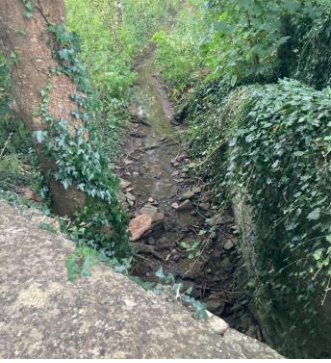
<p>11. School Hill bridge</p> <p>The stream has a very low flow similar to that at Grange Farm.</p>

<p>There is evidence of a fine muddy silt building up at the edges of the channel.</p>

<p>This flow has reduced since the last monitoring in July.</p>

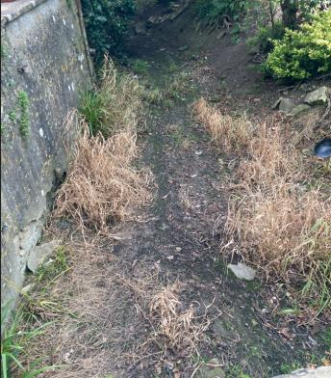
<p>13. Barn Way bridge.</p> <p>The vegetation in the stream bed has dried up and there is no flow.</p> <p>A low flow has been observed at this location during days of heavy rain in August. This is believed to be rainwater from the road.</p>

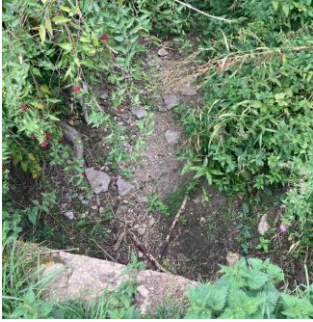
<p>15. Footpath at Lower Stratton.</p> <p>The stream bed is dry.</p> <p>No flow has been observed at this location since the 23rd May 2024.</p>

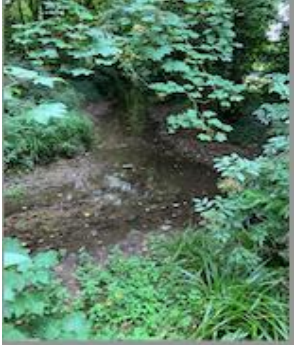
<p>16b. Daglingworth stream at Barton Lane</p> <p>Location downstream of Bathurst Estate boundary wall.</p> <p>Very low flow is observed.</p>

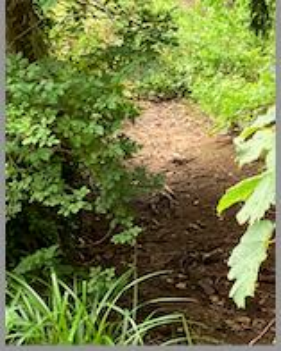
<p>17. Gumstool Brook balancing stream at sluice gate.</p> <p>No flow is observed.</p>

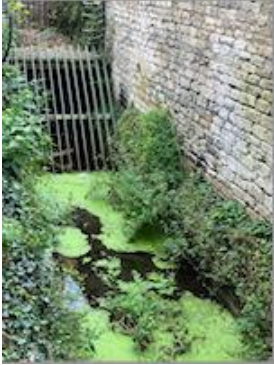
<p>20. Gunstoole Brook at culvert trash screen.</p> <p>A very low flow is observed, and there are water plants on the stream surface.</p>

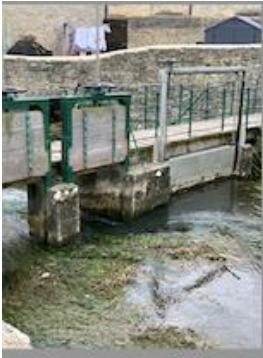
<p>23b. Glos St bridge sluices</p> <p>The large sluice is closed and the two small sluices are fully open.</p>

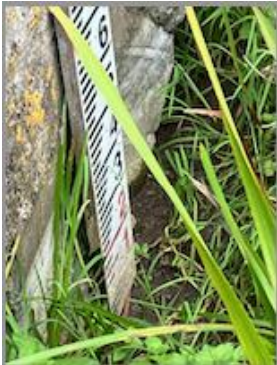
<p>24a. River Churn at the measuring gauge on Glos St bridge.</p> <p>Gauge is showing a level around 0.5 (0.05m) mark</p>

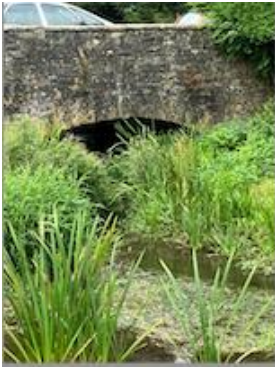
<p>24b. Glos St bridge view towards the Mill Pound.</p> <p>Extensive vegetation present</p>

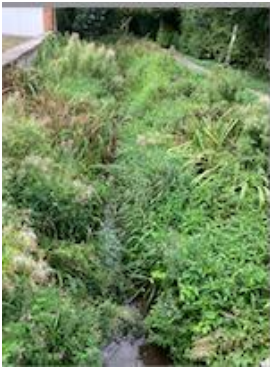
<p>24c. Mill Pound looking downstream from Glos St bridge.</p> <p>A very low flow is observed in the central channel.</p> <p>Significant vegetation present on around the stream flow.</p>

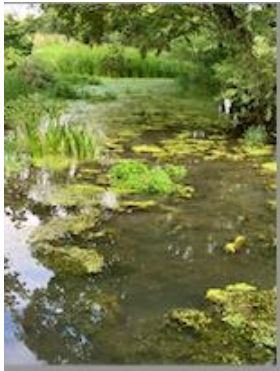
<p>25. Mill Pound Overflow (New)</p> <p>No flow is observed at the offtake as the Mill pound level is significantly below the two overflow pipes.</p>	 	<p>26. Mill Pound Overflow (Old)</p> <p>No flow is audible.</p>	 
<p>27a. Mill Pound upstream of footbridge.</p> <p>A low, almost static, flow is observed.</p> <p>Increased level of algae / weed is visible.</p>

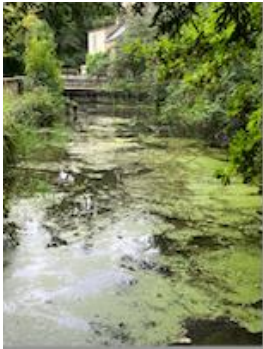
<p>27b. Mill Pound downstream of footbridge.</p> <p>A low, almost static, flow is observed.</p> <p>Increased level of algae / weed is visible.</p>
