Friends of Gumstool Brook is a group of local people interested in Cirencester's Gumstool Brook and its associated streams. Visit our website at <https://gumstool.org.uk>

Summary

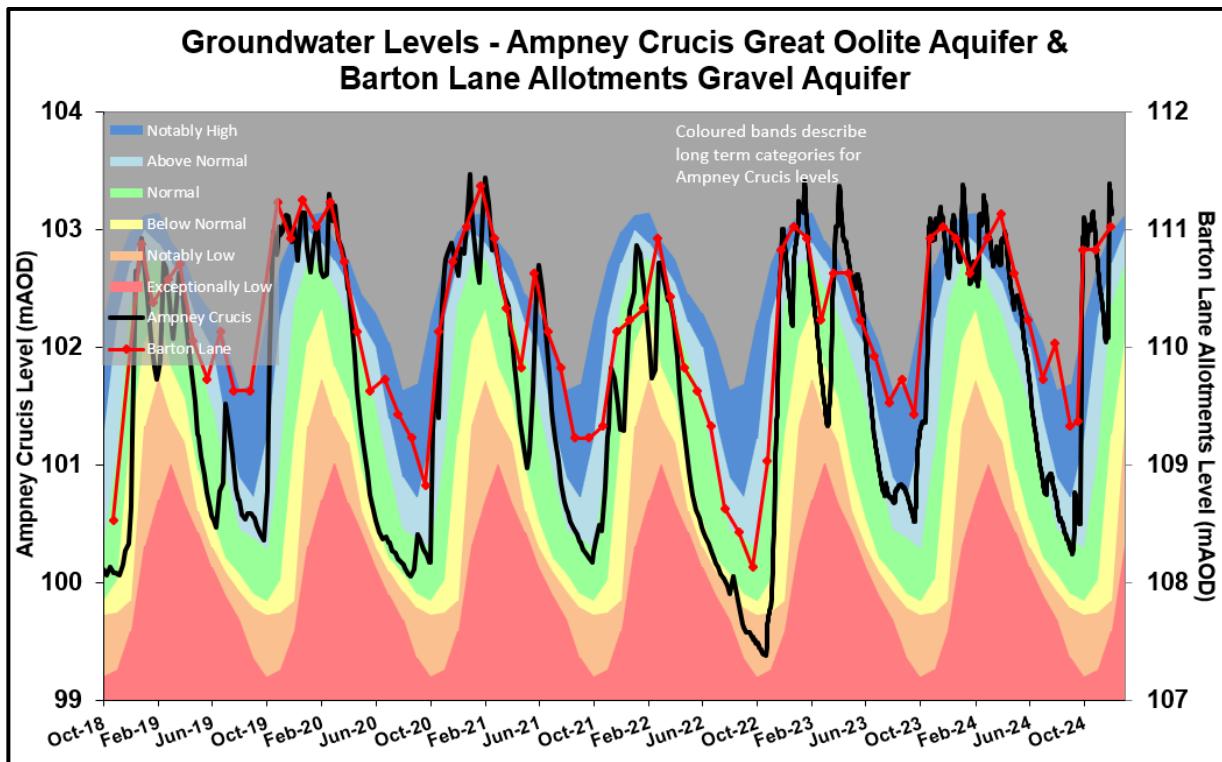
Groundwater in the Great Oolite limestone aquifer rose more rapidly and earlier to exceptionally high levels this autumn, because of the exceptionally wet end to September, remaining there for much of October. As the Great Oolite aquifer can respond rapidly to changes in rainfall, especially in autumn and winter, the dry end to October resulted in groundwater levels declining, which continued into November until Storm Bert arrived. As a result of the significant rainfall brought by this storm event, it can be seen from the graph below that groundwater levels rose rapidly from above normal to exceptionally high levels for the time of year.

The graph above also shows a similar groundwater level trend in the shallow Gravel aquifer at Barton Lane Allotments, having risen by the end of November in response to rainfall during Storm Bert, reaching the joint highest November level in the 6 years of monitoring. As shown on the graph below, a similar trend has been observed in Gravel aquifer at The Plough Inn well, with a higher groundwater level recorded in November. In the shallow wells at the Swimming Pool and Salvation Army, November groundwater levels were either the same as or lower than those recorded in October. This may reflect differences in the degree of connection between the aquifer and the adjacent watercourse. Water levels in watercourses at a number of locations are now being measured to compare with groundwater levels, which should help understand their interconnection.

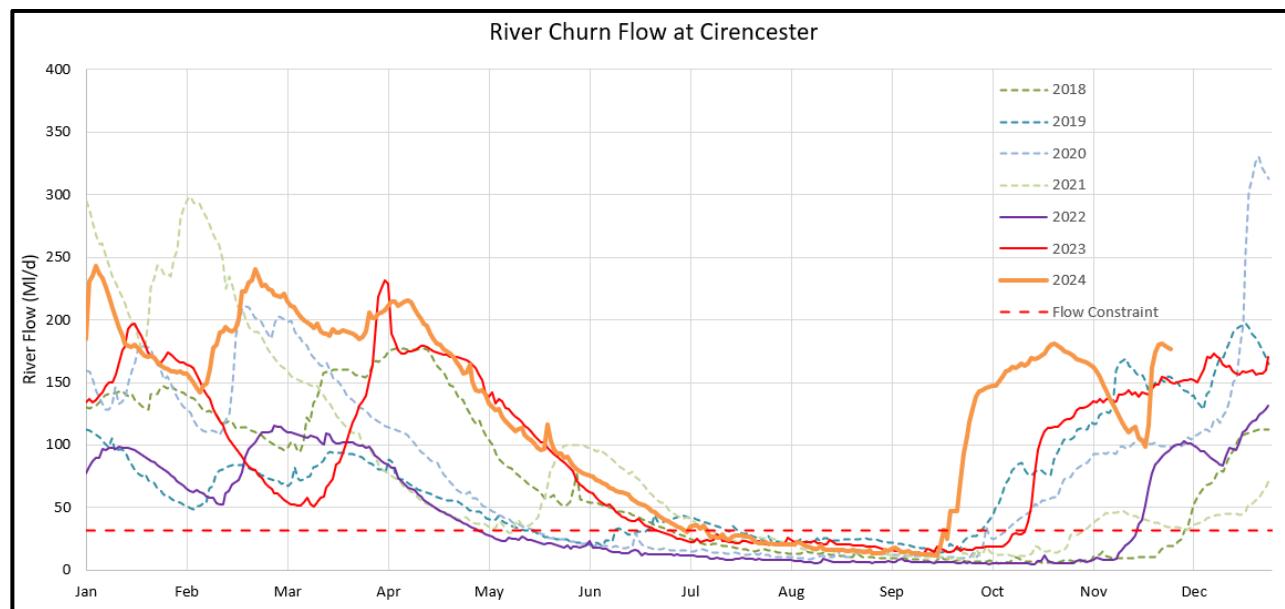
As can be seen from the graph below, flow in the River Churn at the EA Cirencester gauging station responded rapidly to the exceptional September rainfall, increasing to 128 million litres per day (ML/d). Flow continued to increase, reaching a peak of 180 ML/d towards the end of October. With the dry weather at the end of October continuing well into November, flow in the River Churn decreased steadily over a period of 4 weeks to 98 ML/d. In response to rainfall during Storm Bert towards the end of November, flow in the Churn again increased rapidly to just over 181 ML/d in the space of 5 days, decreasing slightly to just over 176 ML/d at the end of the month. These trends in river flow follow those recorded in the Great Oolite aquifer, with the exceptionally high groundwater levels at the end of November corresponding with the Churn flow being higher than is normally expected for the time of year.

With the River Churn flowing higher than expected for the time of year, it continues to be much higher than 32ML/d. This flow rate is the River Churn trigger above which groundwater abstraction by Thames Water at Baunton can operate. Although the river flow rose above this trigger towards the end of September, groundwater abstraction did not recommence until early November following a period of maintenance, but it has been operational since then.

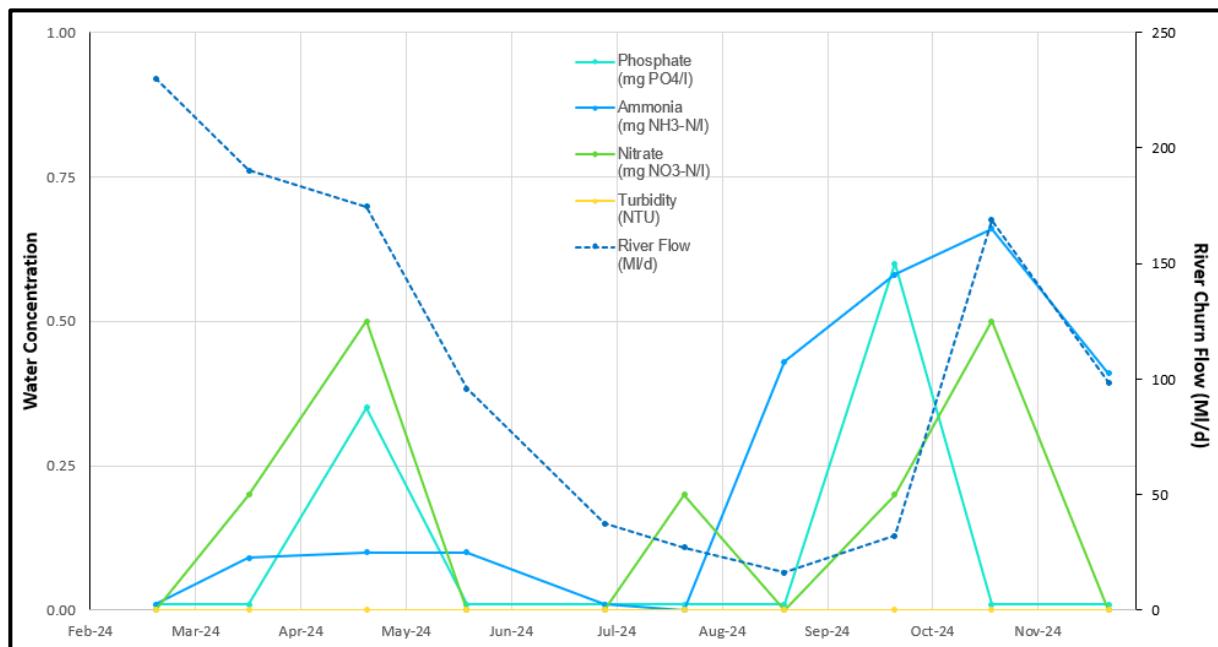
Monitoring of river water quality covers the nutrients, ammonia, nitrate and phosphate, and turbidity, a measure of how clear the water is. Results initially showed little evidence of persistent pollution by nutrients, but intermittent elevated phosphate and nitrate concentrations have been detected in the Churn and Gumstool Brook. The graph below for the Churn shows these spikes, but also evidence of more persistent increasing trends in ammonia and nitrate from summer into early autumn, which are not apparent in the Gumstool Brook. It is possible that rainfall and particularly rainfall intensity influences these spikes, with rising trends perhaps linked to increasing river flows. With flow in the River Churn decreasing between the October and November monitoring rounds, and the November water quality results showing a decrease in ammonia and nitrate, there is further evidence for a connection between river flow and its quality. As the November monitoring preceded Storm Bert, short term impacts from increased river flows are unlikely to be detected in the next round of monthly monitoring. Although the nutrient concentrations are not particularly high, they will continue to be tracked.

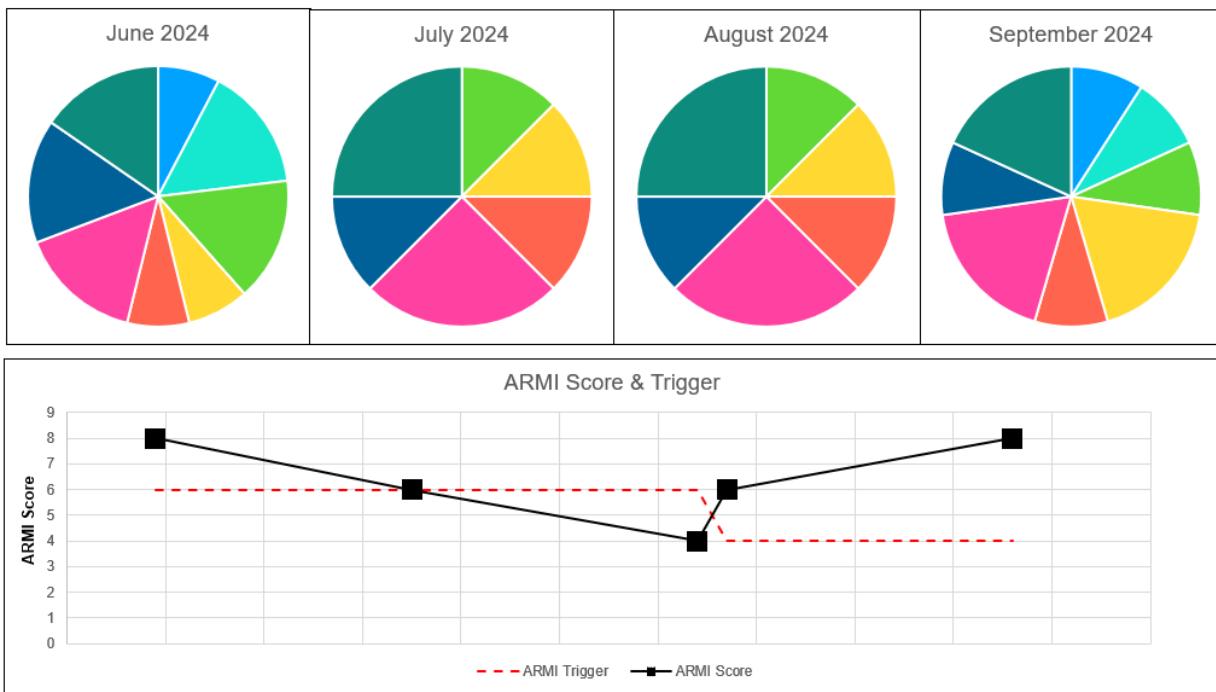
The graphic below for the River Churn shows the riverfly monitoring results from June to September with the pie charts indicating the number and diversity of species found. The graph shows how these results, expressed as an ARMI (Anglers Riverfly Monitoring Initiative) score, compare with an ARMI trigger that indicates poor river health. As the period of baseline data is limited to 4 months, an appropriate trigger level is yet to be confirmed; this will be done in conjunction with the Cotswolds' Rivers Trust. Nevertheless, riverfly sampling to date indicates

that both the River Churn and the Gumstool Brook are healthy and are sustaining a riverfly population.

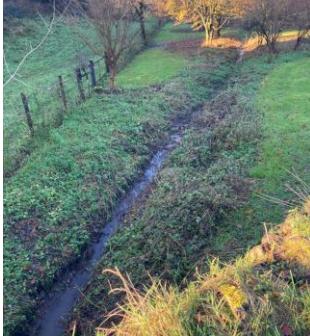
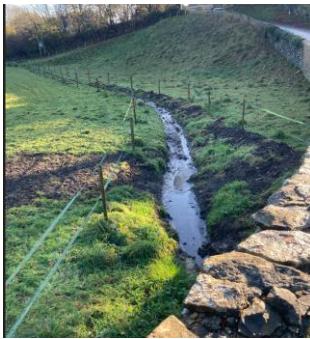
<p>1a. Daglingworth Stream upper source north of Duntisbourne Abbots.</p> <p>The stream channel is muddy and there is some standing water on the upstream side of the road.</p> <p>Downstream of the road, there is a small flow from surface water runoff.</p>

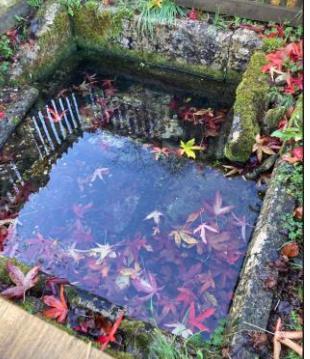
<p>1b. Duntisbourne Abbots village spring.</p> <p>There is a gentle flow of very clear water in the spring.</p>

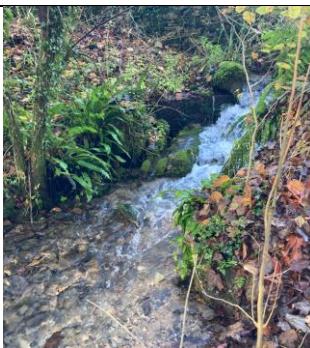
<p>2. Duntisbourne Abbots Daglingworth Stream downstream of inferred confluence of spring sources.</p> <p>There is a normal clear flow of water in the channel.</p>

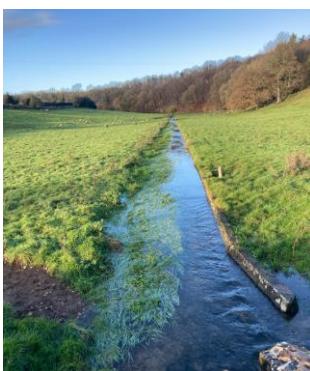
<p>6. Daglingworth Stream Grove Hill bridge.</p> <p>A normal flow is observed that fills one half of the channel in the field upstream of the road bridge. Downstream of the road, the stream is almost filling the full depth of the channel, up to the underside of the private stone footbridge.</p>

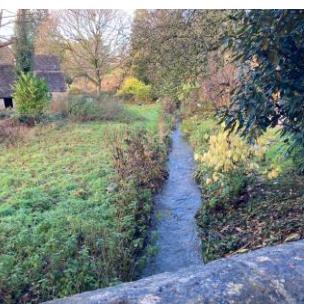
<p>7. Daglingworth Stream at Lower End road bridge.</p> <p>A normal flow is observed in the upstream garden, and the walled channel downstream of the bridge.</p>

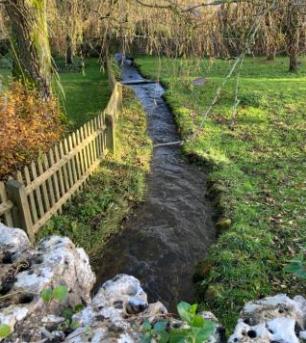
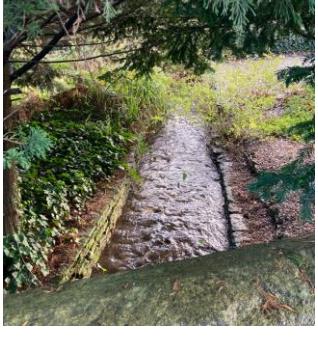
<p>8. Wellhill Copse, Daglingworth Stream.</p> <p>In the fields upstream of Wellhill Copse, the stream is flowing outside of its banks.</p> <p>At the footpath stile the stream has a normal flow and the water is clear.</p>

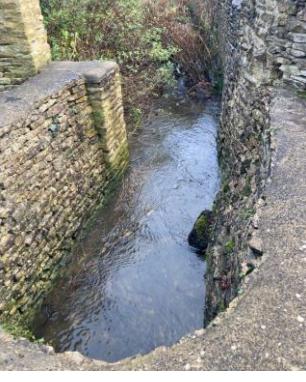
<p>10. Grange Farm bridge, Daglingworth Stream.</p> <p>There is a steady flow into the farm channel.</p> <p>There is standing water present in the horse fields upstream of Grange Farm adjacent to the stream.</p>

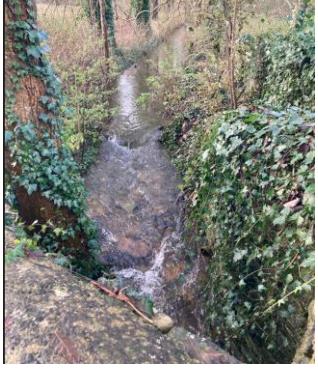
<p>11. School Hill bridge, Daglingworth Stream.</p> <p>The stream has a high flow similar to that at Grange Farm.</p>

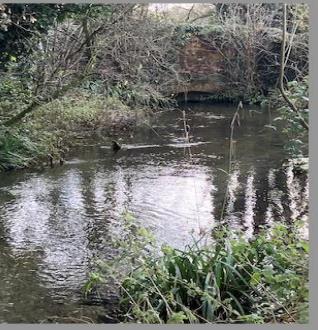
<p>16a. Daglingworth Stream at Barton Lane upstream of Bathurst Estate boundary wall</p> <p>A high flow of clear water is observed.</p>

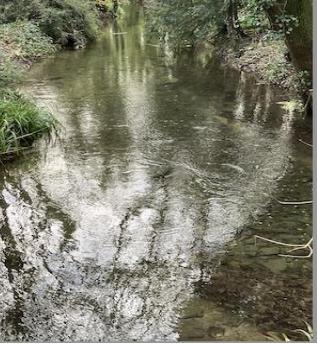
<p>16b. Daglingworth stream at Barton Lane downstream of Bathurst Estate boundary wall.</p> <p>A high flow of clear water is observed.</p>

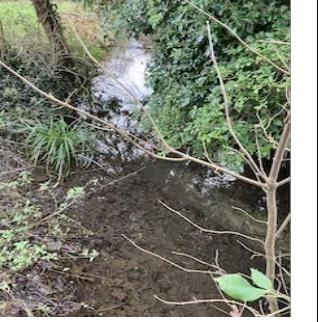
<p>17. Gumstool Brook balancing stream at sluice gate.</p> <p>The stream is flowing with clear water.</p>

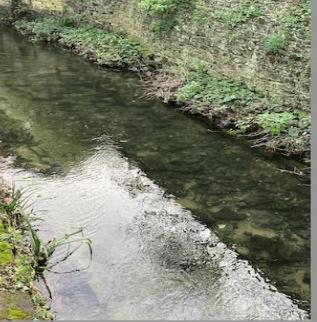
<p>18. Gumstool Brook adjacent to the swimming pool on Riverside Walk.</p> <p>The stream has a high flow, and less vegetation is present.</p>

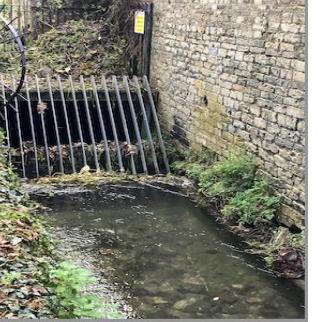
<p>20. Gumstool Brook at Thomas Street culvert trash screen.</p> <p>A large amount of vegetation was cleared in the preceding 1-2 days</p>

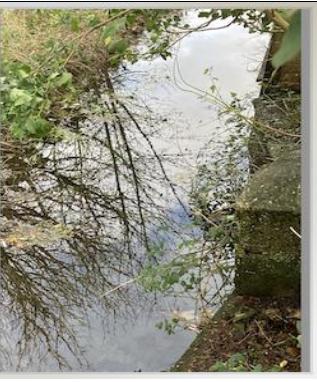
<p>22a. Balancing Stream behind Salvation Army.</p> <p>The stream channel is flowing almost full, with clear water.</p>

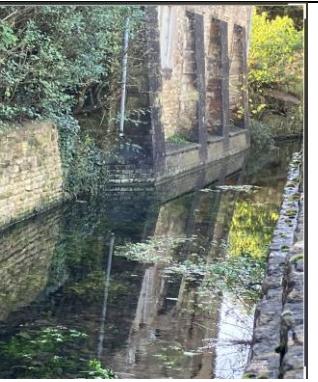
<p>22b. Balancing Stream at Powell's School looking upstream to Salvation Army</p> <p>The stream is flowing with clear water.</p>

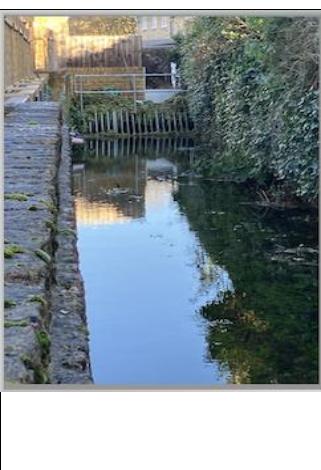
<p>22c. Balance Streaming at Powell's School looking downstream to trash screen.</p> <p>There is a steady flow, with less vegetation in the stream following significant recent vegetation clearance from the trash screen by the site manager.</p>

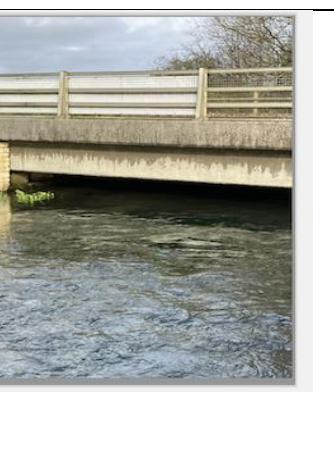
<p>23a. River Churn at Glos St bridge upstream of sluices</p> <p>The river has a high flow with limited vegetation present.</p>

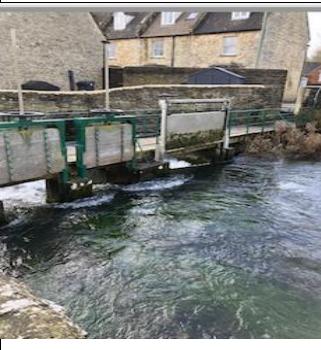
<p>23b. Glos St bridge sluices</p> <p>All sluice gates are open and there is a high flow, with vegetation visible in the river.</p>

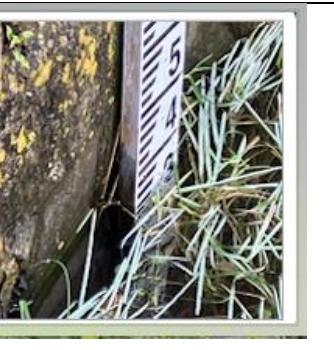
<p>24a. River Churn measuring gauge on Glos St bridge.</p> <p>Water level is 0.34m (3.4 on gauge)</p>

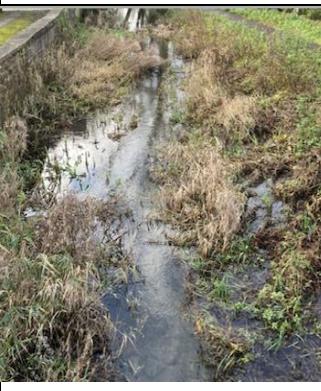
<p>24b. Glos St bridge looking downstream towards the Mill Pound.</p> <p>There is a steady flow with much vegetation still present.</p>

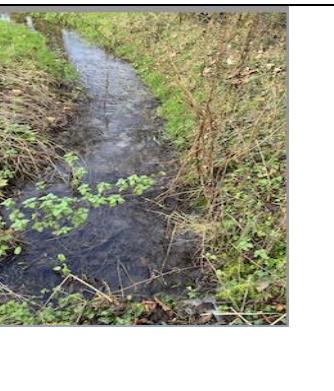
<p>25. Mill Pound Overflow (New)</p> <p>There is a high flow from the new overflow.</p>

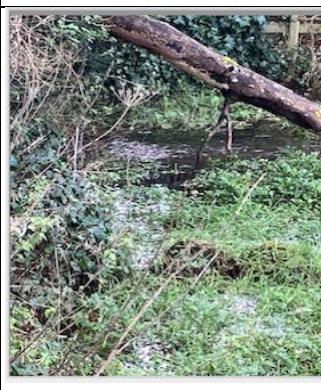
<p>25. Mill Pound Overflow (Old)</p> <p>There is water visibly flowing from Mill Pound old overflow. The surrounding field has standing water.</p>

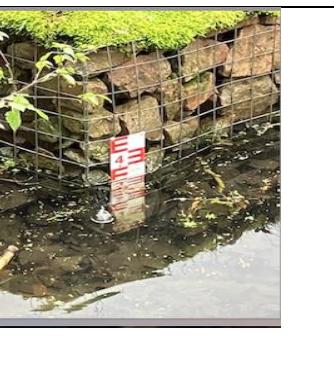
<p>27. Barton Mill Footbridge Measuring gauge.</p> <p>Water level is 0.36m (3.6 on gauge)</p>

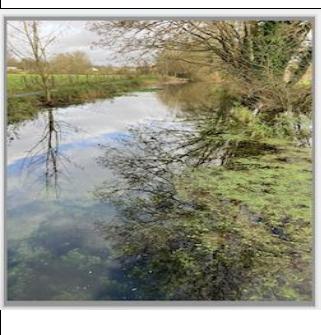
<p>27a. Mill Pound upstream of the footbridge.</p> <p>There is a slow flow of clear water. Some surface vegetation still present.</p>

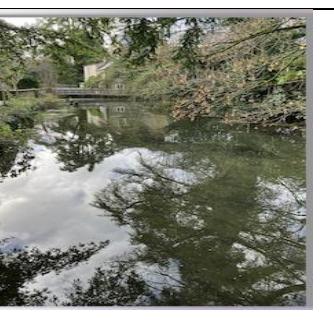
<p>27b. Mill Pound downstream of footbridge.</p> <p>There is a slow flow of clear water. Some sub-surface vegetation still present.</p>

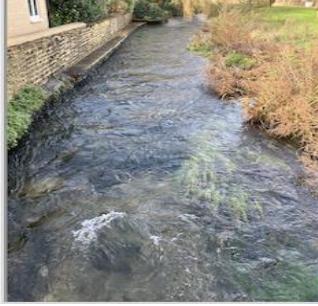
<p>34. River Churn upstream side of Gooseacre Lane bridge</p> <p>The river has a high flow.</p>

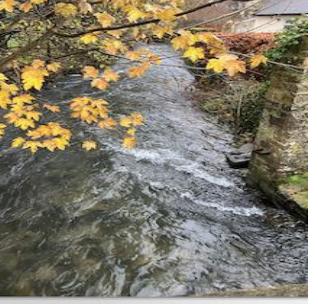
<p>34a. River Churn downstream side of Gooseacre Lane bridge</p> <p>The river has a high flow.</p>

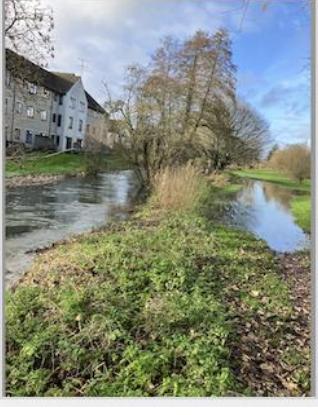
<p>35. River Churn north of Spitalgate Lane bridge, looking upstream</p> <p>The river has a high flow, with flooding onto its floodplain having occurred.</p>

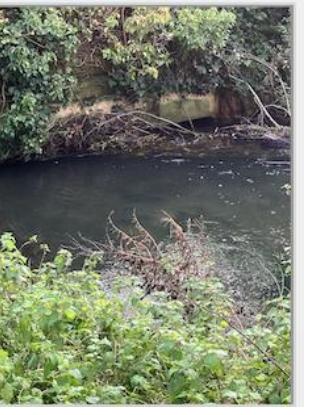
<p>35b. River Churn, looking downstream towards Spitalgate Lane bridge</p> <p>There is a buildup of debris at bridge</p>

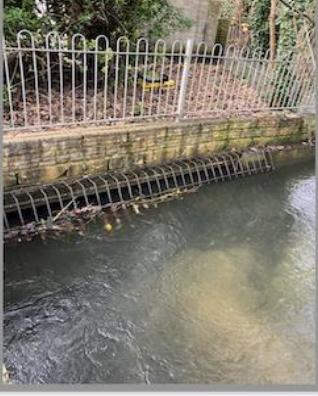
<p>36a. River Churn at Hereward Road trash screen.</p> <p>There is a significant flow into the culverted stream feeding to the Abbey Lake.</p>

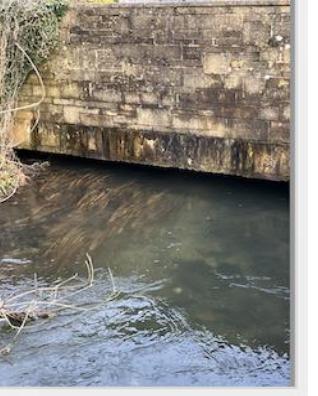
<p>36b. River Churn upstream side of Hereward Road bridge</p> <p>The stream has a high flow.</p>

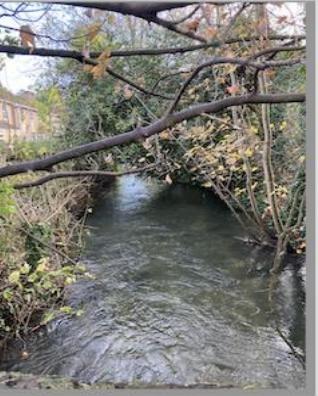
<p>37. Churn flowing into Abbey grounds</p> <p>Lake is flowing onto its floodplain at various places in the Abbey grounds.</p>

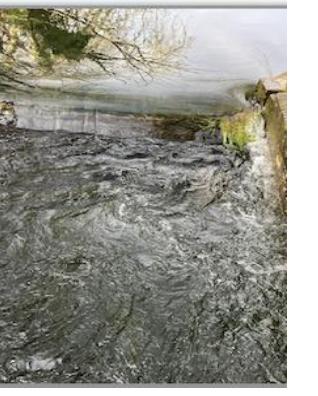
<p>38a. Weir at outlet from Abbey Lake.</p> <p>High flow with the weir almost drowned.</p>

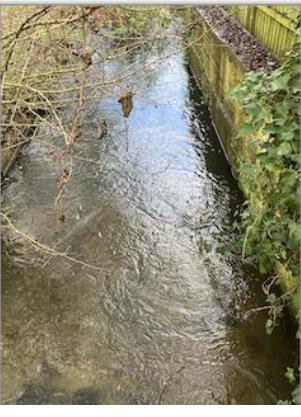
<p>38b. Footbridge at downstream stream outlet from Abbey Lake.</p> <p>There is a clear high flow.</p>

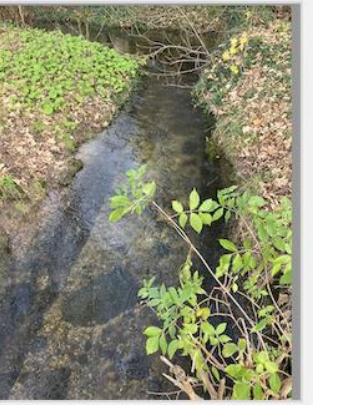
<p>39 Abbey Lake outlet stream in Corinium Gate looking upstream.</p> <p>There is a clear high flow.</p>

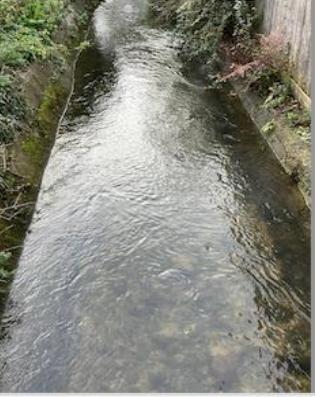
<p>39 Abbey Lake outlet stream at Corinium gate bridge looking downstream.</p> <p>The stream has a high flow.</p>

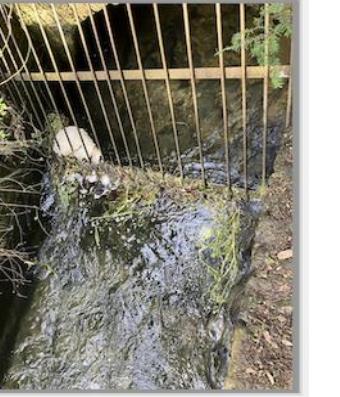
<p>40. Gumstool Brook culvert outlet in Abbey grounds.</p> <p>There is a high flow of clear water, and some debris in the trash screen.</p>

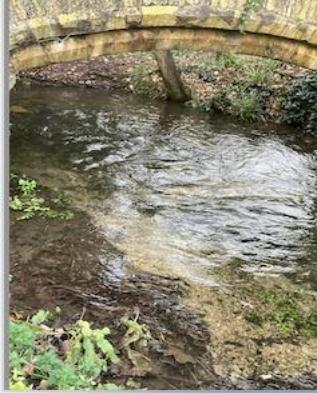
<p>41a. Gumstool Brook – Looking upstream to Abbey grounds</p> <p>There is a high stream flow.</p>

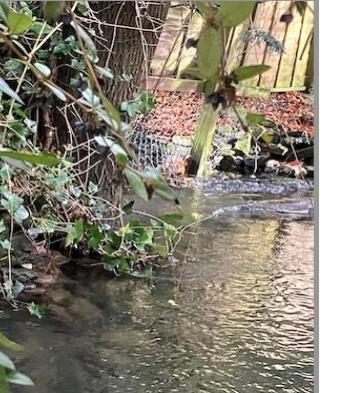
<p>41b. Confluence of Gumstool Brook (Daglingworth Stream) & Churn outflow from Abbey Lake in Waterloo car park.</p> <p>The stream has a high flow.</p>

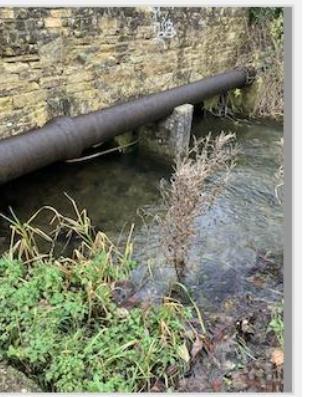
<p>42. River Churn (West), south side of London Rd Bridge looking upstream.</p> <p>The stream has a high flow.</p>

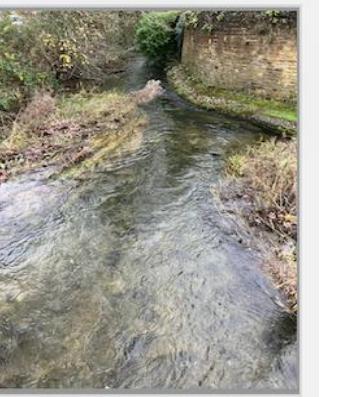
<p>42a. River Churn (West), looking downstream from London Road bridge.</p> <p>The stream has a high flow.</p>

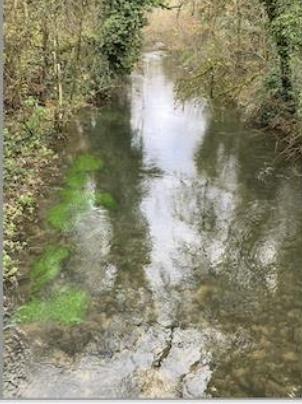
<p>43. River Churn (East) upstream of Old Beeches Road Bridge.</p> <p>There is a medium flow.</p>

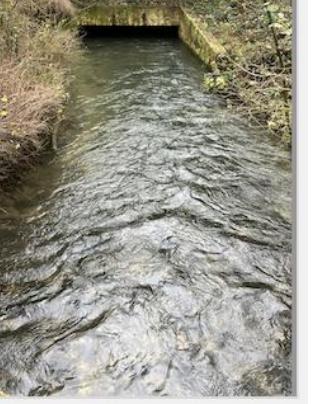
<p>44. River Churn (East) at Old Beeches Road Bridge, looking downstream to the road bridge.</p> <p>The stream has a high flow.</p>

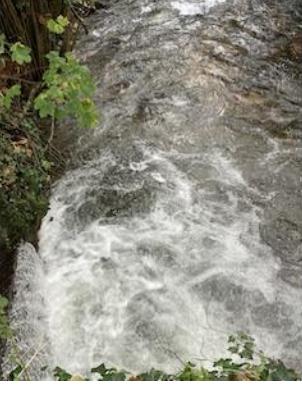
<p>45. River Churn (East) Overflow from New Mills</p> <p>The overflow has a high flow.</p>

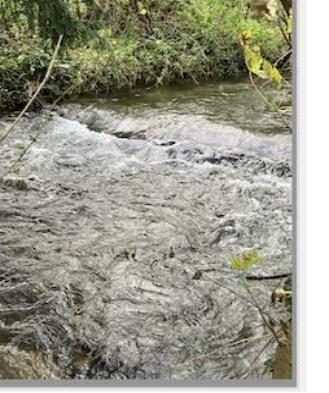
<p>46. River Churn (West) weir at City Bank Glade</p> <p>The stream is flowing fast.</p>

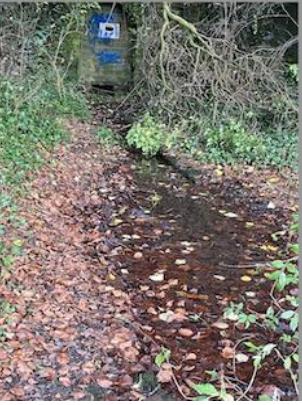
<p>46a. City Bank Park - Furnes Hole overflow from New Mills Pound to River Churn (West)</p> <p>Some pooled water and mud is present.</p>

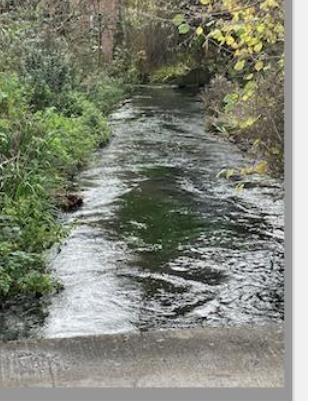
<p>47. River Churn (West) at City Bank Park footbridge</p> <p>The river has a high flow.</p>

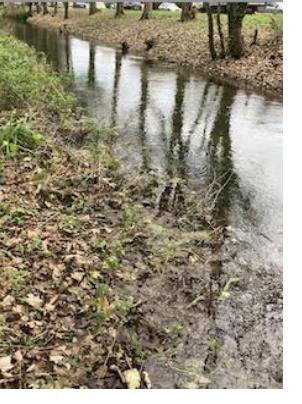
<p>48. River Churn (West) Brook at Watermoor Point.</p> <p>The river has a high flow.</p>

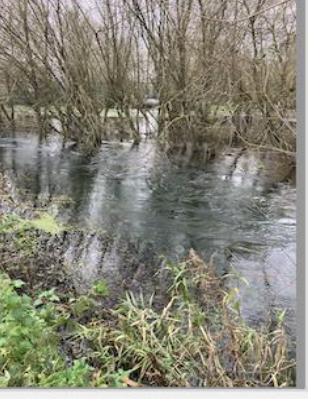
<p>49. River Churn at Cricklade Road (opposite Aldi)</p> <p>The river has flooded onto its surrounding floodplain.</p>

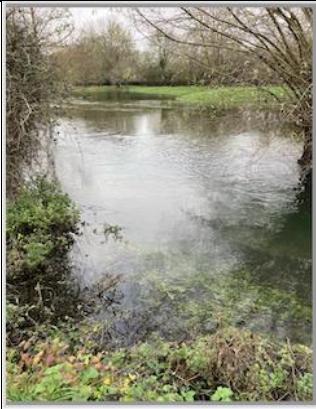
50. River Churn at
Cricklade Road
(opposite Tesco)

The river has flooded
onto its surrounding
floodplain.
