Friends of Gumstool Brook is a group of local people interested in Cirencester's Gumstool Brook and its associated streams. Visit our website at <https://gumstool.org.uk>

Summary

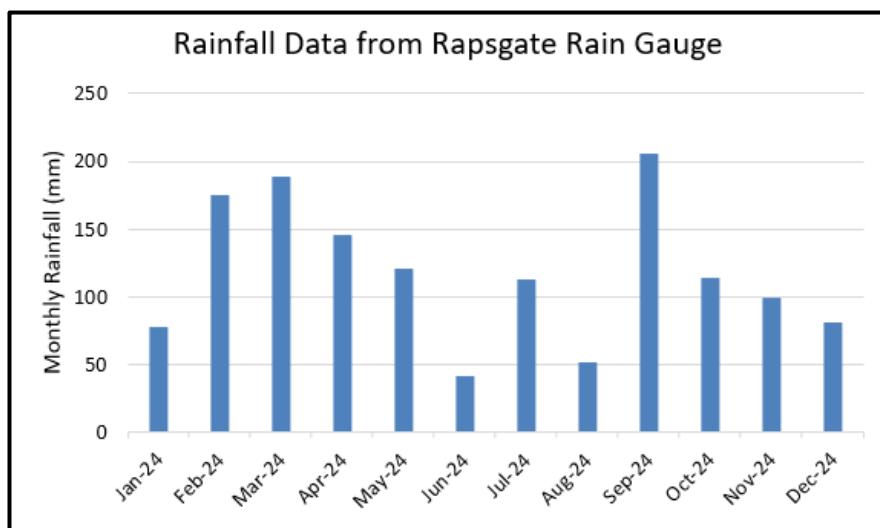
Following an exceptionally wet September in the upper Churn and Daglingworth Stream catchments, the monthly rainfall totals for October, November and December were progressively drier, as shown on the graph. This accounts for Storm Bert which brought around 50mm of rain on the 23rd and 24th November, while the November rainfall total reported for the Miserden rain gauge in the Frome catchment has been updated, increasing from 97% to 118% of the monthly average. As a result, the November rainfall in the upper Churn and Daglingworth Stream catchments was around 15% above average. The December rainfall total at the Rapsgate rain gauge in the Churn catchment was 81mm, with 81mm also recorded at Miserden, equating to 105% and 85% of their monthly averages, respectively. Although December rainfall was around average, about 70mm of the 81mm total fell in the first 18 days of the month, with noticeably drier weather occurring over the remainder of the month. Considering 2024 as a whole, the data indicates that it was the wettest year in the 41 year record for the Rapsgate gauge, and the 3rd wettest year in the 44 year long record for Miserden.

Since the exceptionally wet September monthly rainfall totals have decreased to around average in December but despite this, soils across the upper Churn and Daglingworth catchments have remained wet, allowing aquifers to recharge when sufficient rain falls.

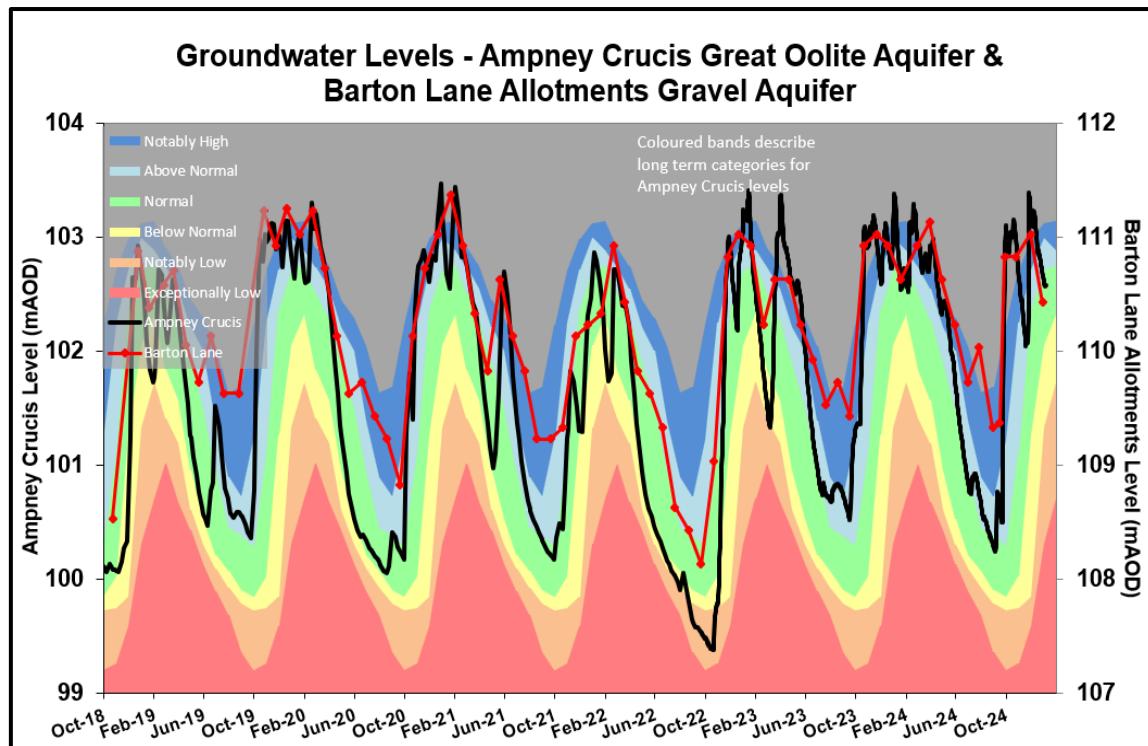
Groundwater in the Great Oolite limestone aquifer rose more rapidly and earlier to exceptionally high levels this autumn, because of the exceptionally wet end to September. Levels remained exceptionally high for much of October but as a result of relatively dry weather from mid-October until the arrival of Storm Bert, groundwater levels declined, although they remained above normal. Significant rainfall during Storm Bert resulted in groundwater levels rising rapidly to exceptionally high levels, as can be seen from the graph below. After some wet weather at the start of December, the drier weather has been accompanied by a decline in groundwater levels with levels in the Great Oolite aquifer at the end of December being normal for the time of year.

The graph above also shows a similar groundwater level trend in the shallow Gravel aquifer at Barton Lane Allotments. Levels rose in November in response to Storm Bert, then subsequently declined in response to the drier end of December. As shown on the graph below, there are similar trends in Gravel aquifer at The Plough Inn well, as well as the shallow wells at the Swimming Pool and Salvation Army. This consistency in the trends suggests that similar rainfall and aquifer recharge processes are operating, with subtle differences in groundwater level responses between the wells perhaps reflecting differences in the degree of connection between the aquifer and the adjacent watercourses. The overall progressive decline in groundwater from high levels at The Plough Inn well to the lowest levels at the Salvation Army well reflects the natural groundwater gradient from north-west to south-east in the shallow Gravel aquifer.

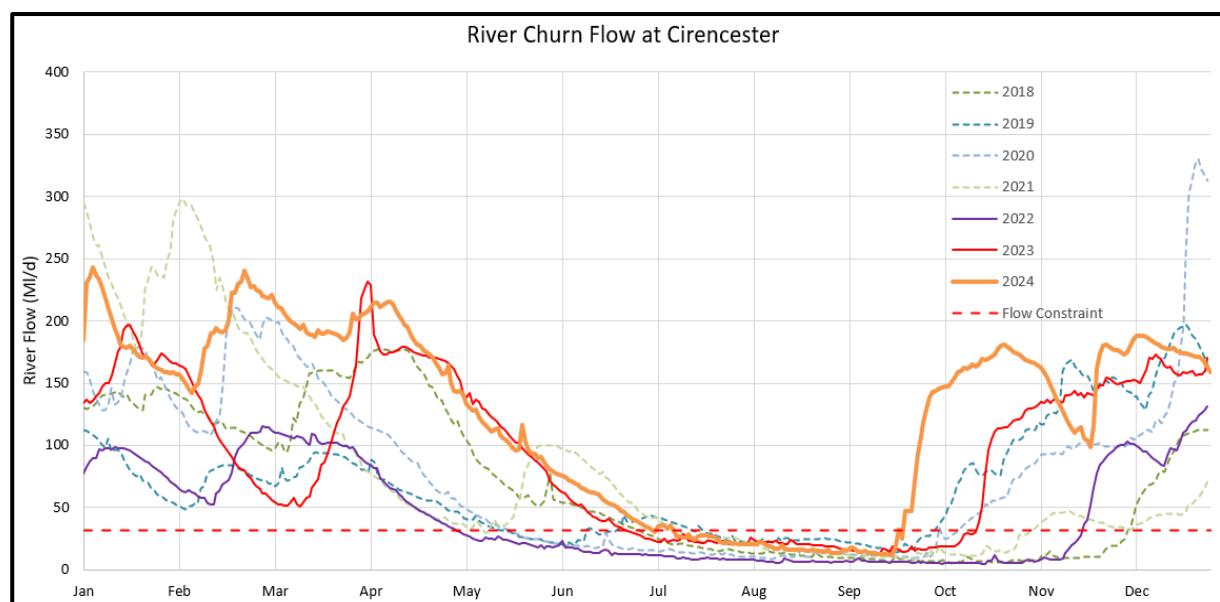
As a result of the exceptional September rainfall, flow in the River Churn at the EA Cirencester gauging station increased rapidly from the typical low summer and autumn flows, although this increase occurred much earlier than normal. As can be seen from the graph below, the flow peaked at 180 MI/d towards the end of October, then decreased steadily in response to the drier weather until Storm Bert occurred. The heavy rainfall resulted in a rapid increase in flow from 98 MI/d to just over 181 MI/d in the space of 5 days. The relatively wet start to December resulted in a further increase in river flow, peaking at 188 MI/d, but with the noticeably drier end to December flow in the Churn again decreased progressively to 159 MI/d at the end of the month.

As noted in previous reports, the trends in river flow largely follow those recorded in the Great Oolite aquifer, with groundwater flow out of the aquifers contributing significantly to the River Churn flow. This is especially the case when groundwater levels are exceptionally high, but even

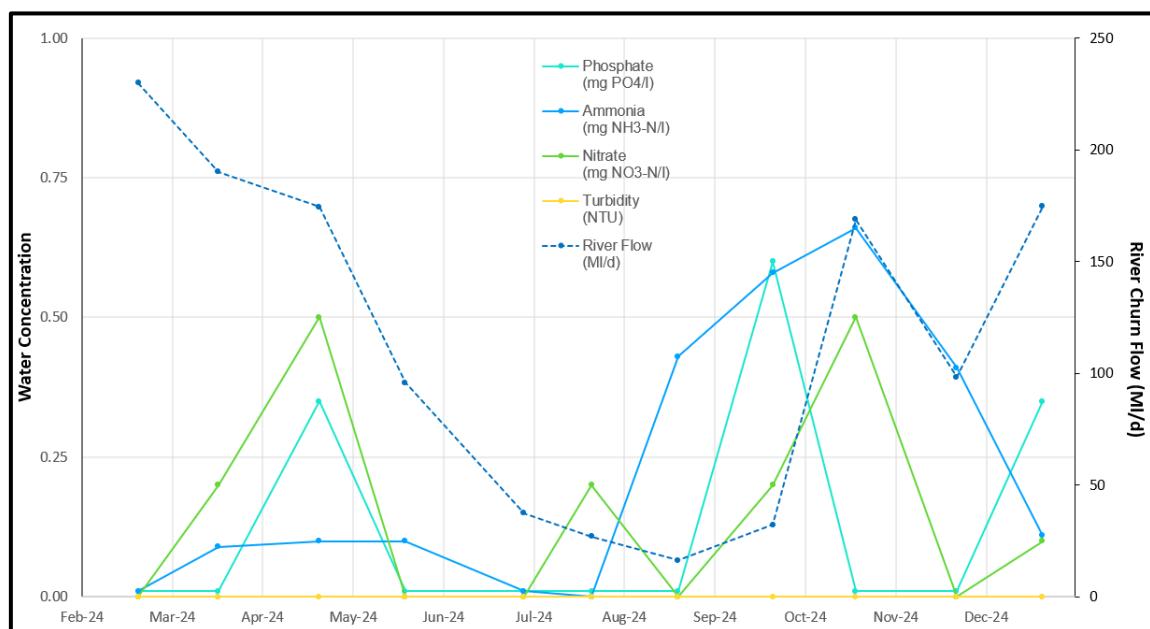
Monitoring of river water quality covers the nutrients, ammonia, nitrate and phosphate, and turbidity, a measure of how clear the water is. During 2024 there was little evidence of persistent pollution by nutrients, but intermittent elevated phosphate and nitrate concentrations have been detected in the Churn and Gumstool Brook. The graph below for the Churn shows these spikes in concentration as well as evidence of more persistent increasing trends in ammonia and, to a lesser extent, nitrate from summer into early autumn. These trends are not apparent in the Gumstool Brook. It is possible that rainfall and particularly rainfall intensity influences these spikes, with rising trends perhaps linked to increasing river flows. With the River Churn flow decreasing between the October and November monitoring rounds, and the November water quality results showing a decrease in ammonia and nitrate, there is further evidence for a connection between river flow and its quality. It is clear however, that the controls on water quality are complex, because higher flow in the River Churn in December is associated with a further decrease in ammonia concentration but increases in nitrate and phosphate concentrations. The increase in phosphate concentration in the Gumstool Brook is particularly apparent with the 2 mg PO₄/l concentration being double the previous highest concentration. Apart from these phosphate concentrations, the nutrient concentrations are not particularly high, although appropriate nutrient concentrations reflecting good quality will need to be defined.

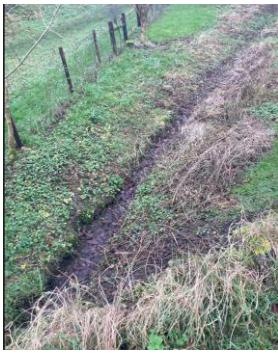
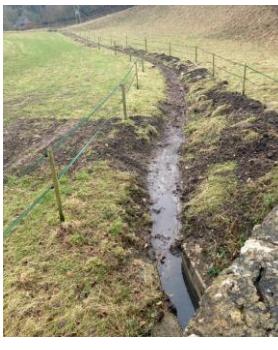
<p>1a. Daglingworth Stream upper source north of Duntisbourne Abbots.</p> <p>The stream channel is muddy and there is some standing water on the downstream side of the road.</p>

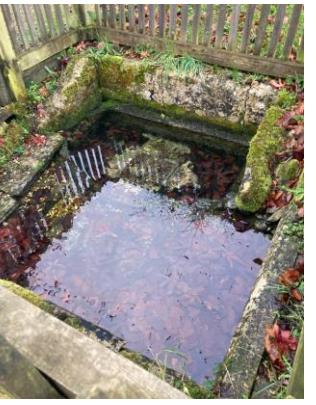
<p>1b. Duntisbourne Abbots village spring.</p> <p>There is a gentle flow of very clear water in the spring.</p>

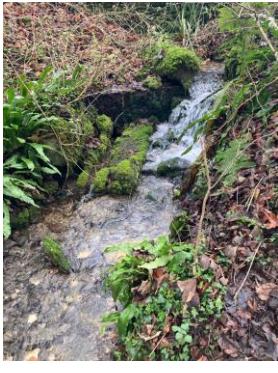
<p>2. Duntisbourne Abbots Daglingworth Stream downstream of inferred confluence of spring sources.</p> <p>There is a normal clear flow of water in the channel.</p>

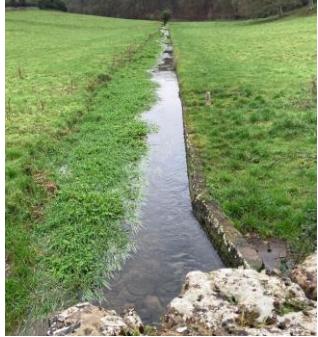
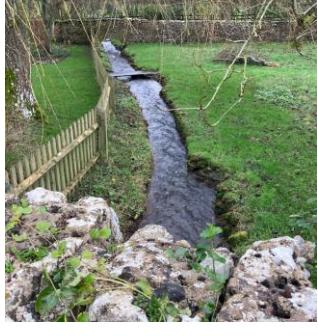
<p>6. Daglingworth Stream Grove Hill bridge.</p> <p>A normal flow is observed that fills one half of the channel in the field upstream of the road bridge. Downstream of the road, the stream is almost filling the full depth of the channel, up to a few centimetres from the underside of the private stone footbridge.</p>

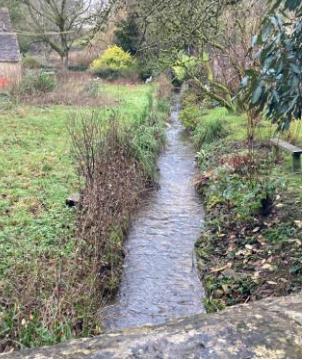
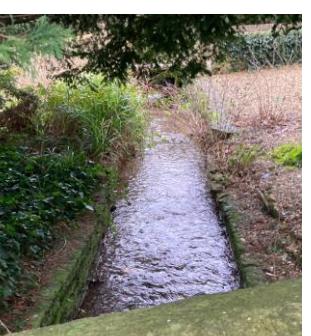
<p>7. Daglingworth Stream at Lower End road bridge.</p> <p>A normal flow of clear water is observed in the upstream garden, and the walled channel downstream of the bridge.</p>

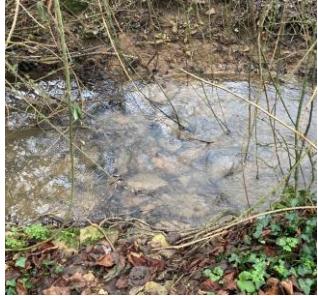
<p>8. Wellhill Copse, Daglingworth Stream.</p> <p>In the fields upstream of Wellhill Copse, the stream is flowing within its banks.</p> <p>At the footpath stile the stream has a steady flow and the water is slightly muddy.</p>

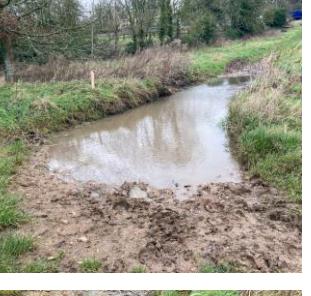
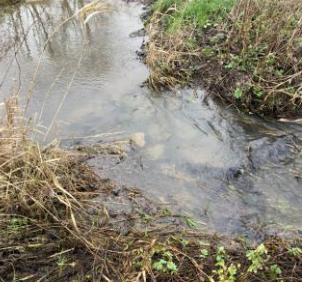
<p>9. Daglingworth Place ford, Daglingworth Stream.</p> <p>A steady flow of slightly muddy water is observed at the ford over the pebble weir.</p>

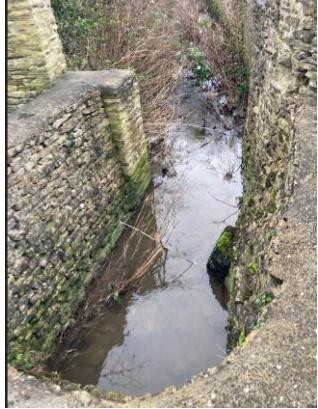
<p>10. Grange Farm bridge, Daglingworth Stream.</p> <p>There is a steady flow of slightly muddy water into the farm channel.</p> <p>There is no standing water present in the horse fields upstream of Grange Farm adjacent to the stream.</p>

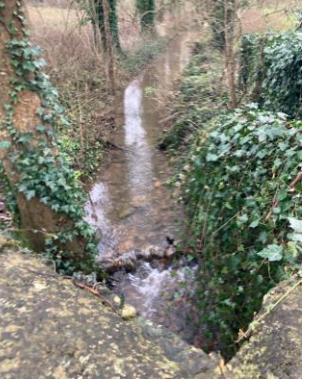
<p>11. School Hill bridge, Daglingworth Stream.</p> <p>The stream has a steady flow of slightly muddy water similar to that at Grange Farm.</p>

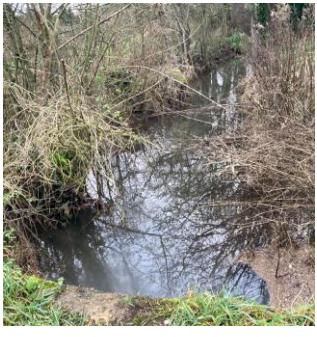
<p>15. Footpath at Lower Stratton.</p> <p>The stream is flowing at a steady rate.</p> <p>The stream level at this location is still very high (close to the footbridge crest). This is believed to be due to heavy undergrowth and debris observed just downstream of this location.</p>

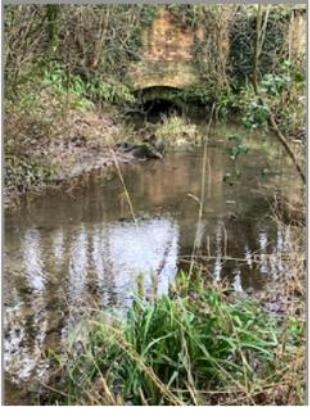
<p>16a. Daglingworth Stream at Barton Lane upstream of Bathurst Estate boundary wall</p> <p>A steady flow of clear water is observed.</p>

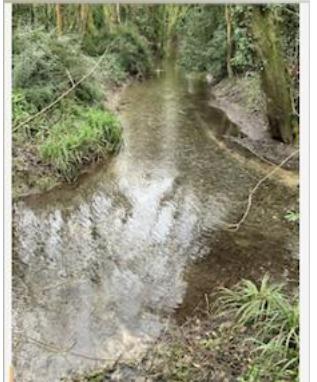
<p>16b. Daglingworth stream at Barton Lane downstream of Bathurst Estate boundary wall.</p> <p>A steady flow of clear water is observed.</p>

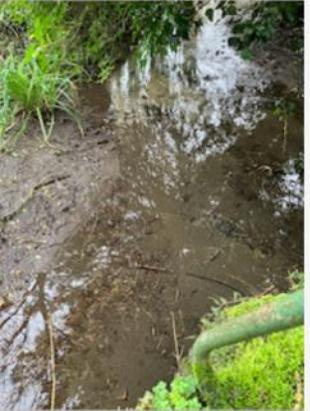
<p>17. Gumstool Brook balancing stream at sluice gate.</p> <p>The stream is flowing with clear water.</p>

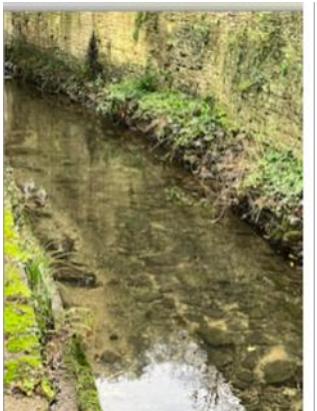
<p>18. Gumstool Brook alongside swimming pool on the Riverside walk.</p> <p>A steady flow of clear water is observed.</p>

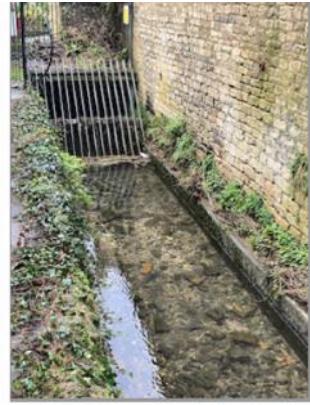
<p>20. Gumstool Brook at culvert trash screen.</p> <p>A steady flow of clear water is observed.</p> <p>There is no significant debris at the screen.</p>

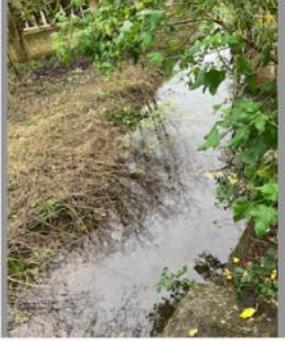
<p>22a. Balancing Stream behind Salvation Army.</p> <p>The stream channel is flowing with clear water.</p>

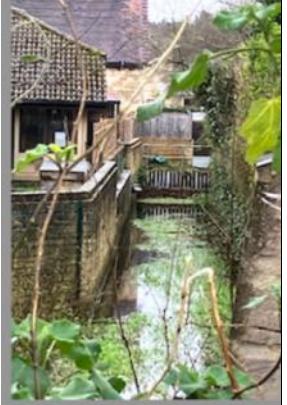
<p>22b. Balance stream at Powell's School at trash screen.</p> <p>The stream is flowing with clear water.</p>

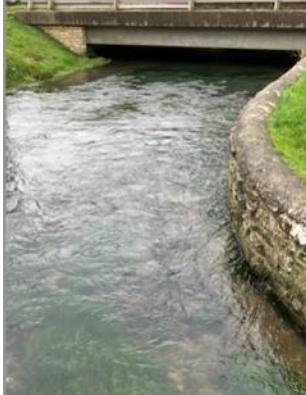
<p>23a. River Churn at Glos St bridge upstream of sluices</p> <p>The river has a high flow with limited vegetation present.</p>

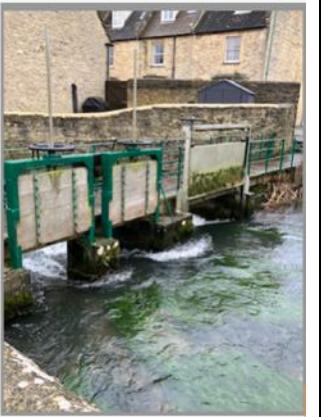
<p>23b. Glos St bridge sluices</p> <p>All sluice gates are open and there is a high flow, with vegetation visible in the river.</p>

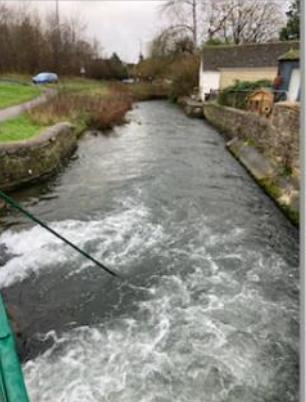
<p>23c. Glos St bridge downstream of sluices</p> <p>There is a high flow with no significant vegetation.</p>

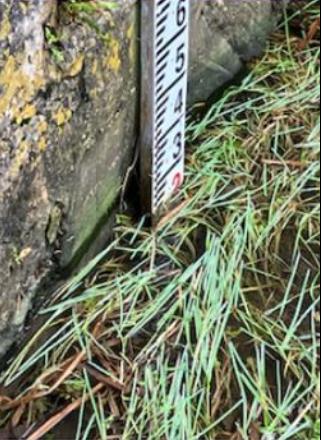
<p>24d. River Churn at the measuring gauge on Glos St bridge.</p> <p>Water level is 0.23m (2.3 on the gauge board)</p>

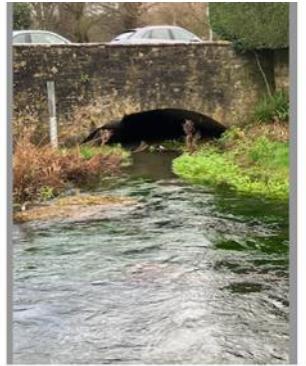
<p>24e. Glos St bridge downstream view from sluices.</p> <p>There is a steady flow into the mill pound.</p>

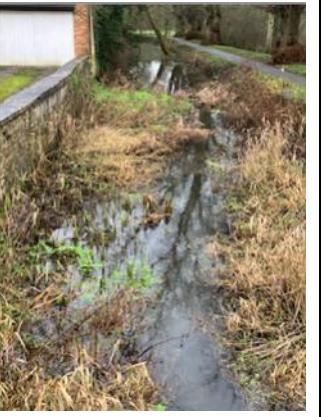
<p>24c. Mill Pound looking downstream from Glos St bridge.</p> <p>There is a steady stream flow between the vegetation.</p>

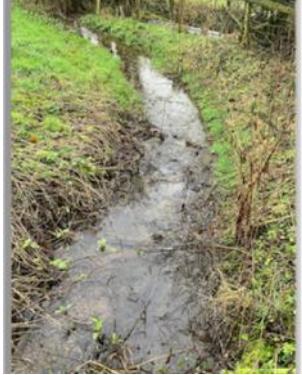
<p>25. Mill Pound Overflow (New)</p> <p>There is a steady flow of water from the overflow pipes.</p>

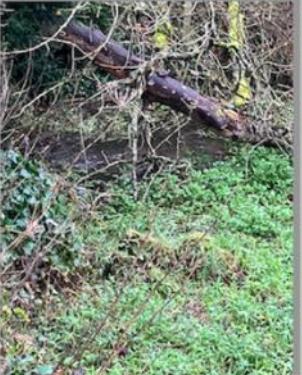
<p>26. Mill Pound Overflow (Old)</p> <p>There is water visibly flowing from the overflow.</p>

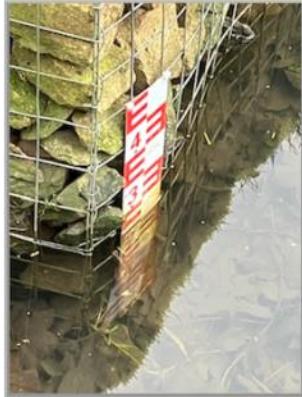
<p>26a Gauge by footbridge</p> <p>Water level is 0.26m (2.6 on gauge)</p>

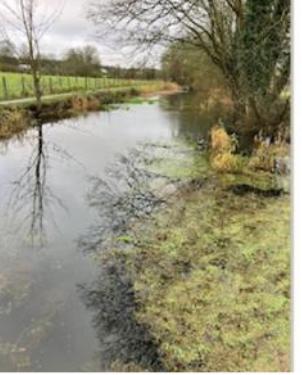
<p>27a. Mill Pound upstream of footbridge</p> <p>There is a slow flow of clear water. Some surface vegetation still present.</p>

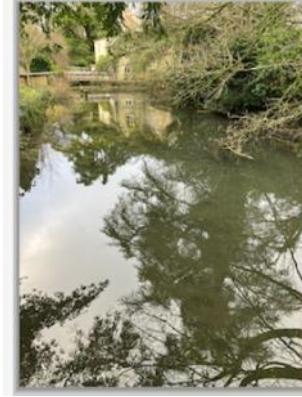
<p>27b. Mill Pound downstream of footbridge.</p> <p>There is a slow flow of clear water. Some sub-surface vegetation still present.</p>

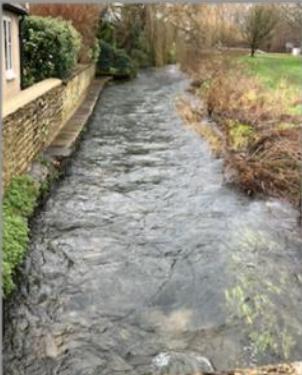
<p>34. River Churn upstream side of Gooseacre Lane bridge</p> <p>The river has a high flow of clear water.</p>

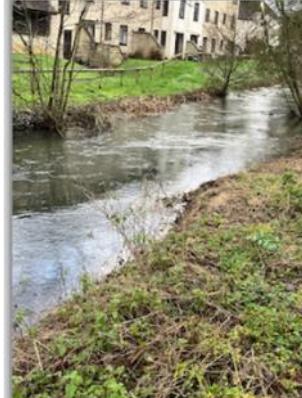
<p>35. River Churn upstream of Spitalgate Lane bridge</p> <p>The river has a high flow of clear water. There is no significant flooding into the adjacent park.</p>

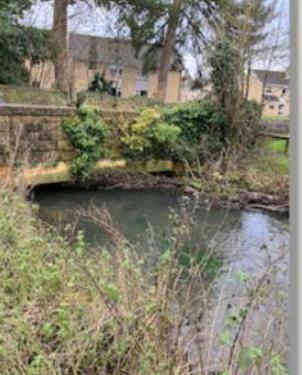
<p>35b. River Churn downstream north of Spitalgate Lane bridge</p> <p>The river has a high flow of clear water.</p>

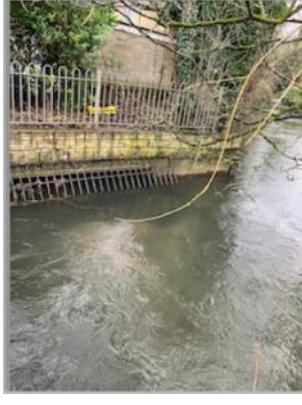
<p>36a. River Churn at Hereward Road trash screen.</p> <p>There is a steady flow into the culverted stream feeding to the Abbey Lake.</p>

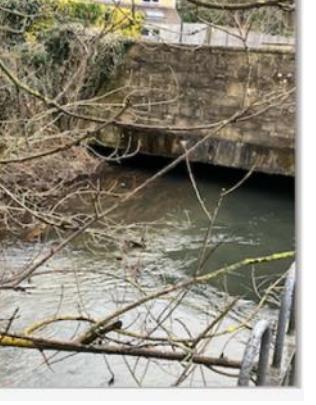
<p>36b. River Churn upstream side of Hereward Road bridge</p> <p>The river has a high flow of clear water.</p>

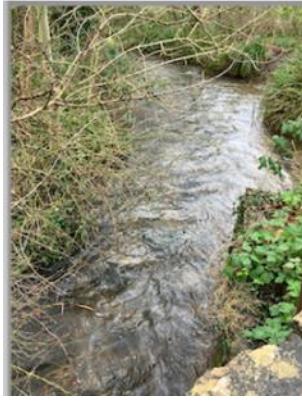
<p>37. Stream flowing into Abbey lake</p> <p>There is a steady flow of clear water.</p>

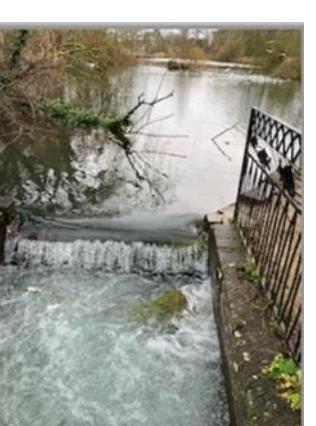
<p>38a. Weir at stream outlet from Abbey Lake</p> <p>The weir has a steady flow of clear water.</p>

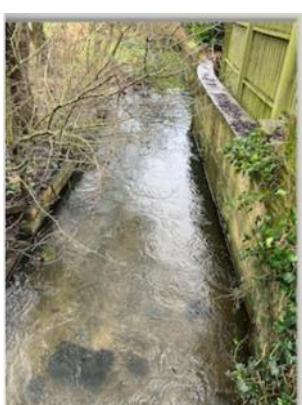
<p>38b. Footbridge at stream outlet from Abbey Lake</p> <p>There is a steady flow of clear water.</p>

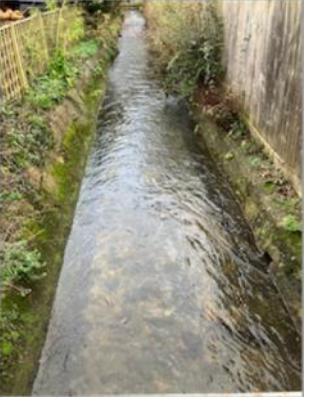
<p>39 Abbey Lake outlet stream at Corinium gate bridge</p> <p>There is a steady flow of clear water.</p>

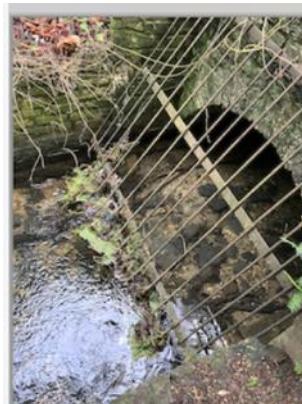
<p>40. Gumstool Brook culvert outlet in Abbey grounds</p> <p>There is a steady flow of clear water.</p>

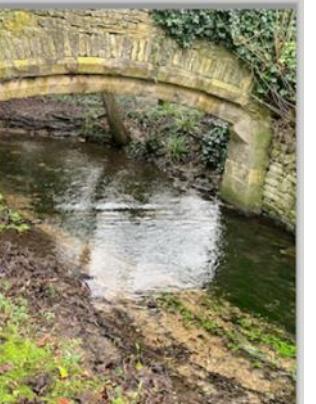
<p>41a. River Churn (W branch) – Looking upstream towards Abbey Lake.</p> <p>There is a steady flow of clear water.</p>

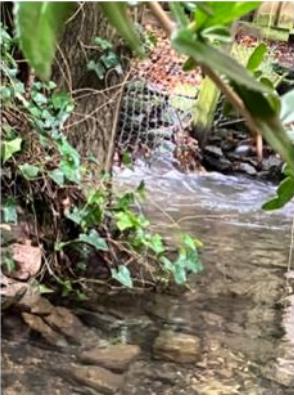
<p>41b. Gumstool Brook - Confluence with Abbey Lake outlet (Waterloo carpark)</p> <p>There is a steady flow of clear water.</p>

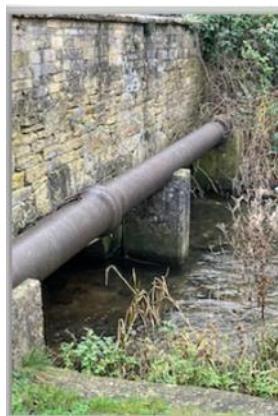
<p>42a. River Churn (W branch) on downstream side of London Road bridge</p> <p>There is a steady flow of clear water.</p>

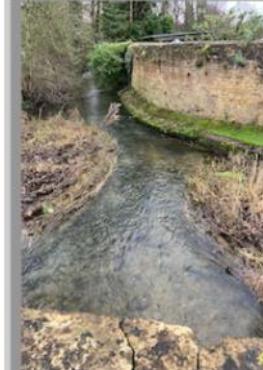
<p>42b. River Churn (West branch) looking downstream from London Road bridge, upstream of Beeches Road</p> <p>The river has a high flow.</p>

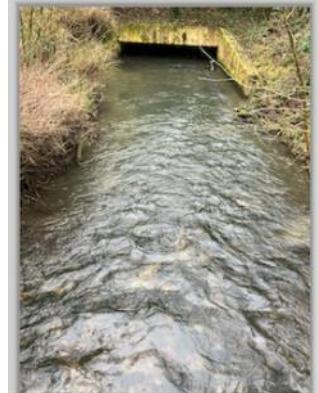
<p>44. River Churn (East branch) at Old Beeches Road Bridge</p> <p>The river has a high flow.</p>

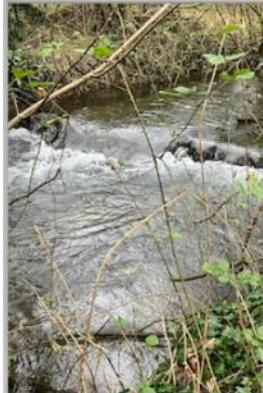
<p>45. River Churn (West branch) – weir in City bank glade</p> <p>The stream has a steady flow.</p>

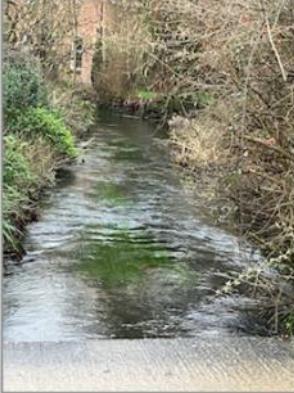
<p>47. River Churn (West branch) at City Bank Park footbridge</p> <p>The stream has a steady flow.</p>

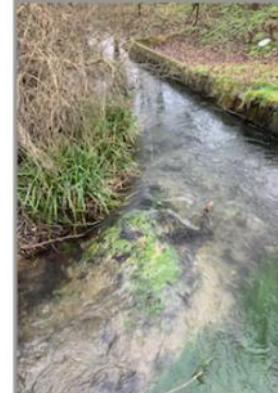
<p>48. River Churn (West branch) at Watermoor Point Car park</p> <p>The stream has a steady flow of clear water.</p>

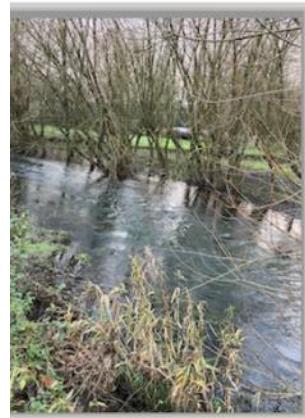
49 River Churn at Cricklade Road (opposite Aldi)

The river has a high flow, but within its banks.

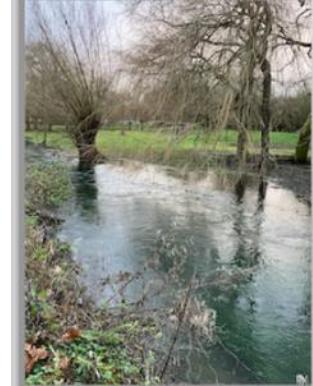
50 River Churn at Cricklade Road (opposite Tesco)

The river has a high flow, but within its banks.
