# Citizen Monitoring Report March 2025

Friends of Gumstool Brook is a group of local people interested in Cirencester's Gumstool Brook and its associated streams. Visit our website at <https://gumstool.org.uk>

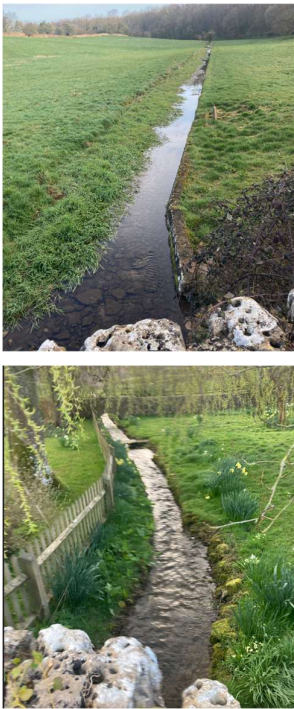
<p>6c. Daglingworth Stream Grove Hill bridge.</p> <p>A low flow is observed that fills over one half of the channel in the field upstream of the Grove Hill bridge.</p> <p>Downstream of the road, the stream is flowing up to a approx. 20 cm from the underside of the private stone footbridge.</p>

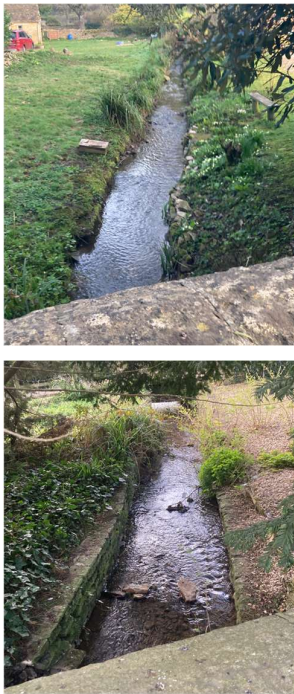
<p>7. Daglingworth Stream at Lower End road bridge.</p> <p>A low flow of clear water is observed in the upstream garden, and the walled channel downstream of the bridge.</p>

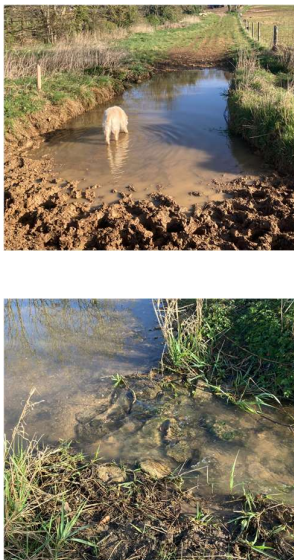
<p>9. Daglingworth Place ford, Daglingworth Stream.</p> <p>A low flow of muddy water is observed at the ford and over the pebble weir.</p>

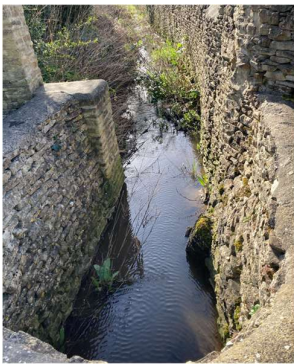
<p>10. Grange Farm bridge, Daglingworth Stream.</p> <p>There is a low flow of slightly muddy water into the farm channel.</p>

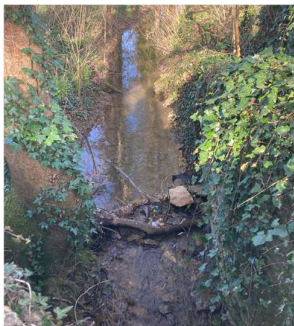
<p>11. School Hill bridge, Daglingworth Stream.</p> <p>The stream has a low flow of slightly muddy water.</p>
