Flooding of North Stratton Meadows Nov 2025

Observations from Gallows Pound Lane

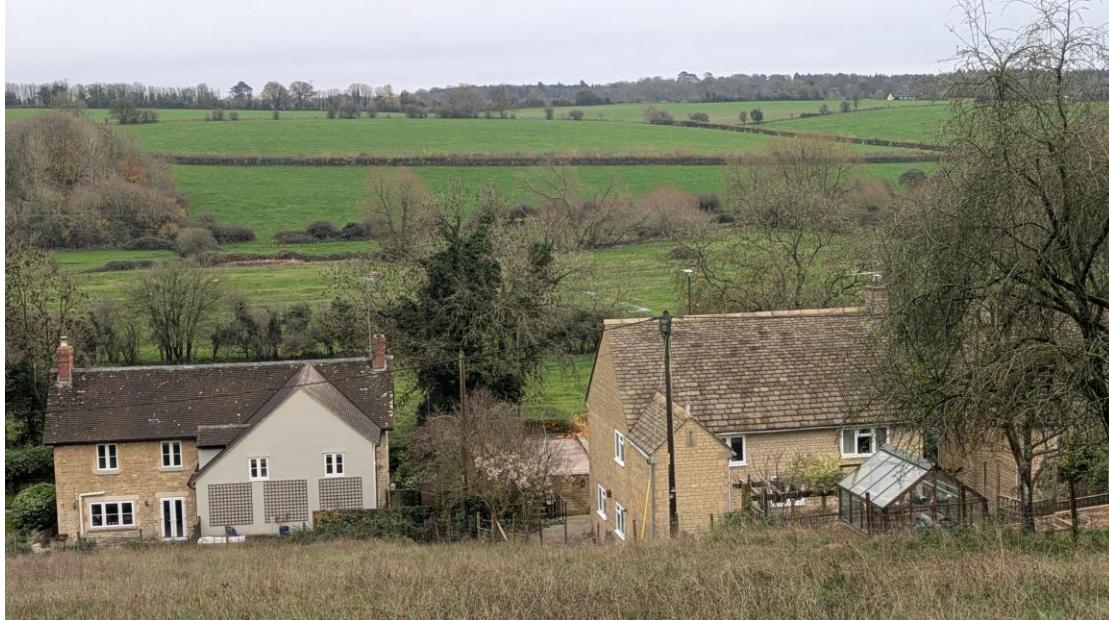
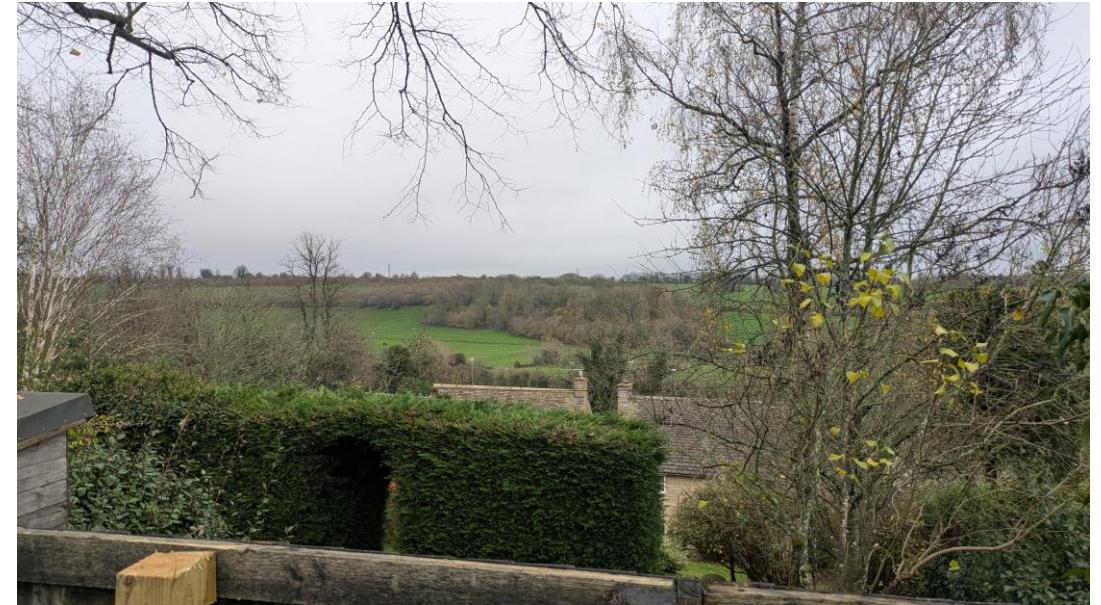
Water first noticed in ditch system south of join 15th Nov 2025 – no obvious link to Churn which seems well within bank. Can't rule out possibility of flow entering system from some control structure upstream (Left in picture). No surface water in filed area to the north of the join that was monitored via the fence in winter 2024/25

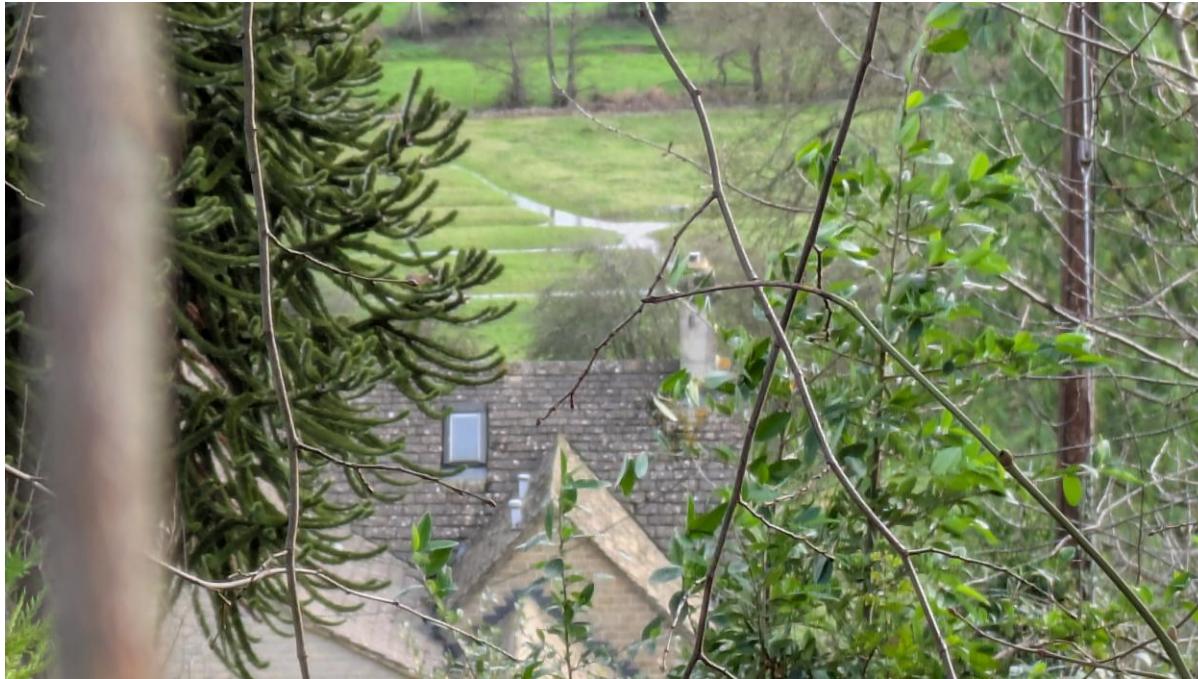
16th Nov 2025

Level rising in ditch system to south of observation area. Still nothing to north

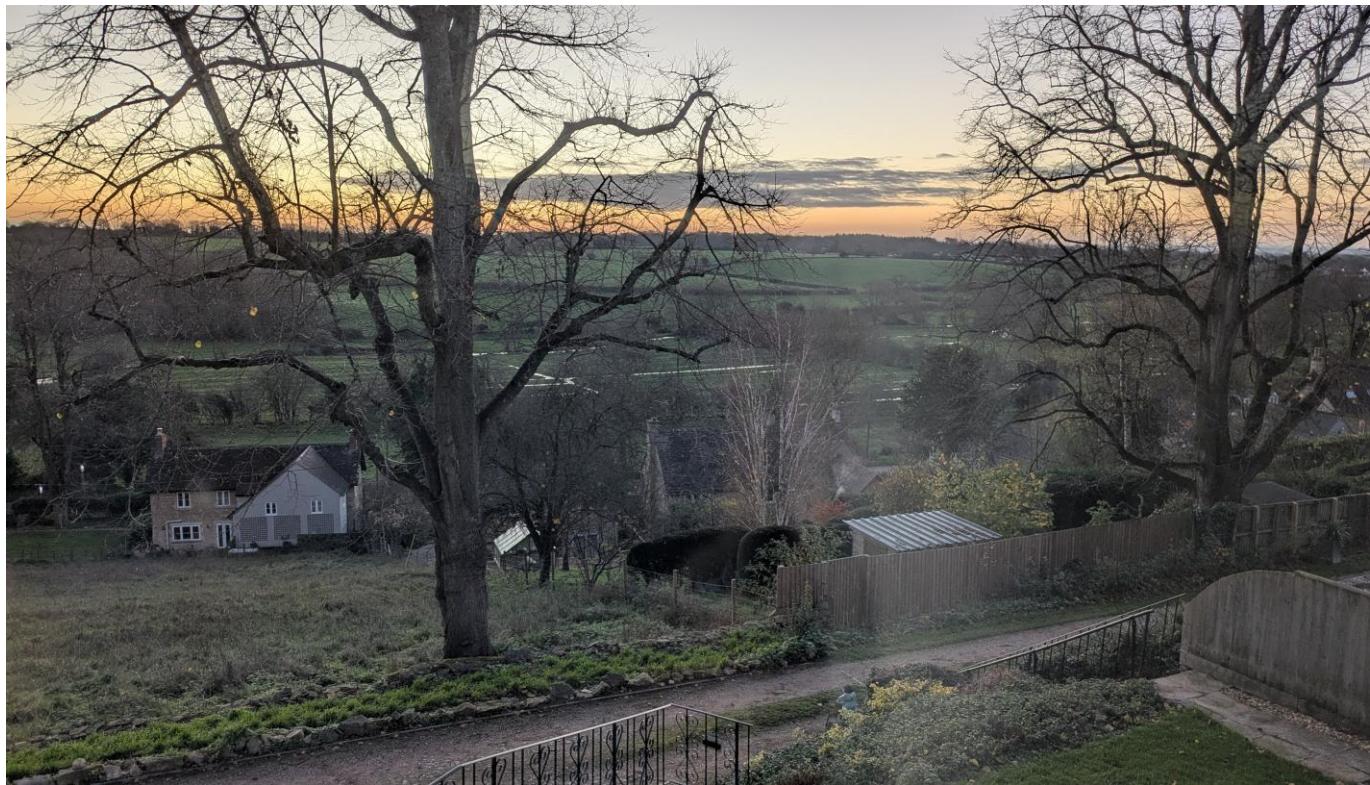
17th Nov 2025

Level rising in ditch system to south of observation area. Suggestion of small area to north? Wasn't prominent to the eye at the time

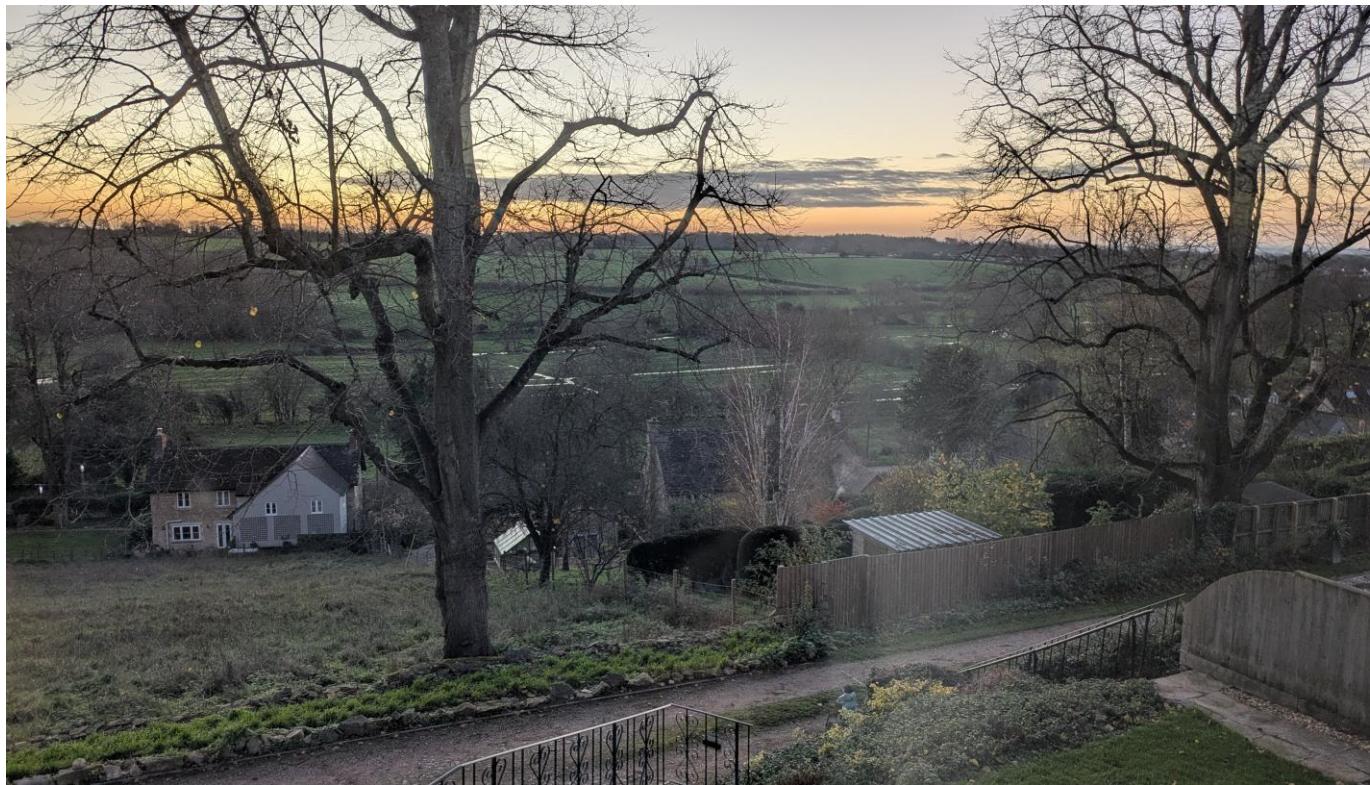
17th Nov 2025

Level rising in ditch system to south of observation area. Suggestion of small area to north? Wasn't prominent to the eye at the time

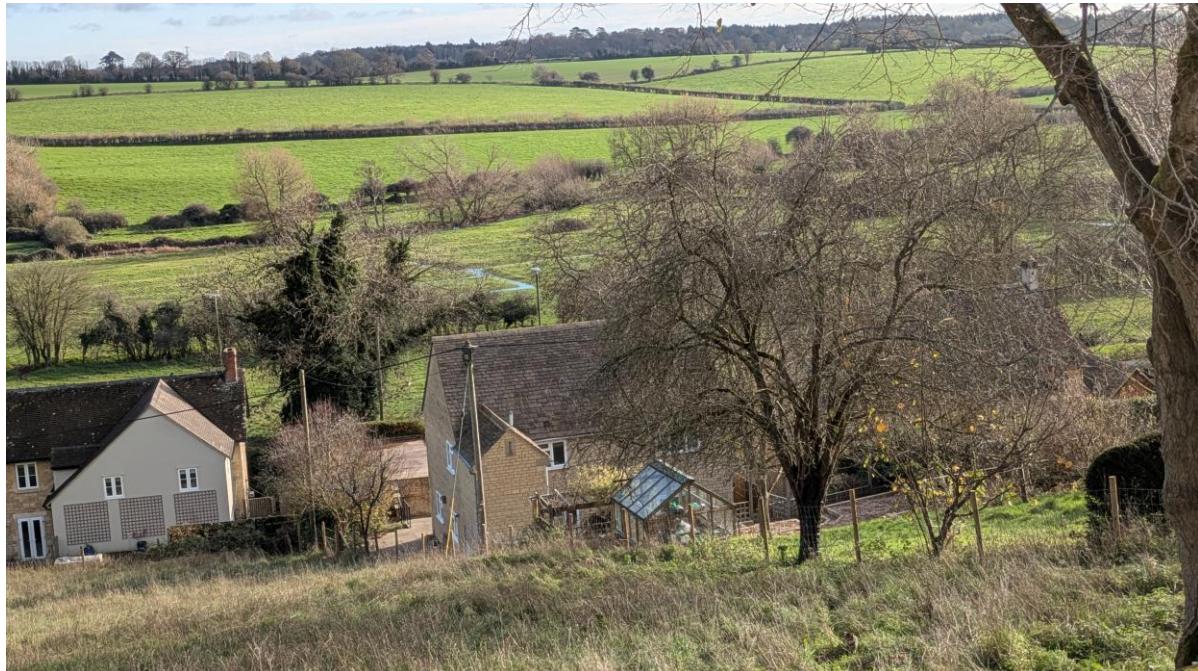
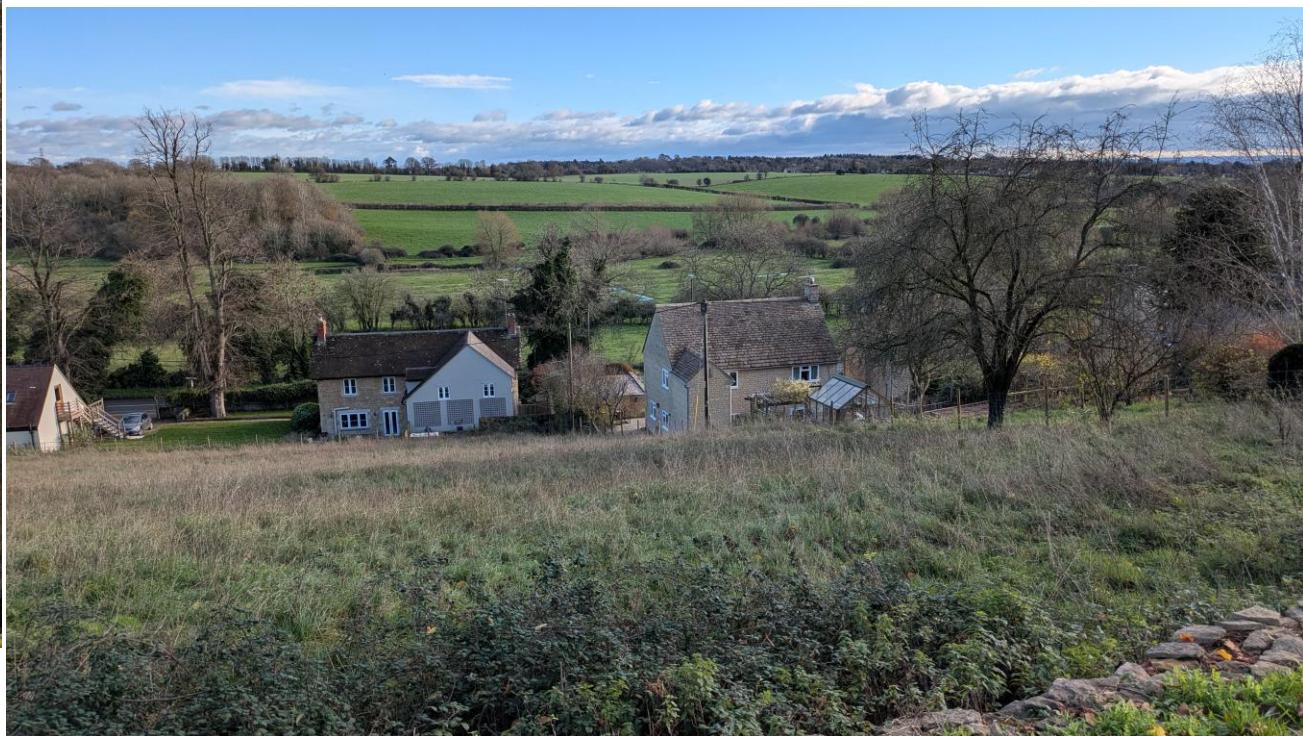
18th & 19th Nov 2025

Levels in ditch system to south of observation area. Nothing was obvious to the eye to the north

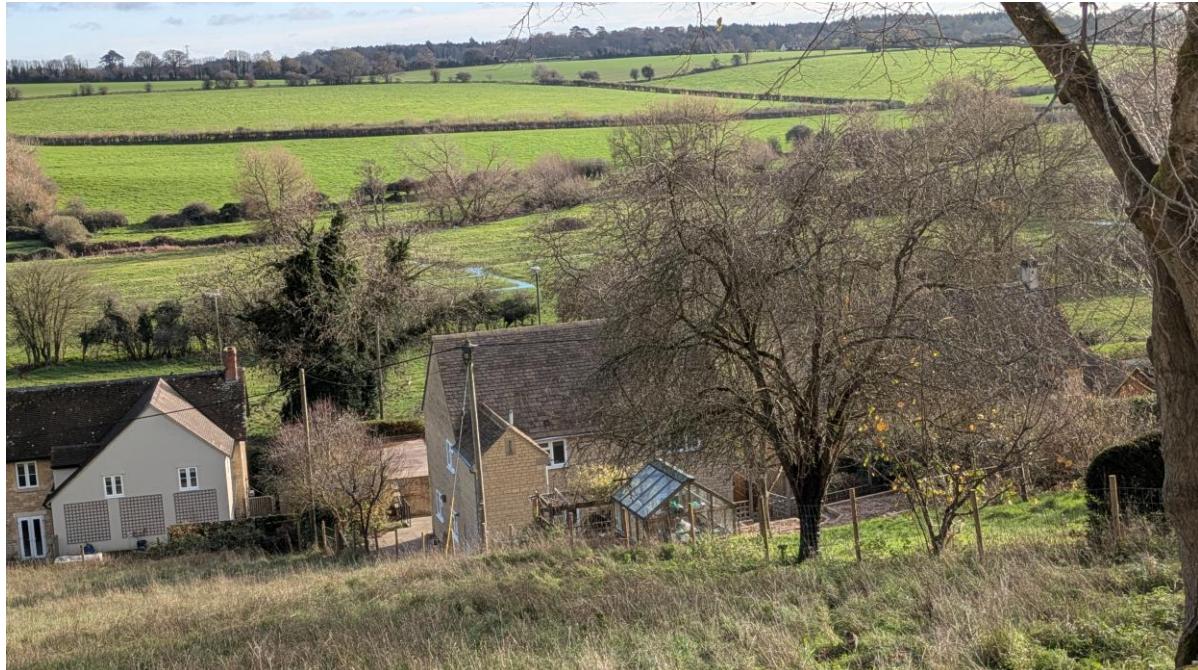
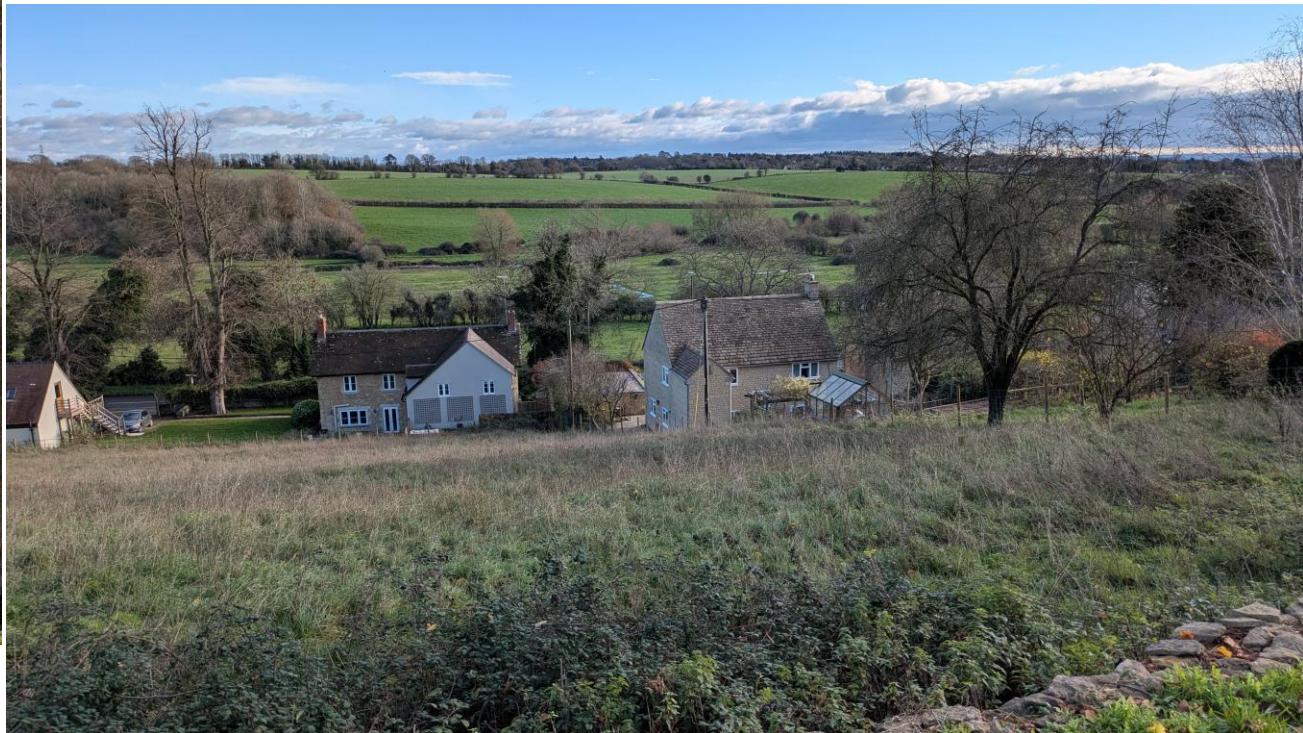
18th & 19th Nov 2025

Levels in ditch system to south of observation area. Nothing was obvious to the eye to the north

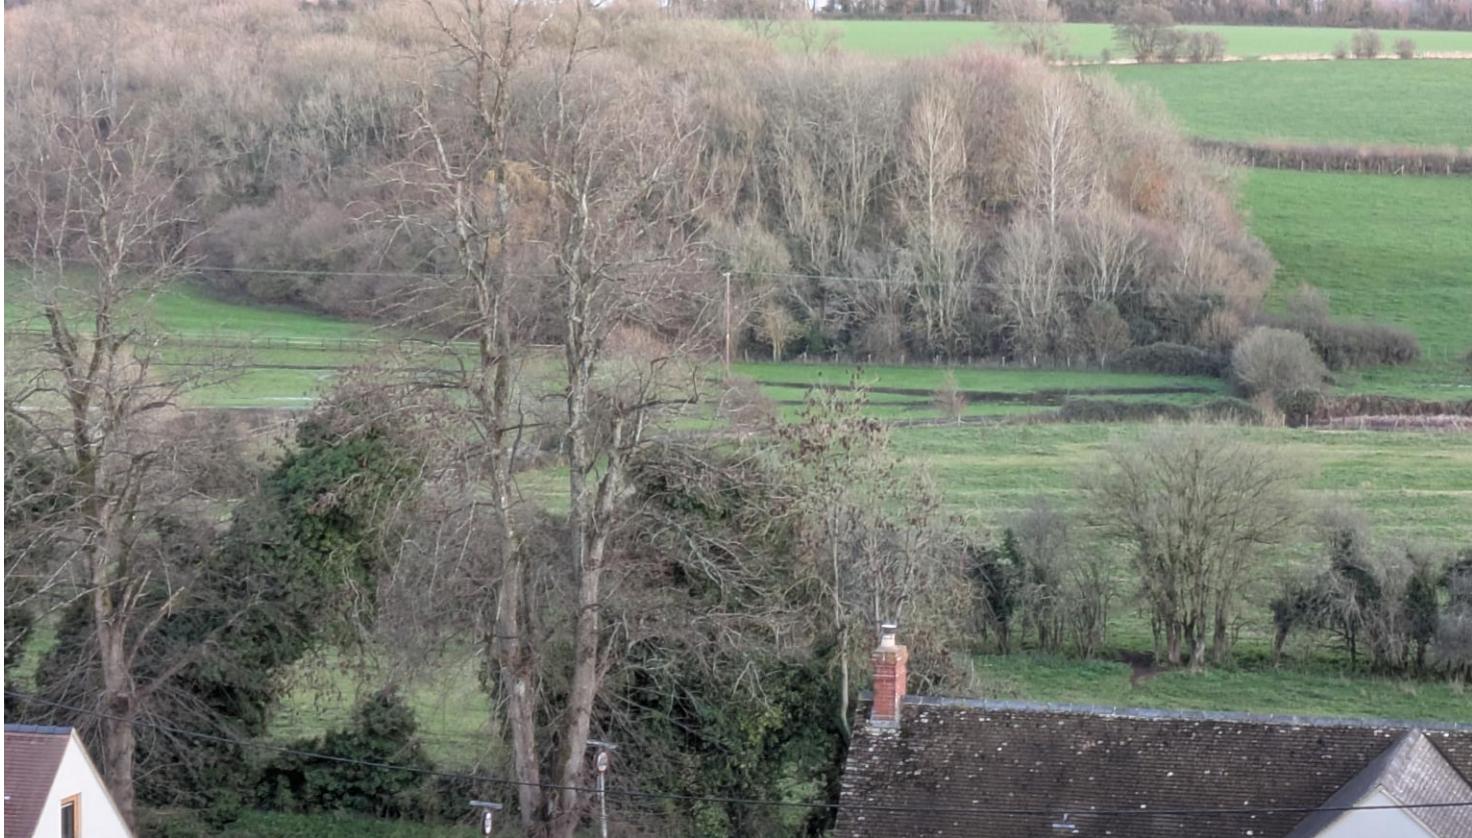
20th Nov 2025

Eastern branch of Churn looks about overbank. Fingers of water in ditches in the north observation area

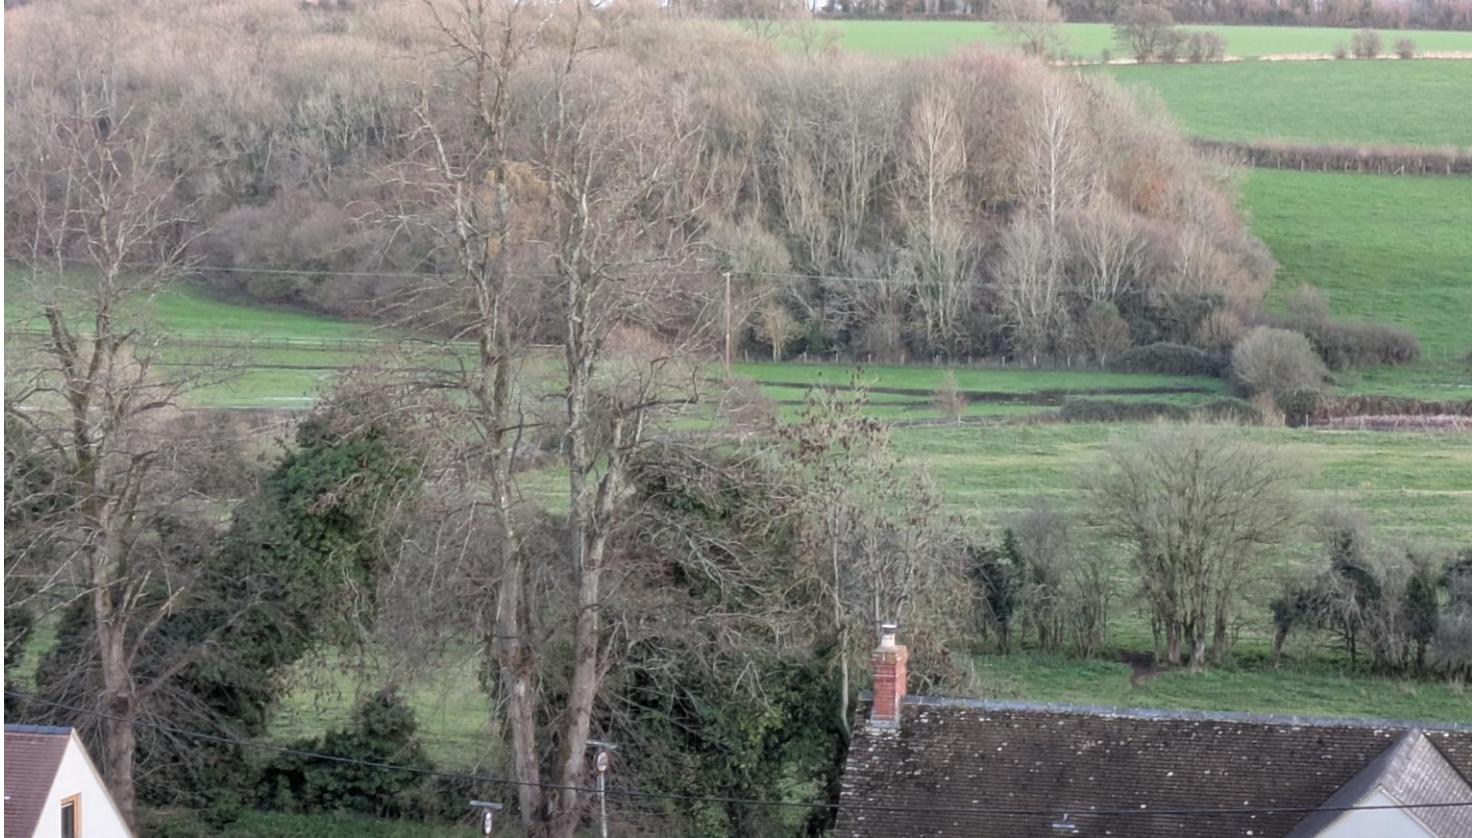
20th Nov 2025

Eastern branch of Churn looks about overbank. Fingers of water in ditches in the north observation area

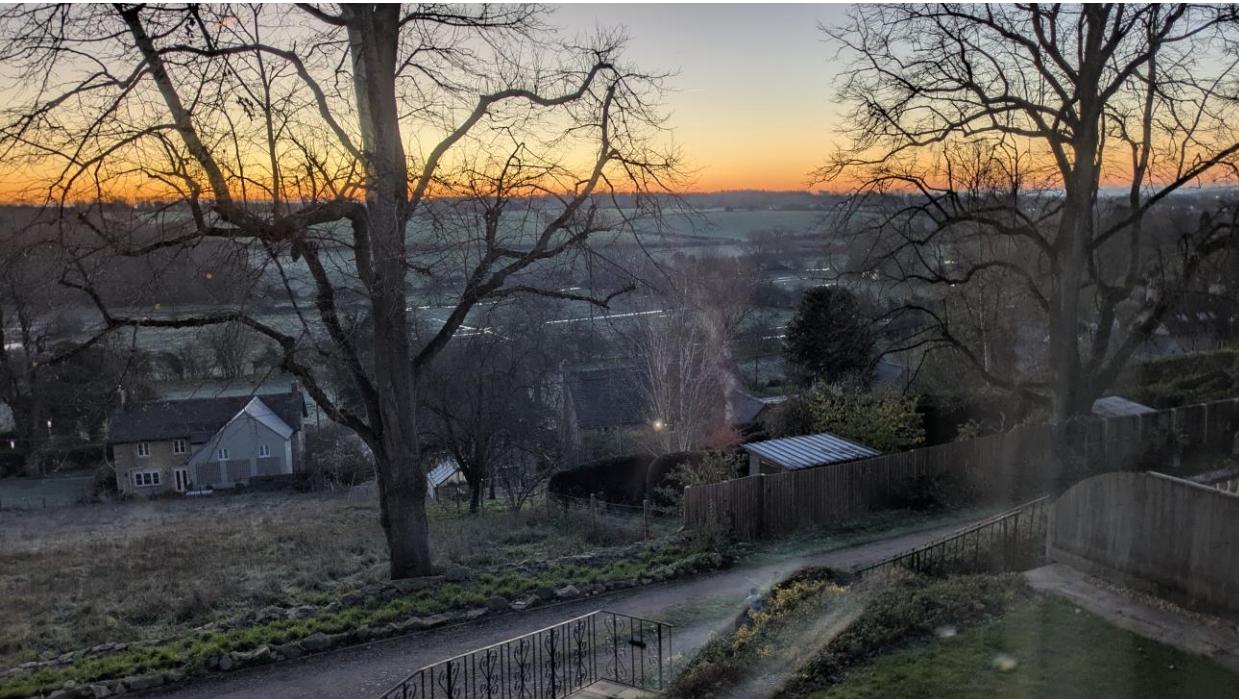
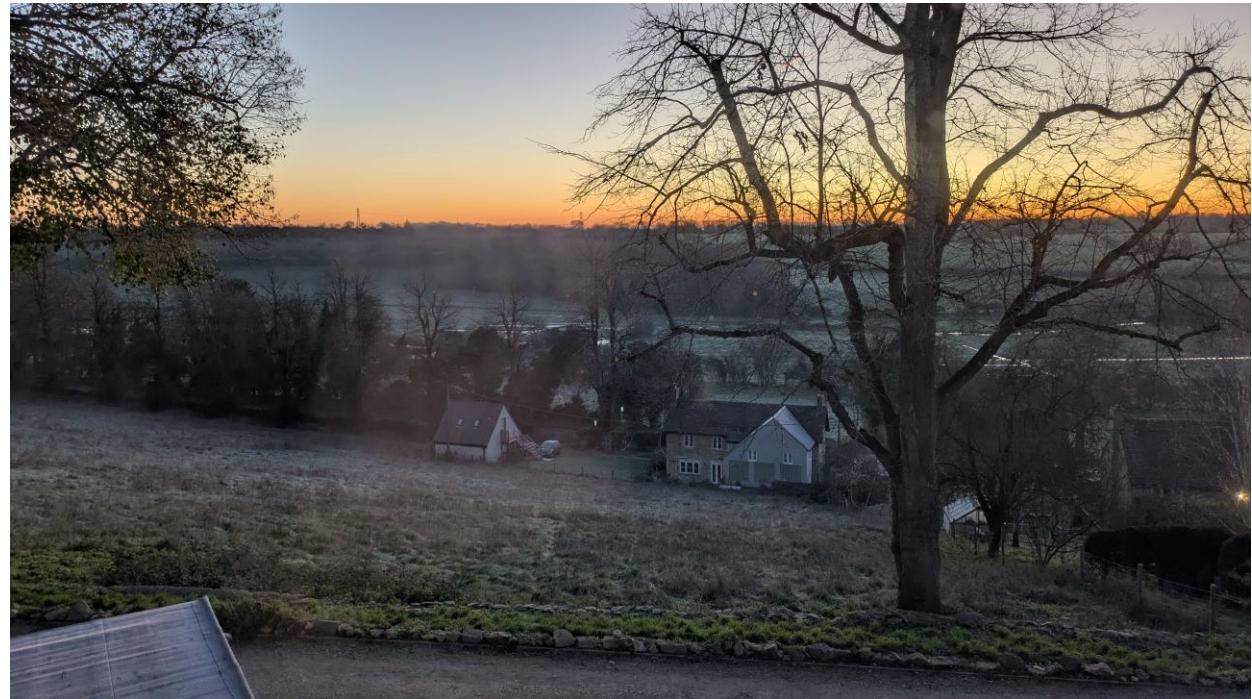
21st Nov 2025

Eastern branch of Churn looks about overbank. Fingers of water evident in ditches in the north observation area and levels higher in south?

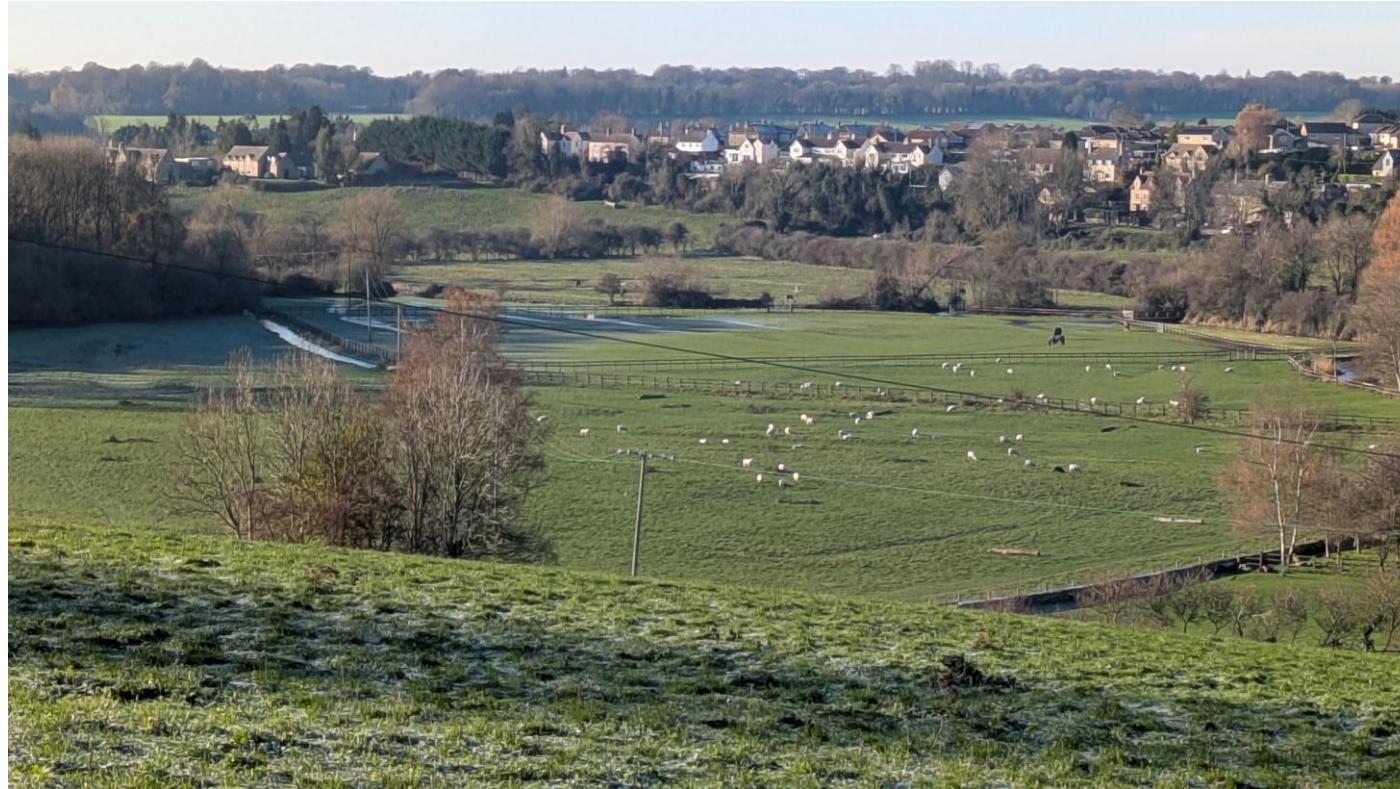
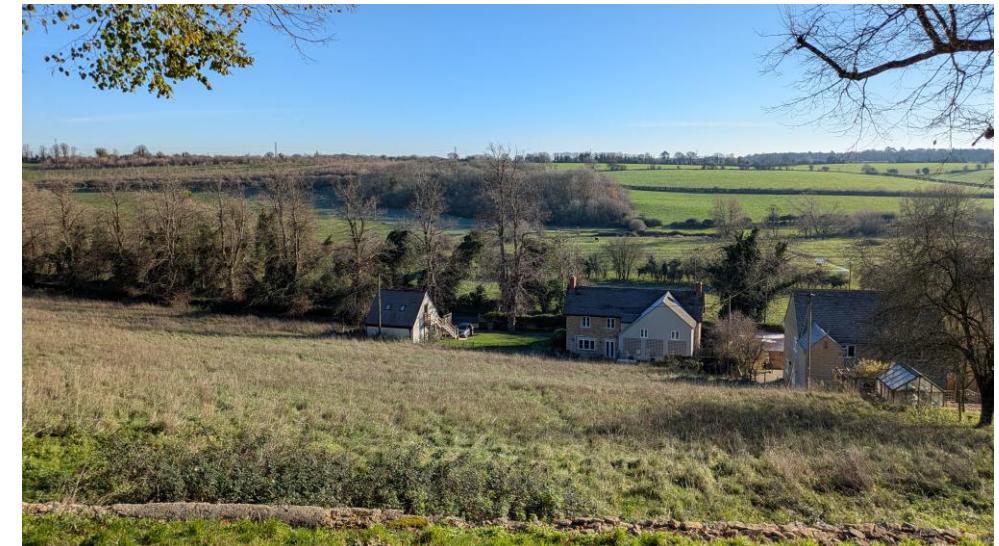
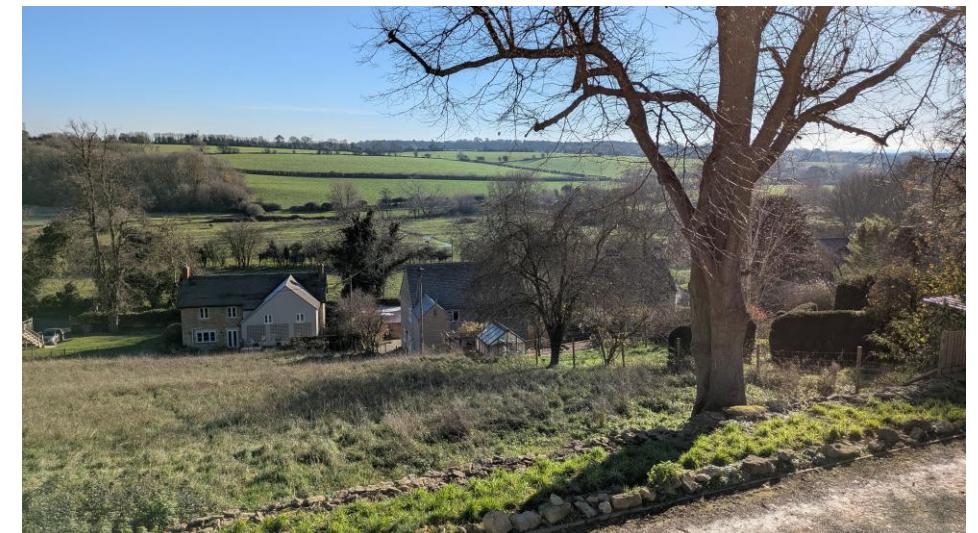
21st Nov 2025 view of area looking back from north on Whiteway and also from GPL

Eastern branch of Churn looks still in bank. Fingers of water evident in ditches in the north observation area.

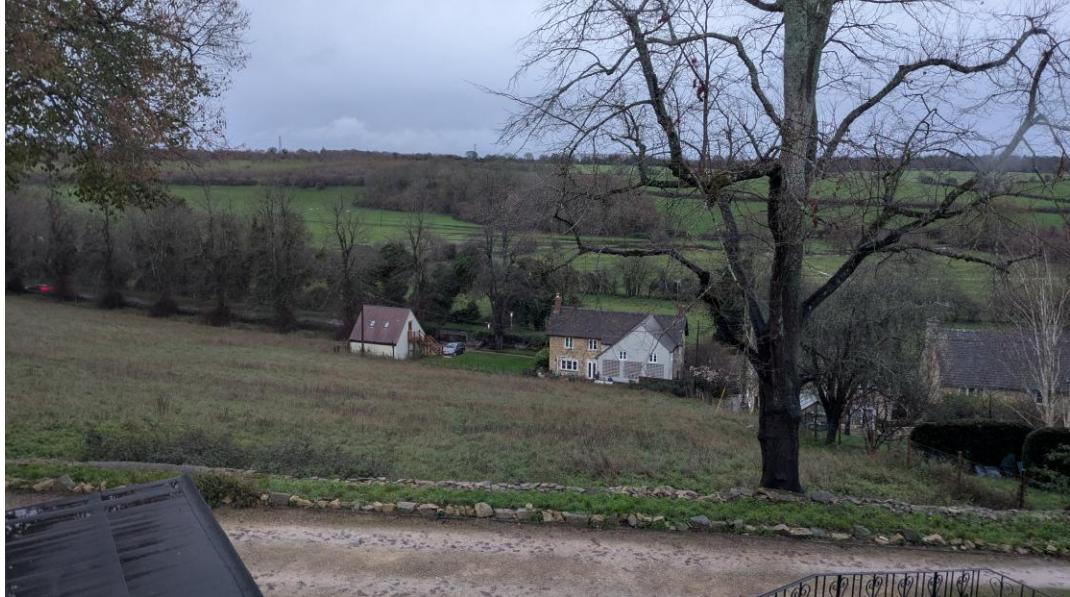
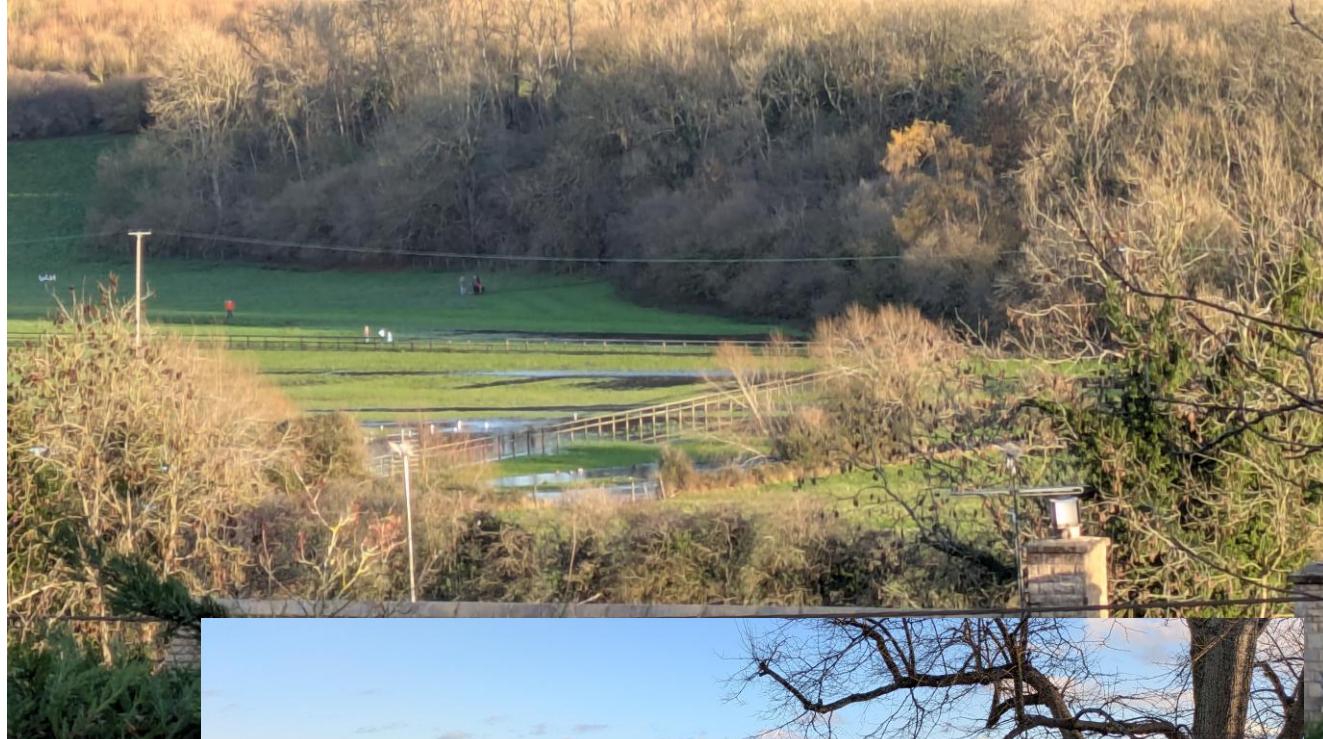
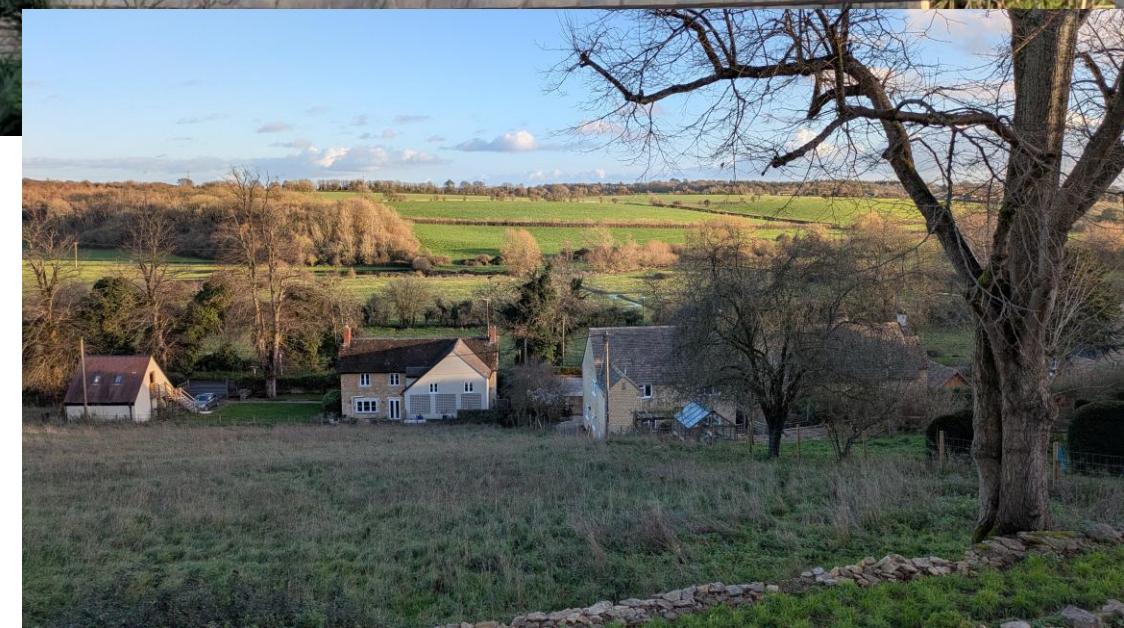
23rd Nov 2025

Eastern branch of Churn at banks level? More surface water in north of observation area – now at fence – not just fingers in ditches. Still obvious water in ditches in south of observation area.

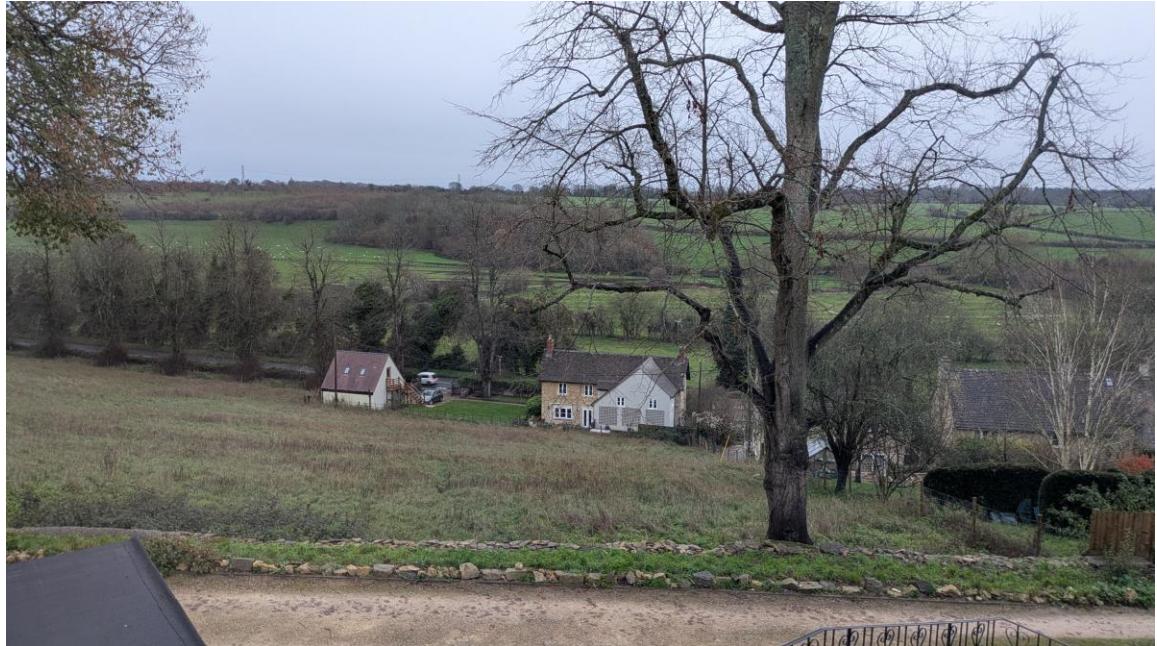
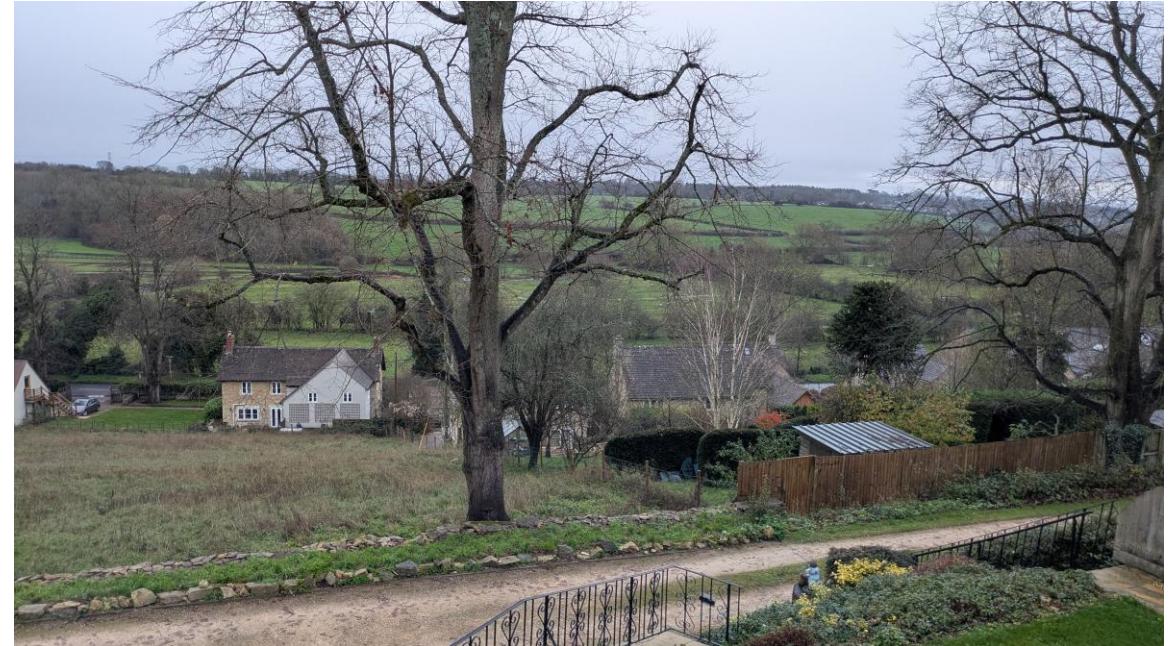
24th Nov 2025

Similar to 23 rd Nov
