Objective

The objective of the work was to assess the potential for the ‘floating apples’ approach to estimate volume flux in the Churn downstream of Gloucester St Sluice. If viable this may have offered a method of estimating the volume flux entering BMP as the difference between the EA gauged flow upstream of Gloucester St and the estimated flow downstream of Gloucester St sluices.

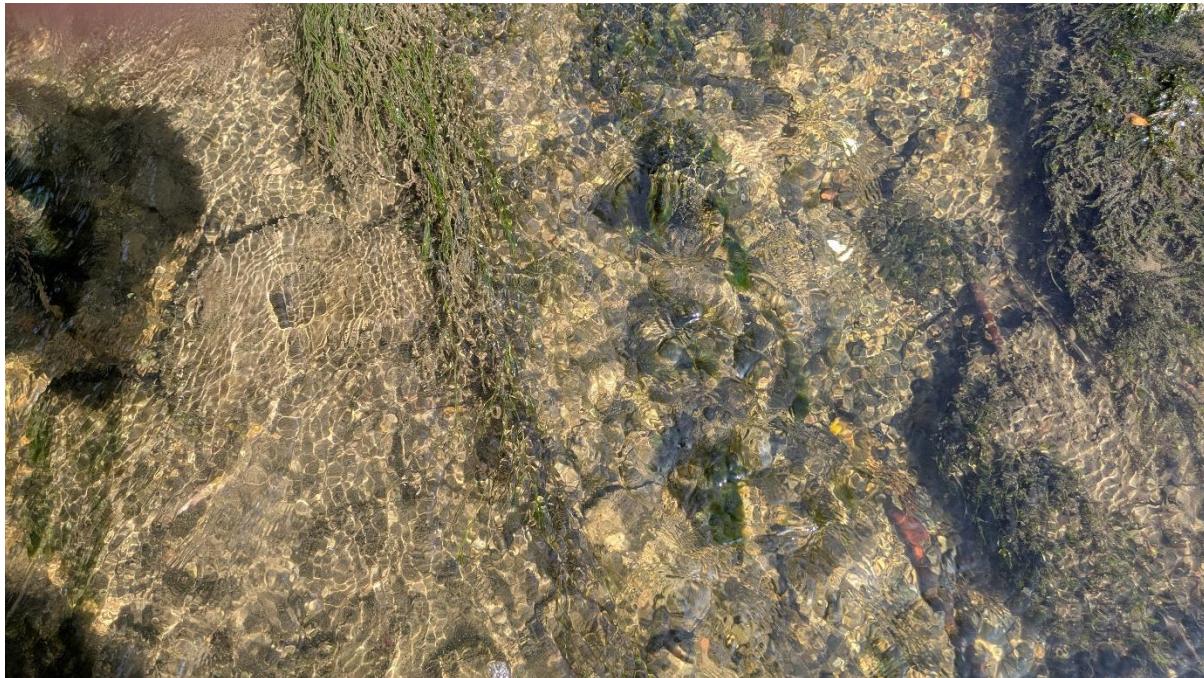
Figure 1 Bed of Churn at Gooseacre

Above the wall on the west bank there is a footpath offering ease of safe movement. The bed appeared of relatively uniform profile along this part of the river being formed of a variety of small stone sizes with occasional large stones, and light in stream vegetation (Figure 1). Disturbance of the bed created small silt clouds, showing some silt was present between stones. Depth was typically around 10-15cm in mid-stream though the large stones were such as to reach near to or to the water surface. The water surface was far from smooth and reflected the small-scale variability of the bed. Thus, although the velocity was evidently predominantly horizontal and aligned with the banks, it was likely that there was considerable structure in the vertical and much horizontal eddy formation which would lead to dispersion and variability in along stream velocity inferred from float-tracking.

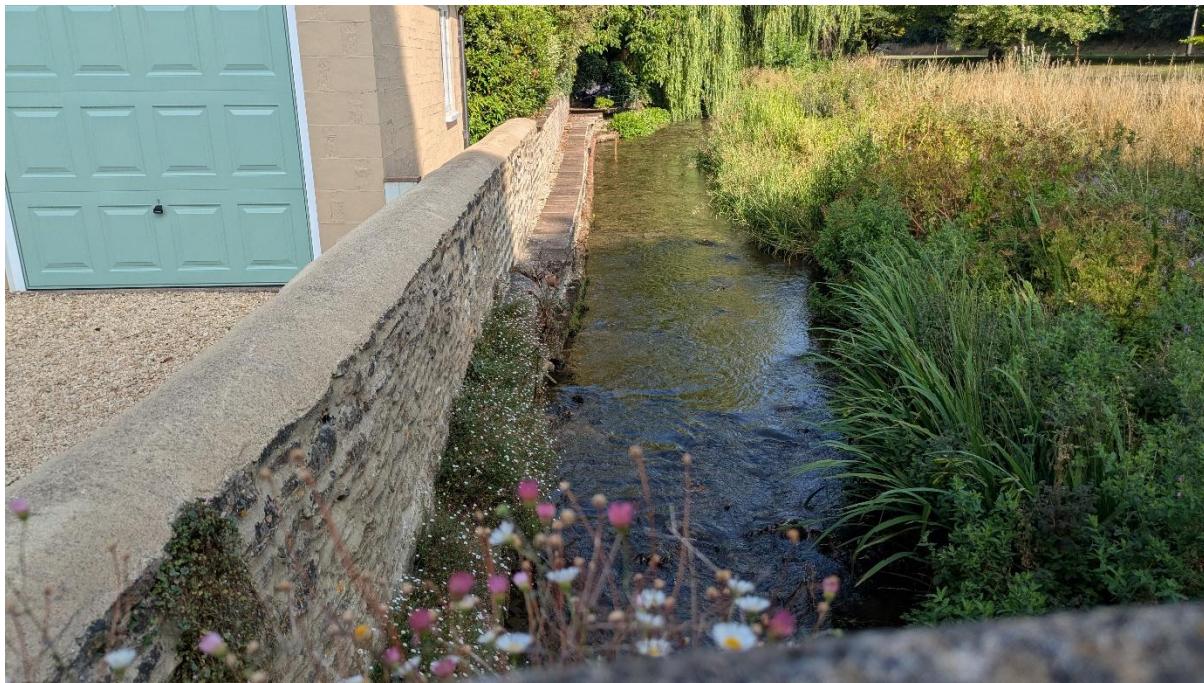
Figure 2 Churn looking upstream from Gooseacre Lane bridge

The Churn upstream of Gooseacre Lane bridge is straight and of uniform width of approximately 4m with a stone wall on the west bank and a heavily vegetated east bank for which the wetted flow boundary was difficult to locate (Figure 2).

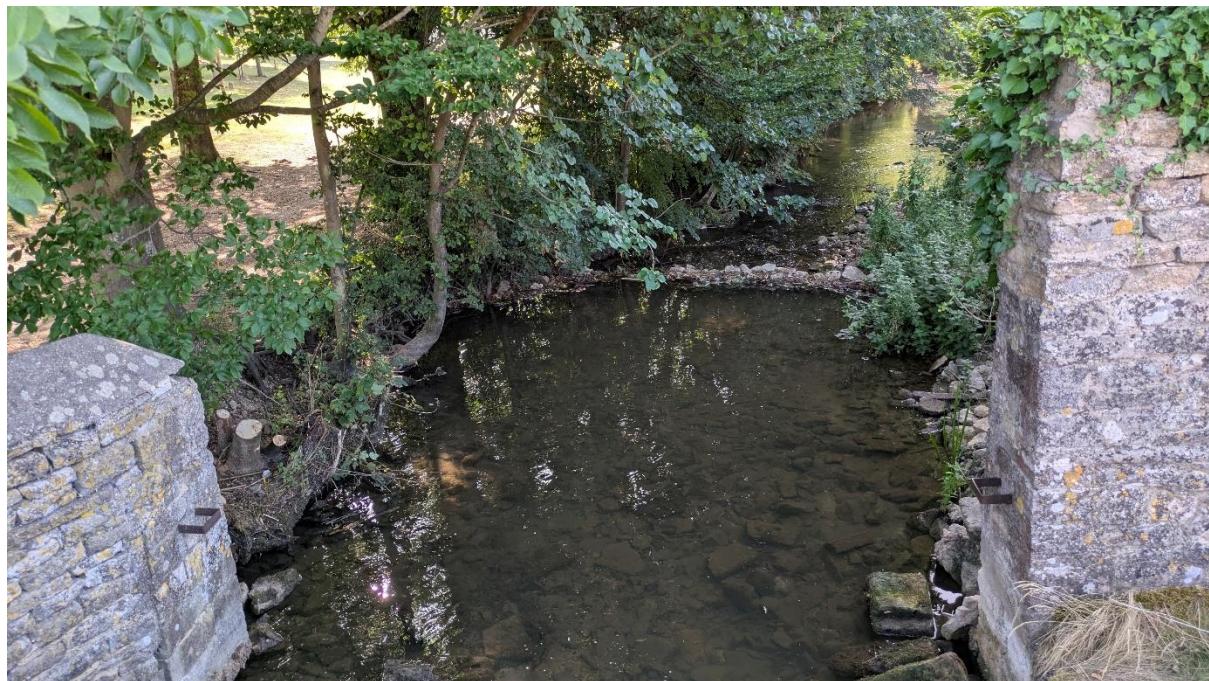
Figure 3 Leaky Dam from Gooseacre Lane Bridge looking downstream

A few metres downstream of Gooseacre Lane Bridge there is an informal leaky stone dam (Figure 3) constructed by members of the public creating a deeper backwater of some 30+cm which likely affects the Gooseacre Lane level board.

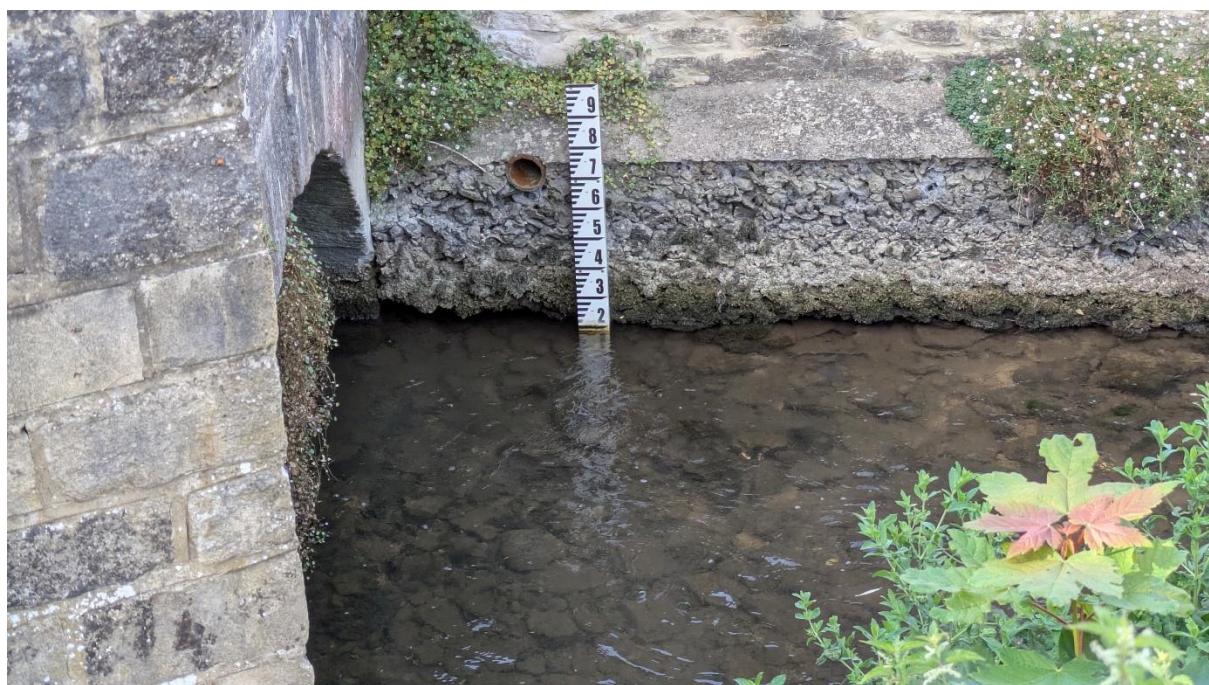
Figure 4 Goosesacre Lane Level Board – taken as 0.18m above board datum

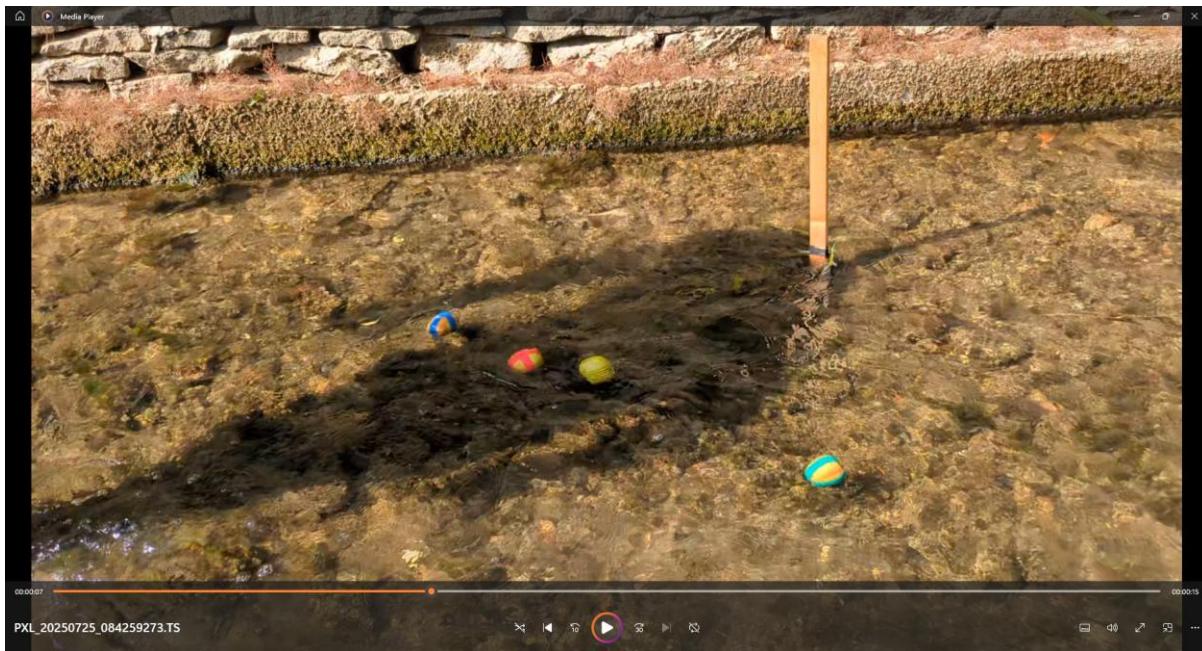
Apples of approximate diameter 5cm and individualised by attached coloured tape were released in clusters of 4 sequentially at half metre intervals across the river. Each release was videoed and the time taken for each individual apple to transit the 5m test reach was taken from the video (to the nearest 1s). An example frame of an apple release from a central subsection is shown in Figure 5.

Figure 5 Example Frame from Shortly After a Cluster of Apples Were Released from a Central Subsection of the Stream. Some Longitudinal and Lateral Dispersion is Already Evident only a Few Seconds after Release.

In the central and western part of the river the apples followed a near linear trajectory and were well clustered. Apples released on the eastern part of the river, particularly the margin, tended to drift towards the central part of the river where the flow was evidently faster with notably greater variability in trajectory. Thus, transit times for the eastern part of the river derived were rather faster than would be associated with the ‘true’ river velocity on the east side. To correct for this the velocity inferred for the 3.5m release was taken as half that resulting from the raw transit time, this approach being ‘validated’ by inspection of the first few seconds of the release before drift towards the central part of the stream occurred.

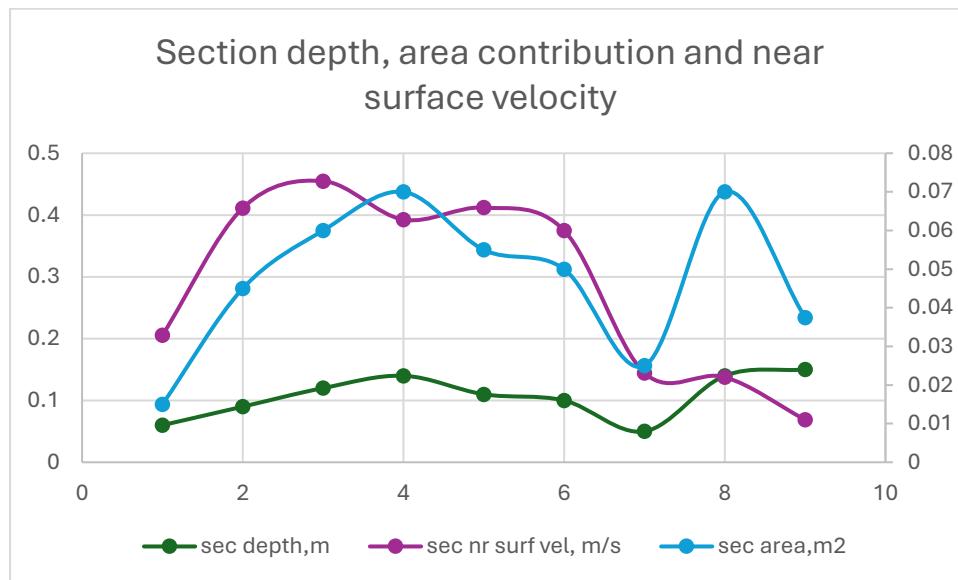
The results are shown in Figure 6 and in Table 2. Velocity measurements for the close to margin sections were not taken in the field because of grounding and wall interference. The results for these subsections are arbitrarily taken as half that of the adjacent measured section.

Figure 6 Field Results - Section Chainage is Shown from the Right (Wall) Bank Looking Downstream. Section Depth and Velocity are Shown on the Left Vertical Axis and Subsection Area on the Right Vertical Axis.

The variability of individual apple velocity in each release cluster was relatively small with standard deviation of individual apple velocities being typically 10cm/s for a velocity of 40 cm/s in the central and west part of the river which was the dominant contribution to total section volume flux. However, the uncertainty in the release average near surface velocity is therefore likely order 10%.

The reduction in bed depth at section 7 was due to the presence of a large stone typical of this part of the river.

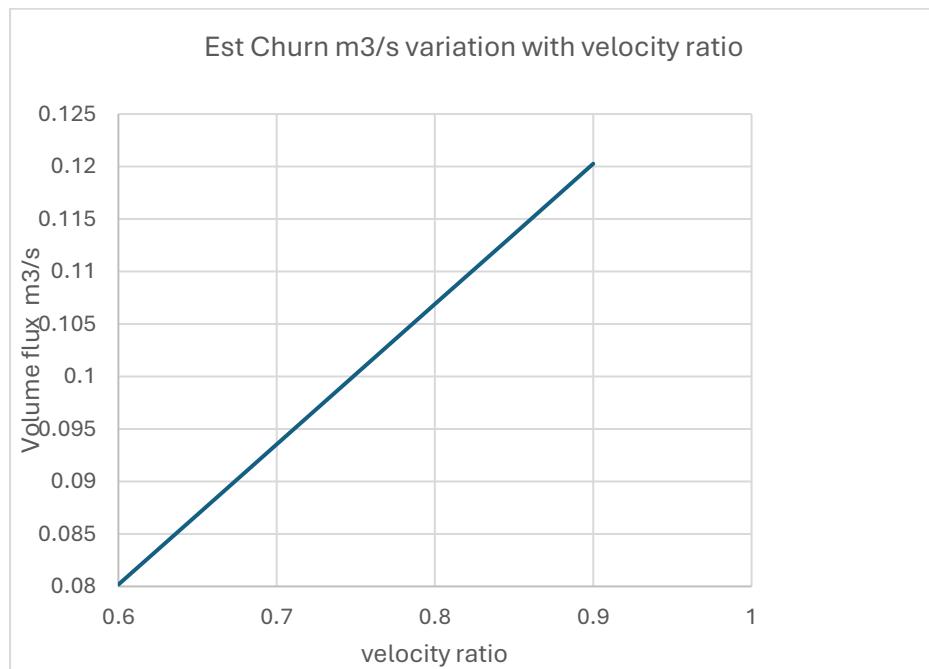
Figure 7 Variation in Estimated Churn Volume Flux with Choice of Velocity Ratio

The inferred section total volume flux is sensitive to the choice of velocity ratio, the two varying in proportion. For the above data it is found as shown in Figure 7

For a reasonable a priori central estimate of velocity ratio of 0.8, the central estimate of total volume flux is 0.107 m3/s.

Using a relatively low but credible velocity ratio of 0.7, perhaps motivated by the dimension of the apples relative to the depth of flow, leads to an estimate of 0.093 m3/s. A lower ratio still might be justifiable because of the roughness of the bed and the shallowness of the stream. A value of 0.6 would lead to an estimated volume flux of 0.08 m3/s.
