Friends of Gumstool Brook is a group of local people interested in Cirencester's Gumstool Brook and its associated streams. Visit our website at <https://gumstool.org.uk>

Summary

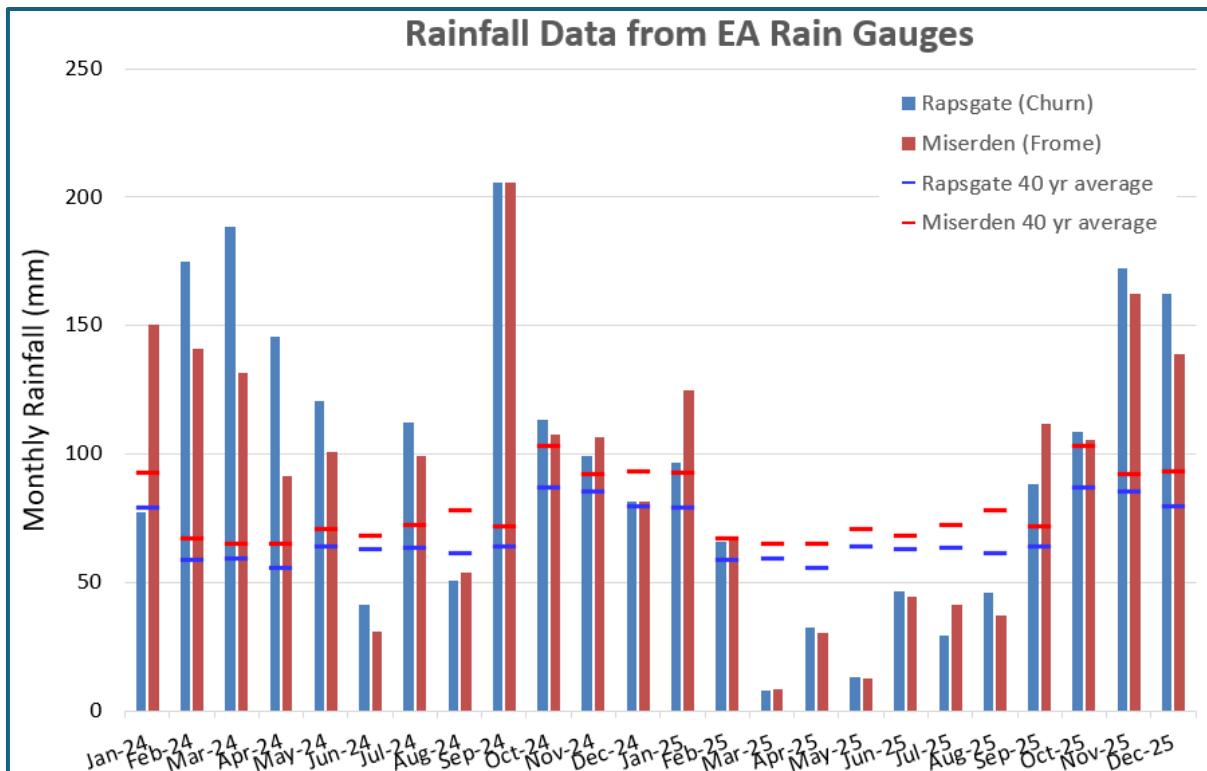
The exceptionally dry Spring and Summer of 2025 in the upper Churn and Daglingworth catchments has been replaced by a wet autumn and early winter, September through to December all experiencing above average monthly rainfall, as shown on the graph below. With September having 130% and 145% of the average monthly rainfall in the Churn and Frome catchments, respectively, October experienced 103% and 120%, and November 193% and 178% of the monthly averages. December continued this trend with 162 mm of rain in the Churn catchment and 139 mm in the Frome, equating to 199% and 144% of the monthly averages. Almost 99% of the total December rain fell in the first 18 days of the month, with less than 4 mm of rain falling from the 18th to 31st December.

With the wet weather continuing into December, soils across the Churn catchment and the rest of the Cotswolds remained wet, with rainfall contributing to further aquifer recharge, an increase in groundwater levels and baseflow of groundwater to rivers, together with at least some runoff. With dry weather in the last two weeks of December, groundwater levels and river flows decreased.

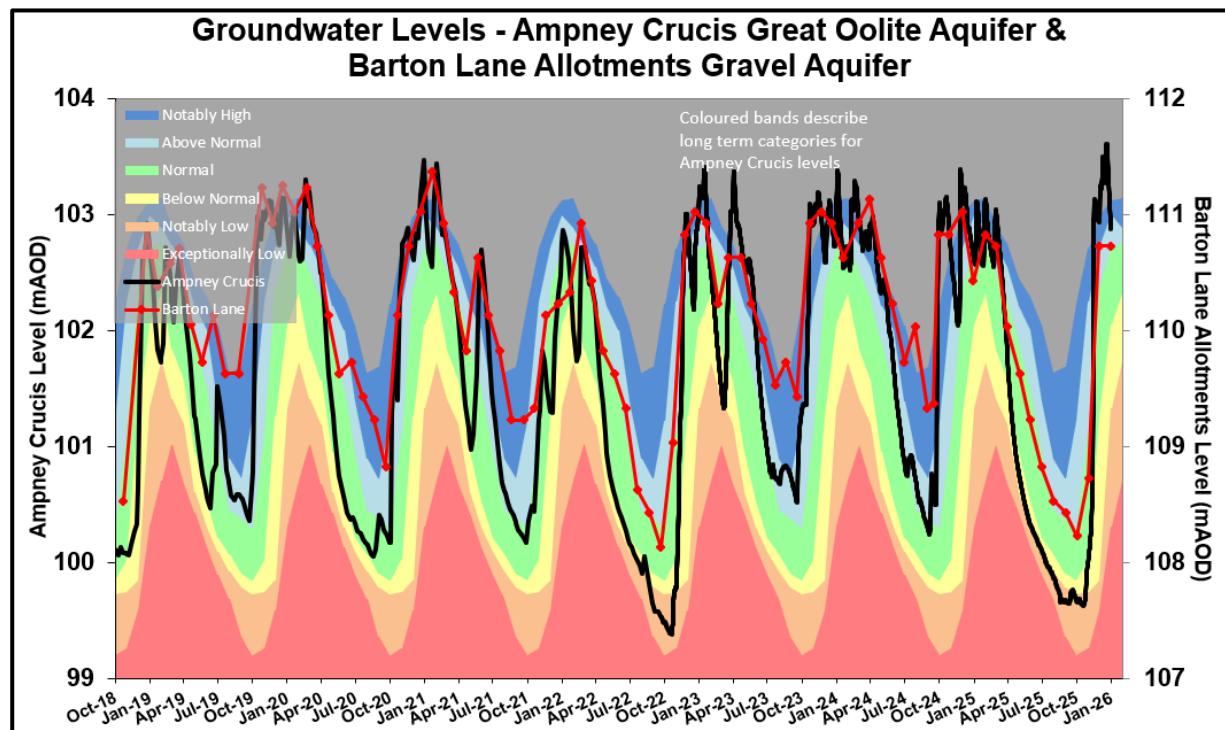
groundwater to rise by almost 3 m to exceptionally high levels. With December also being particularly wet, groundwater continued to rise to peak levels that have only been seen previously in 4 years out of groundwater monitoring records, in and around the Churn catchment, that extending back to 2007, 1998 and 1993. It is noticeable that all of these years are in the 20th century. These peak December groundwater levels are illustrated on the graph below, which also shows the late December decline in groundwater to above normal by the end of 2025.

The graph above includes groundwater levels measured in the shallow Gravel aquifer at Barton Lane Allotments. Although only usually measured once a month, the declining trend from Spring through to early Autumn and the rapid rise in groundwater levels by the end of November is apparent and consistent with the groundwater trend seen in the Great Oolite aquifer. As a result of the monthly monitoring frequency, it can be inferred from the graph that groundwater in the Gravel aquifer also peaked at higher levels in the middle of December, subsequently declining to levels very similar to those seen at the end of November.

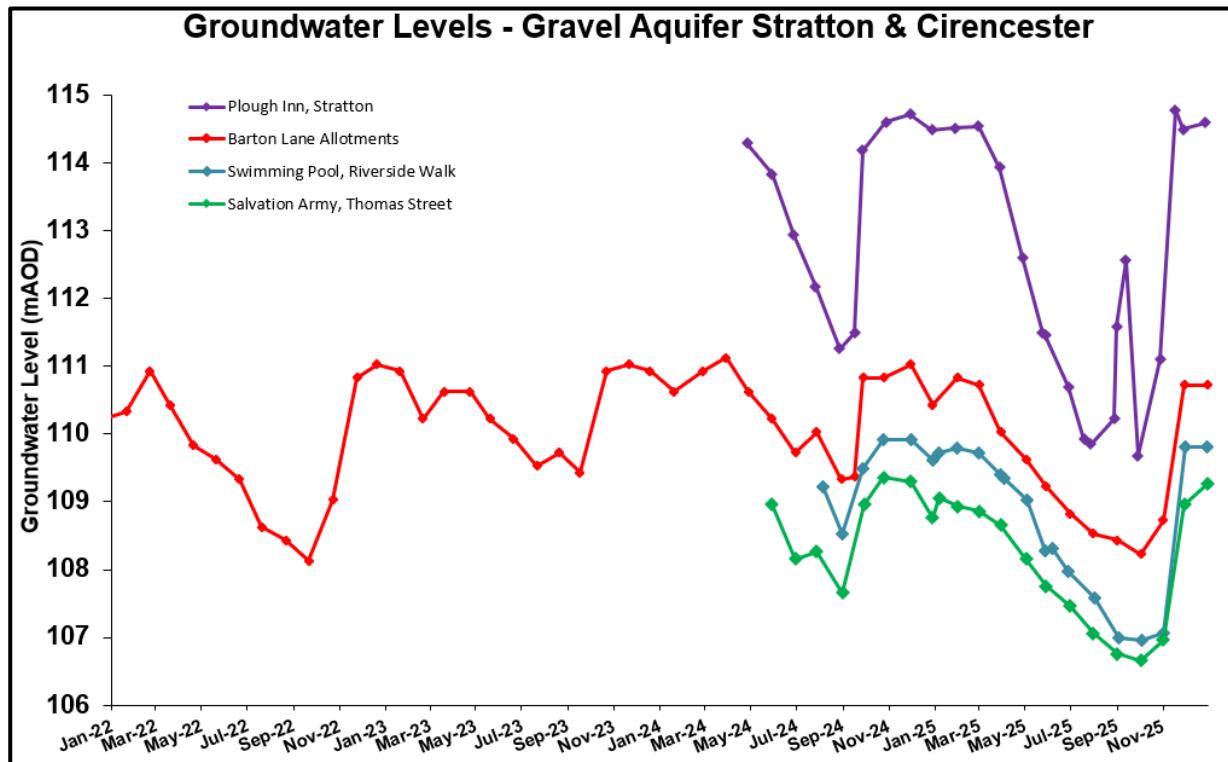
As shown on the graph below, similar groundwater level trends in the Gravel aquifer continue to be measured in the shallow wells at Barton Lane allotments, the Swimming Pool and the Salvation Army in Cirencester, and the Plough Inn in Stratton with the unexpected and unexplained rise in groundwater levels reported in August and September at the Plough Inn having dissipated. As reported previously, the significant rise in groundwater levels in response to the exceptionally wet November is apparent in all of these shallow Gravel aquifer wells. It is also apparent that the similarity of groundwater levels at the end of November and December noted in the Barton Lane Allotments Well is also the case for the three other Wells used to monitor the Gravel aquifer, although a larger increase is recorded in the Salvation Army Well. From this it is inferred that the Gravel aquifer groundwater levels also peaked in the middle of December and it is monthly monitoring frequency that prevents further detailed fluctuations from being observed. This is supported by the additional groundwater level measurements during November which showed a peak in levels with a subsequent decline.

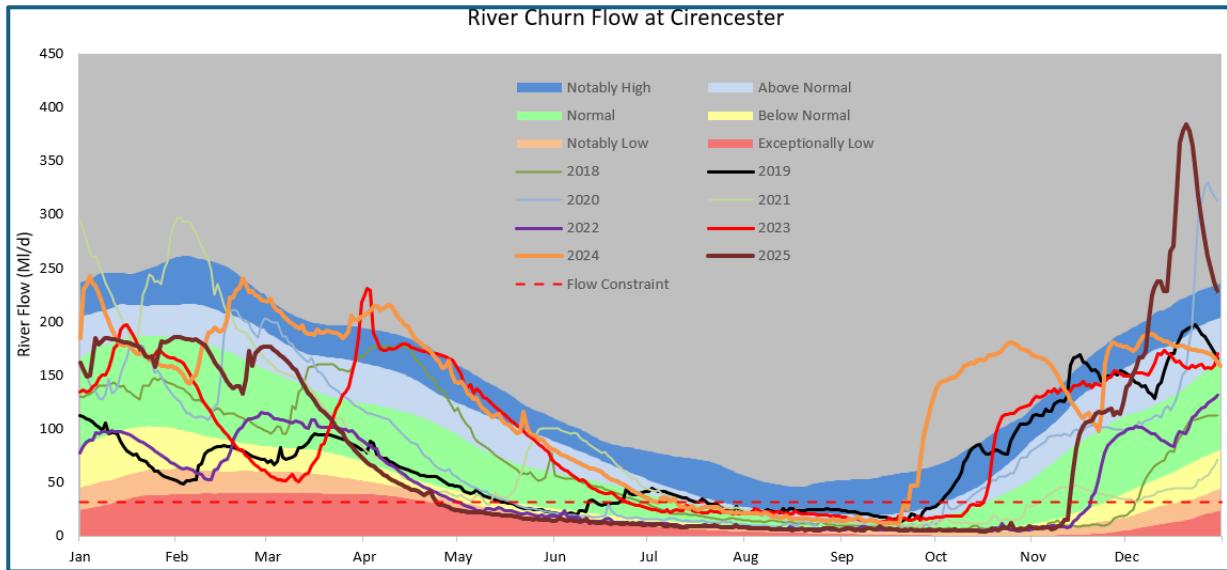
As illustrated by the graph below, flow in the River Churn measured at the EA Cirencester gauging station rose significantly during December as a result of the exceptional rainfall. The flow reached a peak of 384 Ml/d, the highest daily flow in the 47-year record, although it is important

to note that the EA has highlighted some of the December data as “suspect”. In addition, there are discrepancies between the daily flows reported by the EA and flows calculated by FoGB from water levels reported by the EA at the Cirencester gauging station. Although there is uncertainty with the Churn flows plotted on the graph, the provisional coloured bands defined by FoGB to help categorise the flow rates suggest that the river flows were exceptionally high for much of December. With the weather at the end of December being dry, flows in the Churn decreased to notably high flows of 229 MI/day by the end of the month.

Although groundwater levels in the Great Oolite aquifer at the end of December 2025 are slightly (15 cm) lower than those recorded in December 2022, it is clear from the graph above that flows in the Churn are much higher in 2025; around 230 MI/d, equating to notably high in 2025, and around 130 MI/d, equating to normal for the time of year in 2022. This in part reflects groundwater levels and river flows recovering earlier in 2025, related to differences in the autumn rainfall distribution between 2022 and 2025, as well as noticeably lower groundwater levels in Summer 2022. However, the much wetter weather in November and December 2025 have resulted in peak groundwater levels and River Churn flows much higher than 2022, potentially reaching record high values.

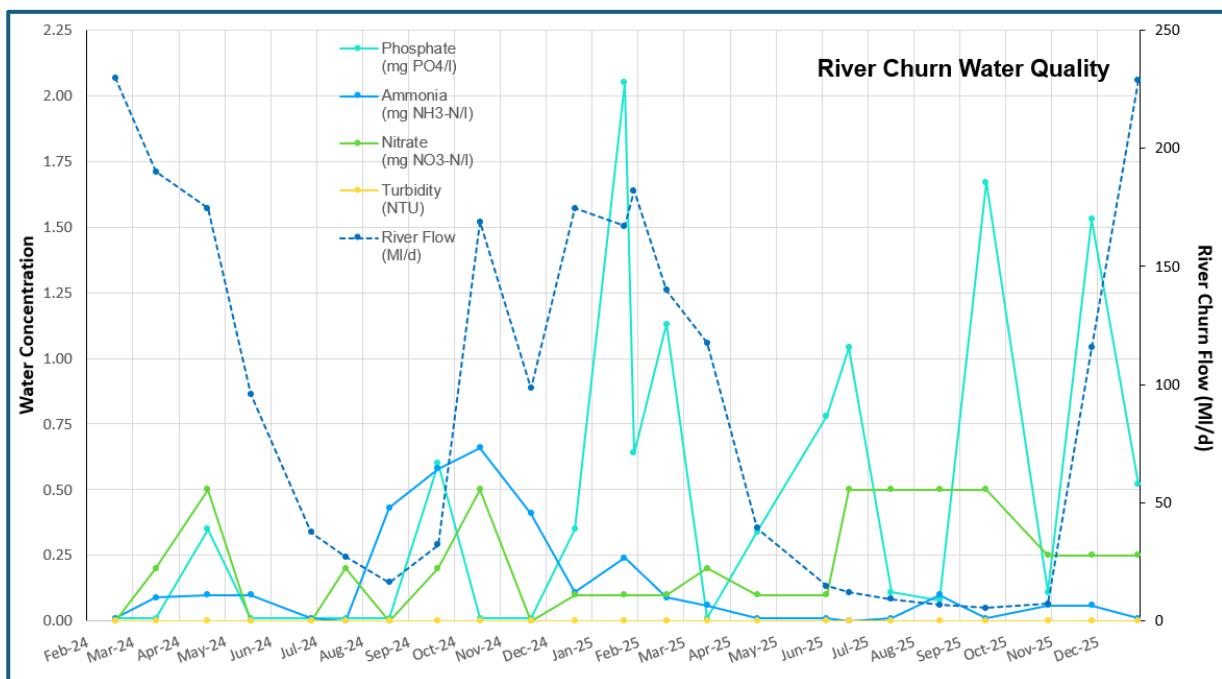
phosphate (PO_4) concentrations that are most obvious and frequent, as shown on the graph for the Churn below. In December, all the nutrients being monitored were at low concentrations, generally falling from concentrations measured in November, with no spikes detected, which may relate to increased river flows and dilution of nutrient concentrations. However, the graphical analysis presented only considers river flow on the date of water quality sampling and it is clear from the graph that there is not a simple relationship between water quality spikes and river flow. It is possible that consideration of antecedent river flows and rainfall events could provide further insight.

As noted previously, the background concentrations of all of the nutrients being monitored appear to be relatively low, although the frequent phosphate peaks are notable. Monitoring will continue to investigate these trends and, ultimately, compared with appropriate nutrient concentrations that reflect good quality that will account for standards set by the UK Technical Advisory Group on the Water Framework Directive (UKTAG). Now that there is a complete calendar year of data from 2025, plus a “water year” from October 2024 to September 2025, an initial comparison can be undertaken.

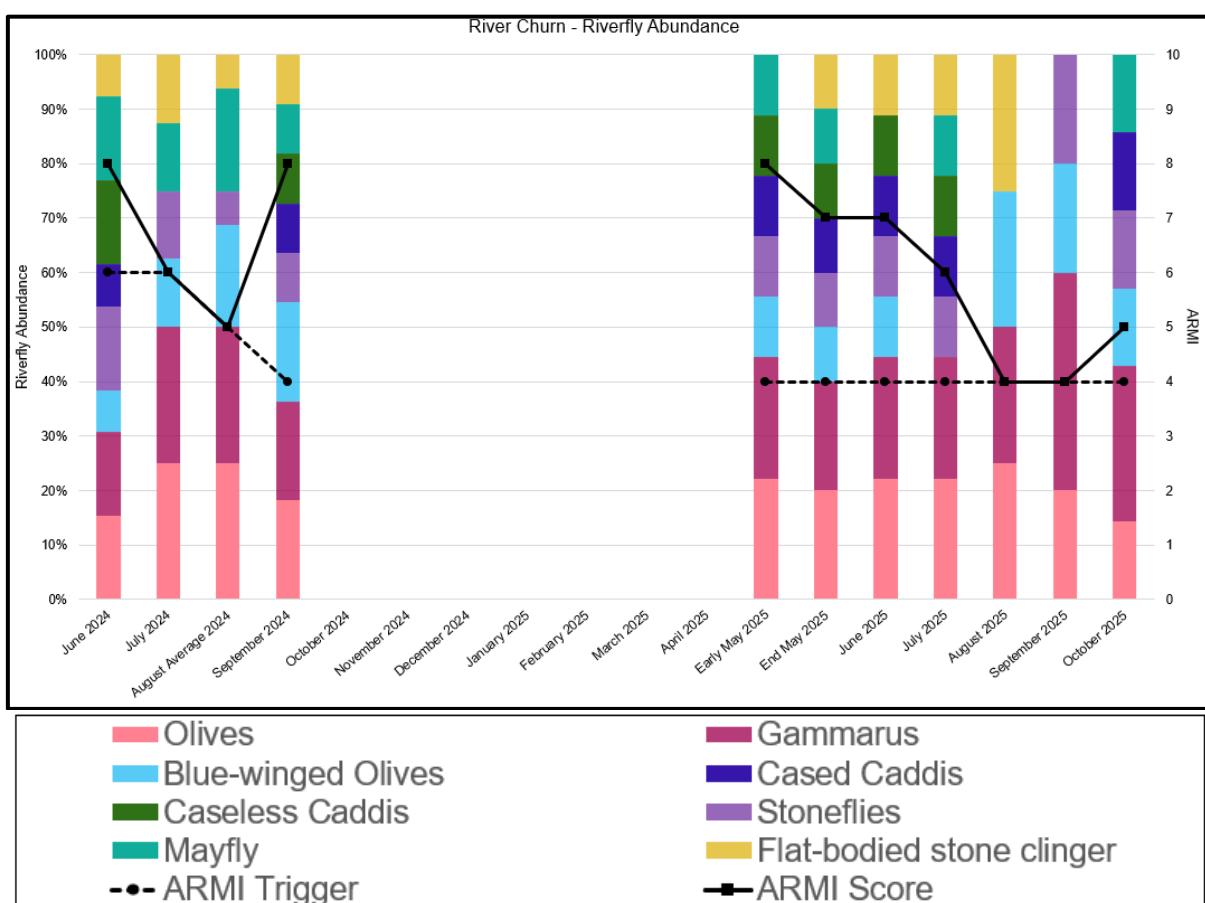
The available results for the River Churn are presented below, comparing the ARMI (Anglers Riverfly Monitoring Initiative) score, calculated from the riverflies identified and counted in the sample, with an ARMI trigger. Following August and September 2025 results, where the Churn ARMI score had decreased to the ARMI trigger level, the October results had a higher ARMI score. This indicates that following a deterioration in the ecological health of the Churn during the Summer, the river experienced its poorest health during the time of lowest minimum flows, but showed improving health in October as river flows began to increase.

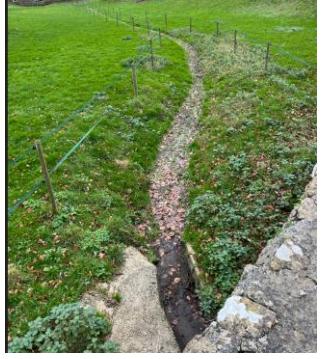
<p>1a. Daglingworth Stream upper source north of Duntisbourne Abbots.</p> <p>The stream channel is muddy with signs of recent flow (probably from road drainage).</p>

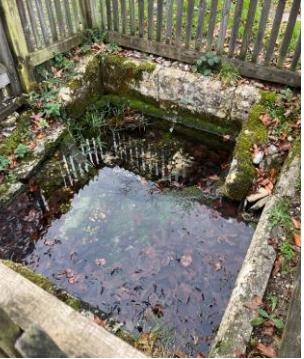
<p>1b. Duntisbourne Abbots village spring.</p> <p>The spring is filled with clear water and there is a flow of water from the back to the front.</p>

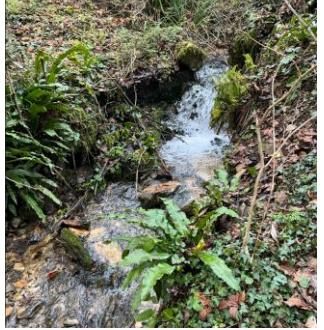
<p>2. Duntisbourne Abbots Daglingworth Stream downstream of inferred confluence of spring sources.</p> <p>There is a flow of clear water from the spring and in the channel.</p>

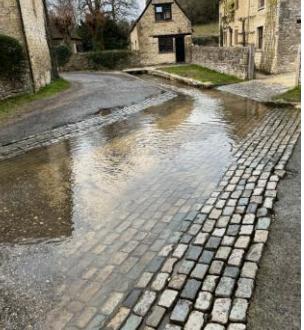
<p>3. Duntisbourne Leer ford, Daglingworth Stream.</p> <p>There is a good flow across the ford that extends to ~ 7 cobbles.</p>

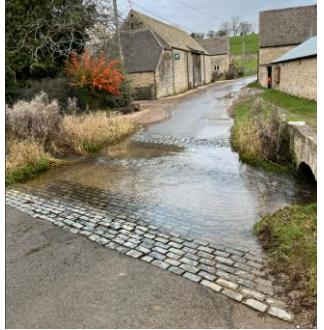
<p>4. Middle Duntisbourne ford, Daglingworth Stream.</p> <p>A good flow is observed that extends to 6 bricks of the cobbled area of the south-west channel edge.</p>

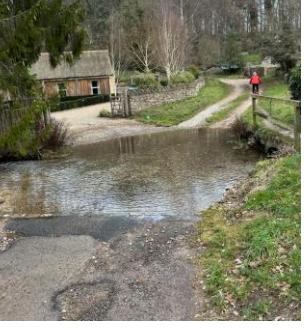
<p>5. Duntisbourne Rouse ford, Daglingworth Stream.</p> <p>A good flow is observed, which is just within the SW boundary cobbles.</p>

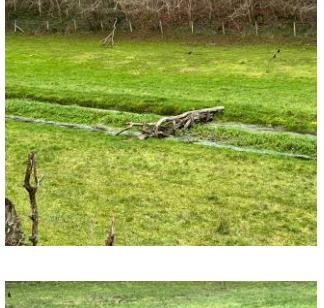
- The flow in the Daglingworth Stream in the Duntisbourne valley down to Daglingworth village has reduced but remains at a 'flowing' level.
- Both of the woody debris leaky dams upstream of Daglingworth are in good condition. The stream is at a 'flowing' level at both dams, and the dams are causing a small amount of restriction to the flow.

<p>6a. Daglingworth Stream – Leaky Dam #1, upstream of Grove Hill Lane.</p> <p>The dam is in good condition. There is a good flow in the stream. There is a slight restriction to flow.</p>

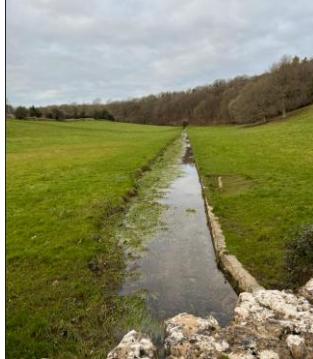
<p>6c. Daglingworth Stream Grove Hill bridge.</p> <p>A good flow is observed that fills half of the channel in the field upstream of the Grove Hill bridge.</p>

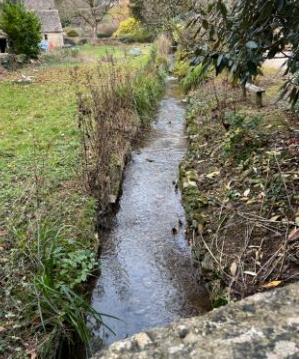
<p>7. Daglingworth Stream at Lower End road bridge.</p> <p>There is a good flow observed in the channel.</p>

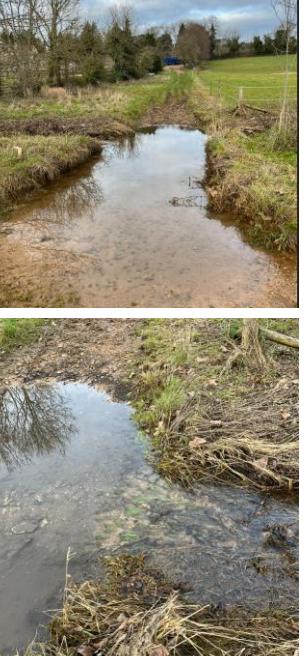
<p>9. Daglingworth Place ford, Daglingworth Stream.</p> <p>There is a good flow in the stream and the river level is good at the ford.</p>

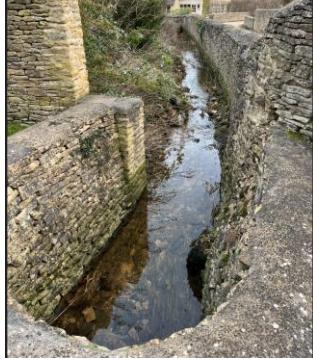
<p>10. Grange Farm bridge, Daglingworth Stream.</p> <p>There is a good flow in the stream channel.</p>

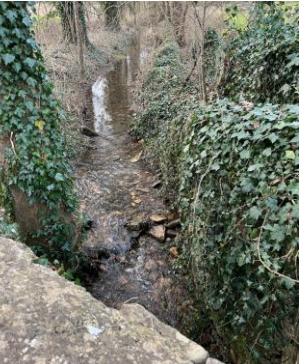
<p>11. School Hill bridge, Daglingworth Stream.</p> <p>There is a good flow in the stream channel.</p>

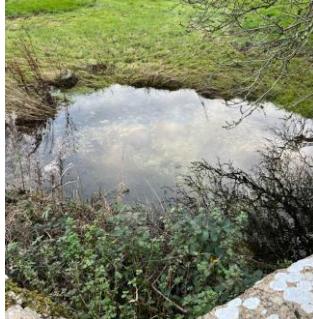
<p>12. Stratton End (private road), Daglingworth Stream.</p> <p>The stream has a good flow, the pool below the bridge is full, and there are indications in the vegetation of recent high water flow.</p>

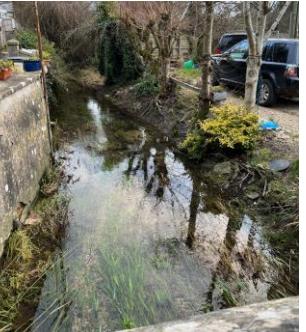
<p>13. Barn Way bridge, Daglingworth Stream.</p> <p>There is a good flow in the stream channel. There is no flow to the overflow channel.</p>

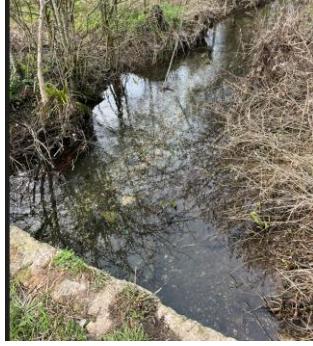
<p>15. Footpath at Lower Stratton.</p> <p>The stream has a good flow with lots of debris present.</p>

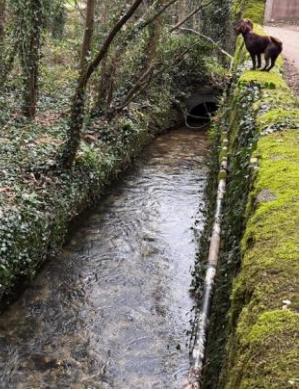
<p>16a. Daglingworth Stream at Barton Lane upstream just outside of Bathurst Estate boundary wall</p> <p>The stream is flowing well into the Gumstool Brook.</p>

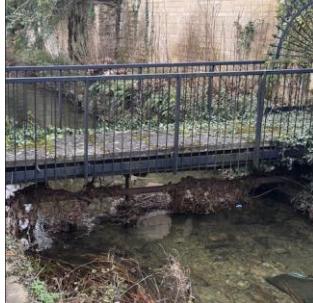
<p>18. Gumstool Brook alongside swimming pool on the Riverside Walk.</p> <p>The steam is flowing with much debris still present at the brook obstructions.</p>

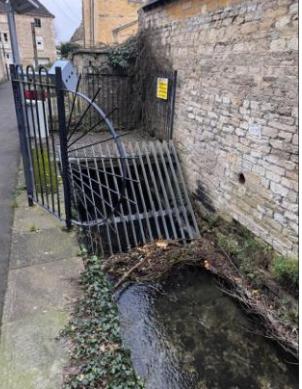
<p>20. Gumstool Brook at Riverside walk culvert trash screen.</p> <p>The stream is flowing, with some debris buildup at the screen.</p>

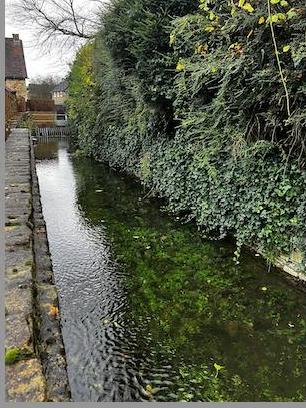
<p>22c. Balancing Stream at Powell's School at trash screen.</p> <p>The stream is flowing with a lot of submerged vegetation present.</p>

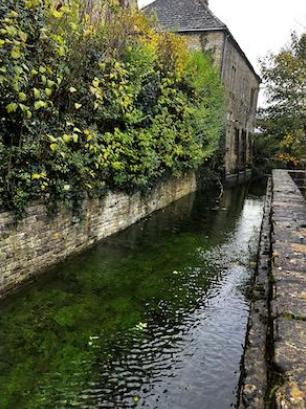
<p>22d. Balancing Stream at Powell's School looking upstream towards Salvation Army</p> <p>The stream is flowing with a lot of submerged vegetation present.</p>

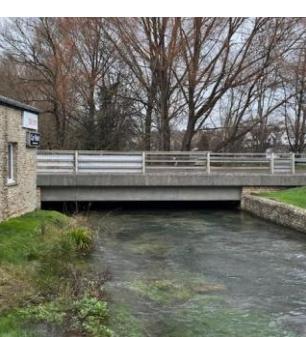
<p>23a. River Churn at Glos St bridge upstream of sluices</p> <p>There is a strong flow in the river with little vegetation present.</p>

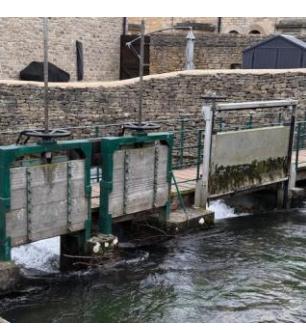
<p>23b. Glos St bridge sluices</p> <p>All sluice gates are open.</p>

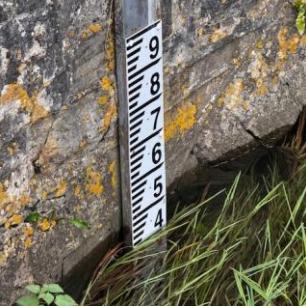
<p>23c. River Churn downstream of Glos St. sluice</p> <p>No picture</p>		<p>24a. River Churn at the measuring gauge on Glos St.</p> <p>The gauge is reading around 0.41m</p>

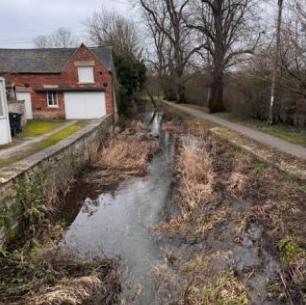
<p>24b. Glos St bridge view towards the Mill Pound.</p> <p>No picture</p>		<p>24c. Mill Pound looking downstream from Glos St bridge.</p> <p>The stream channel in the Mill Pound has widened as the vegetation has died back.</p>

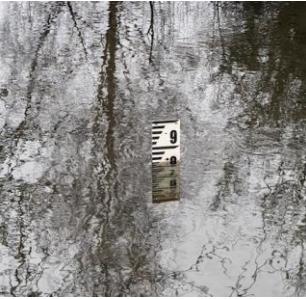
<p>25. Gauge in Mill Pound at the new overflow.</p> <p>The gauge is reading 0.84m</p>

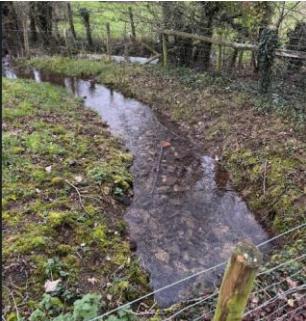
<p>25. Mill Pound Overflow (New)</p> <p>There is a good flow in the overflow stream. The mill pound level is half way up the overflow pipe but there is much debris preventing a high flow.</p>

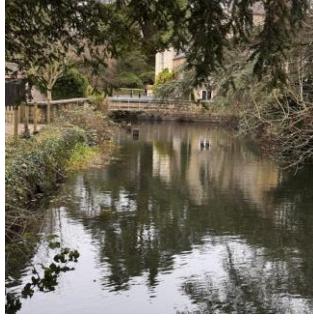
27a. Mill Pound upstream of footbridge. There is a good level in the Mill Pound. Many ducks present.	No picture
27b. Mill Pound downstream of footbridge.

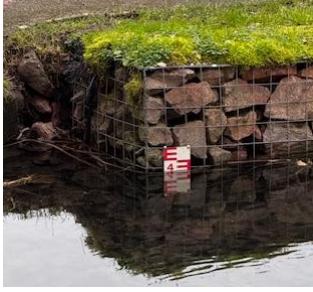
27c. Gauge at footbridge The gauge is reading 0.41m

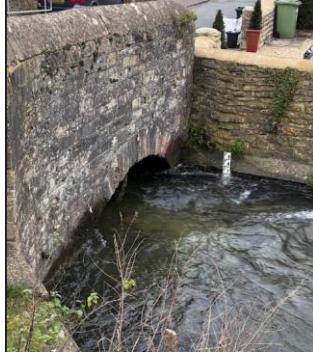
34a River Churn upstream side of Gooseacre Lane bridge There is a strong flow in the river.

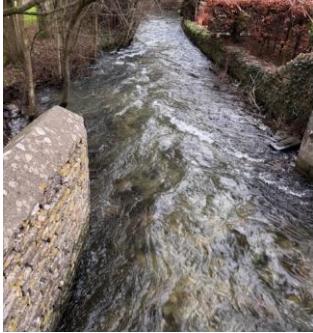
34b. River Churn downstream side of Gooseacre Lane bridge There is a high flow in the river.

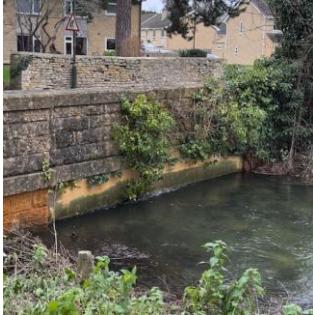
35. River Churn upstream of Spitalgate Lane bridge. The river level is up to the bridge bea.

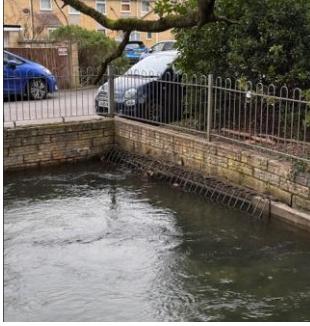
<p>36a. River Churn at Hereward Road trash screen.</p> <p>The river level is near to the top of the trash screen.</p>

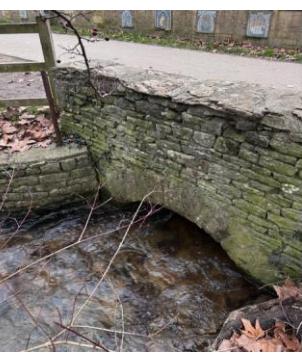
<p>37. Stream flowing into Abbey Lake</p> <p>There is a strong flow into the Abbey lake.</p>

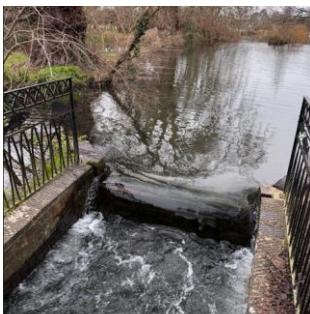
<p>38a. Weir at stream outlet from Abbey Lake</p> <p>There is a strong flow over the weir.</p>

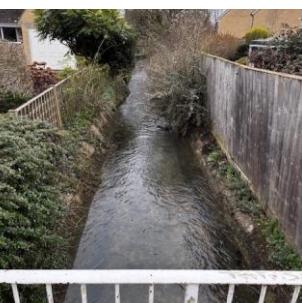
<p>38b. Footbridge at stream outlet from Abbey Lake</p> <p>There is a strong flow.</p>

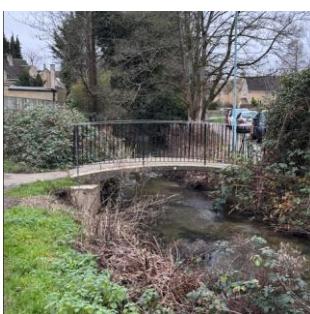
<p>39 Abbey Lake outlet stream at Corinium gate bridge</p> <p>There is a strong flow in the stream.</p>

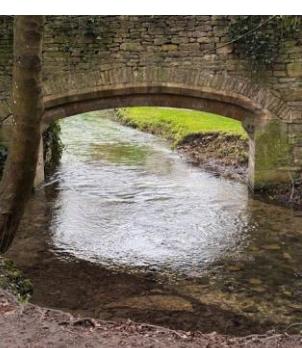
<p>40. Gumstool Brook - in Abbey Grounds</p> <p>There is a good flow in the stream.</p>

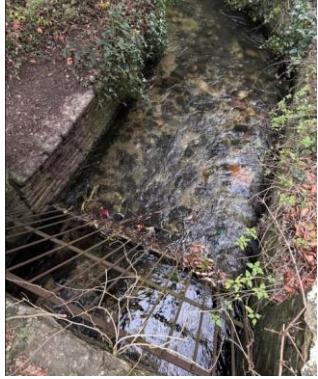
<p>40a.. Gumstool Brook culvert outlet in Abbey grounds.</p> <p>There is a small buildup of debris on the inside of the screen, but stream is flowing well.</p>
