**Report on sewage discharge: Ashton Rd, Siddington
December 2025 to February 2026**

Based on monitoring by Huw Jones, Parkway, Siddington

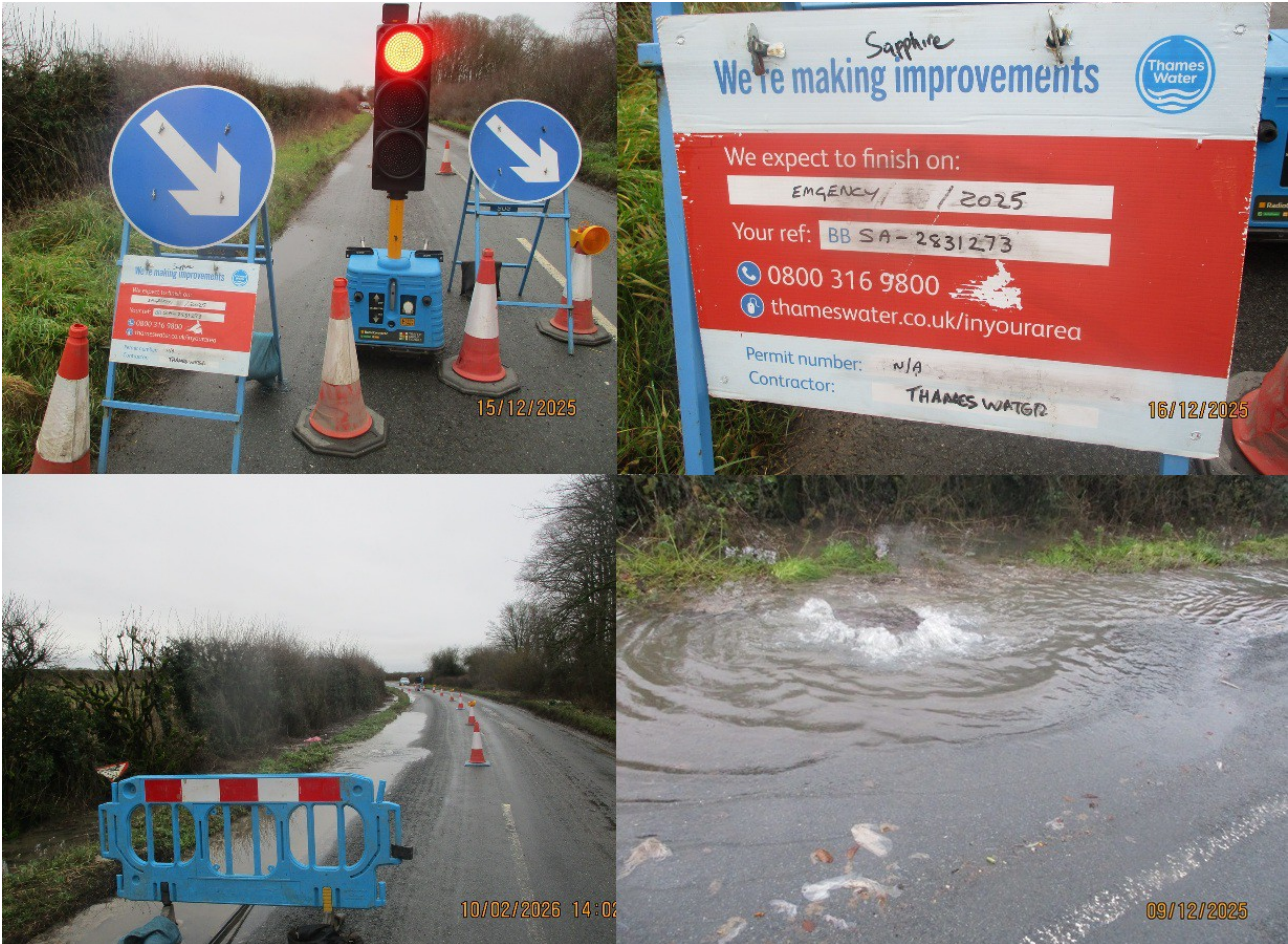
On each occasion, manhole covers were lifted, apparently by the pressure of water in the sewer. On two occasions, the discharges lasted over two weeks, during which Ashton Road was partially closed with temporary traffic lights limiting access to a single carriageway. Thames Water erected signage alongside the road barriers indicating an emergency closure, which if valid, would bypass road closure permit requirements. On the second occasion, the traffic lights and partial road closure were left in place for over a week after the end of the discharge.

Flow was continuous and was greater at the start of each period of discharge, gradually reducing as river levels fell to more normal levels. A very rough visual estimate was made of the maximum discharge rate of up to approximately 5 litres per second, which is equivalent to 0.5 million litres or 500 cubic metres every day, enough to fill Cirencester's Open Air Swimming Pool.

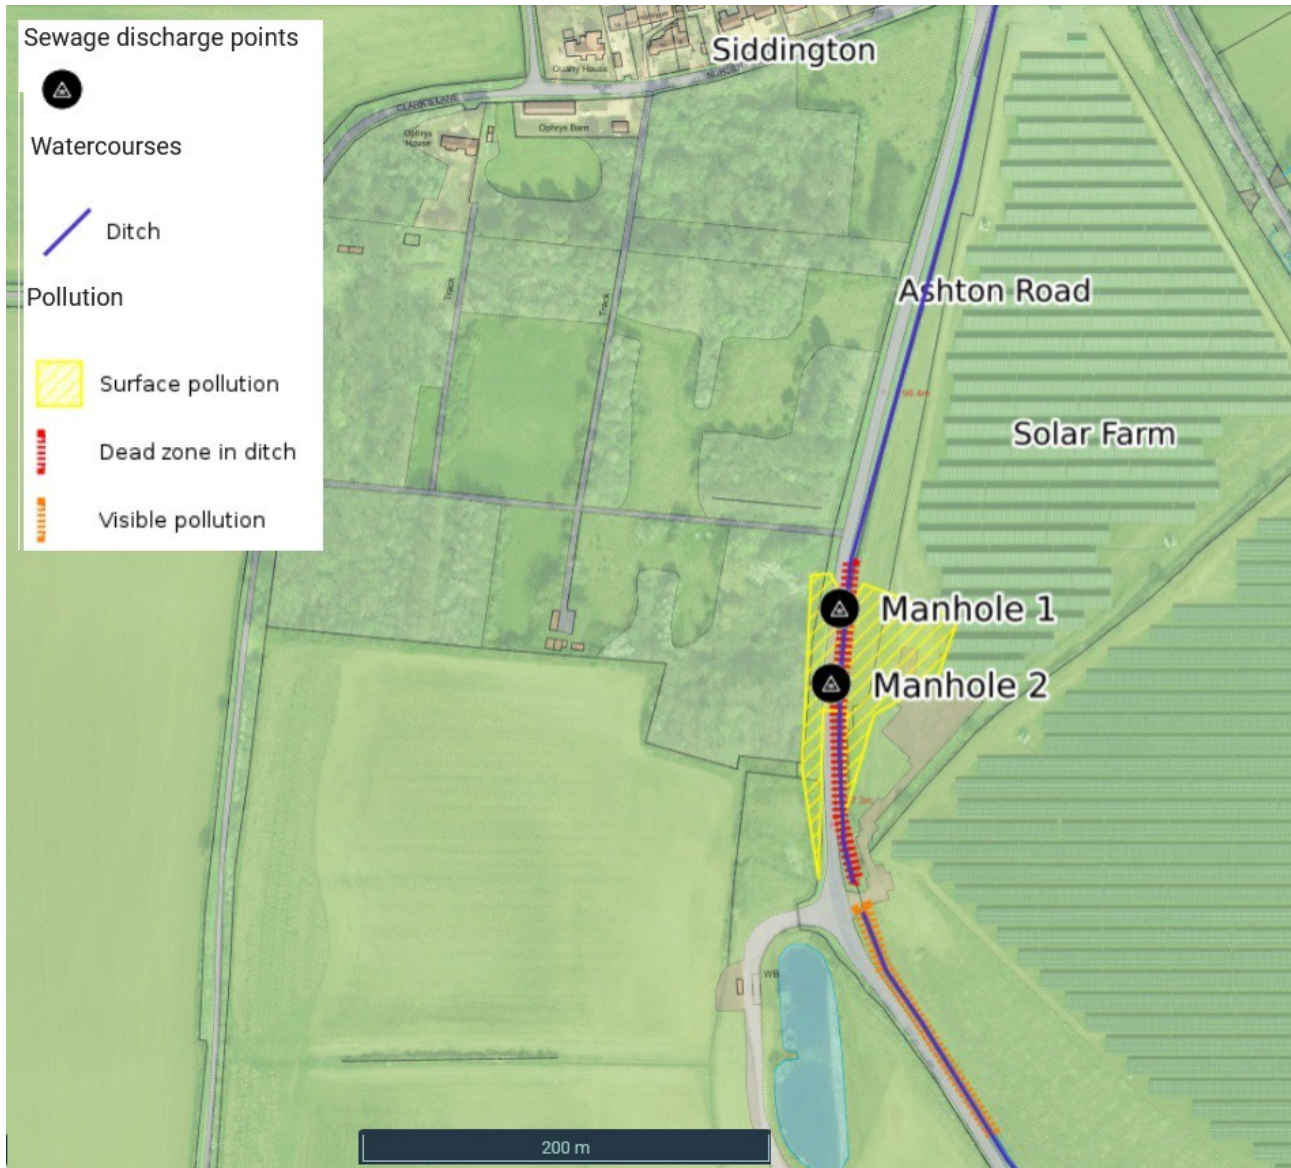
Figure 1. Observed extent of visible pollution

The manholes are on Ashton Road, 300m south of the edge of Siddington village. The extent of visible pollution is shown in Figure 1 below. This includes a 100m dead zone in the roadside ditch with no surviving vegetation other than filamentous algae.

Accumulation of sewage debris was observed for more than 100m beyond that in the roadside ditch. Contaminated water also flowed onto the Solar Farm east of Ashton Road and into the private woodland to the west.

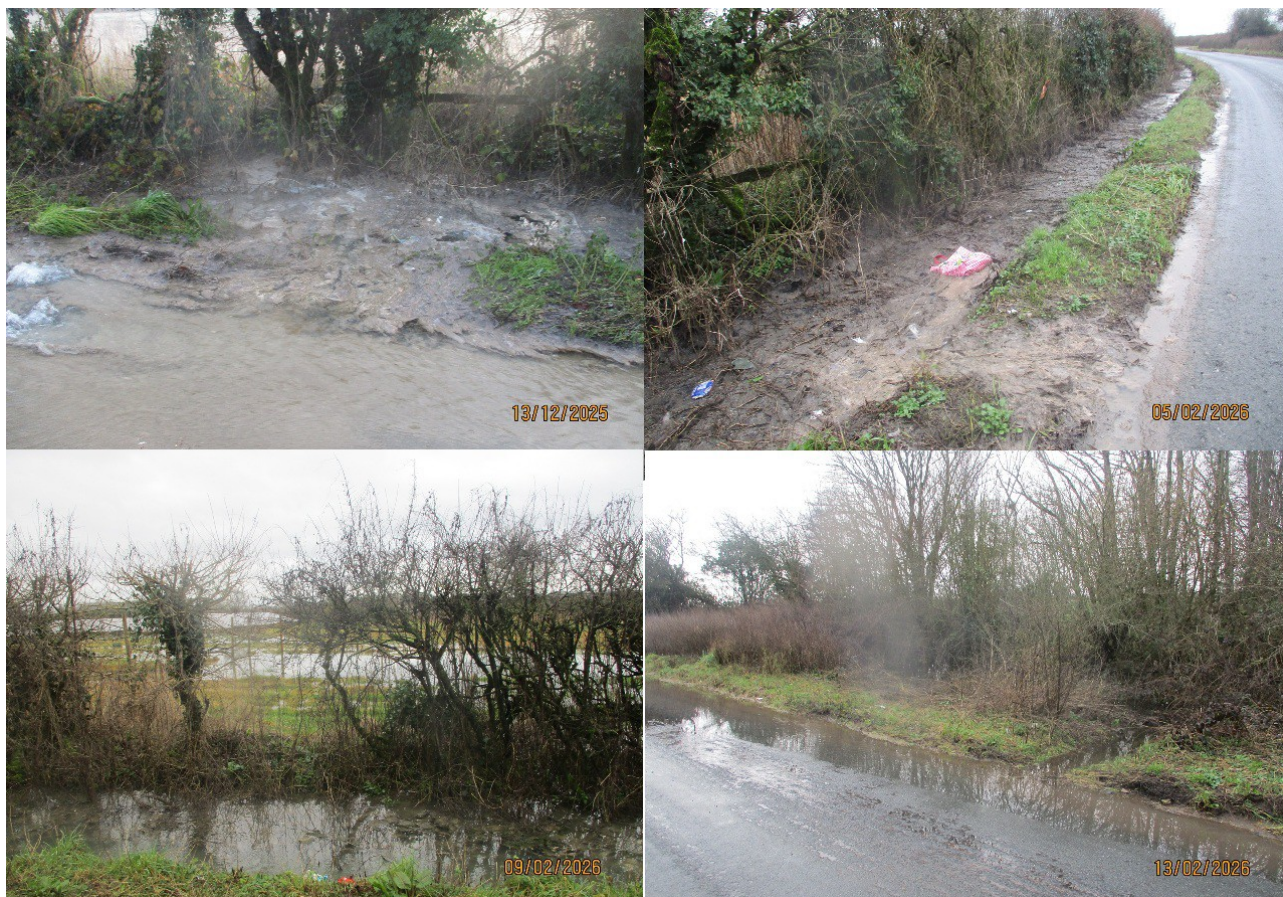
Table 2 records the extent of visible pollution as well as precise locations for the two manholes discharging wastewater.
