Citizen River Monitoring Report May 2026

Friends of Gumstool Brook is a group of local people interested in Cirencester's Gumstool Brook and its associated streams. Visit our website at <https://gumstool.org.uk>

6. Stream Monitoring Photographic Record

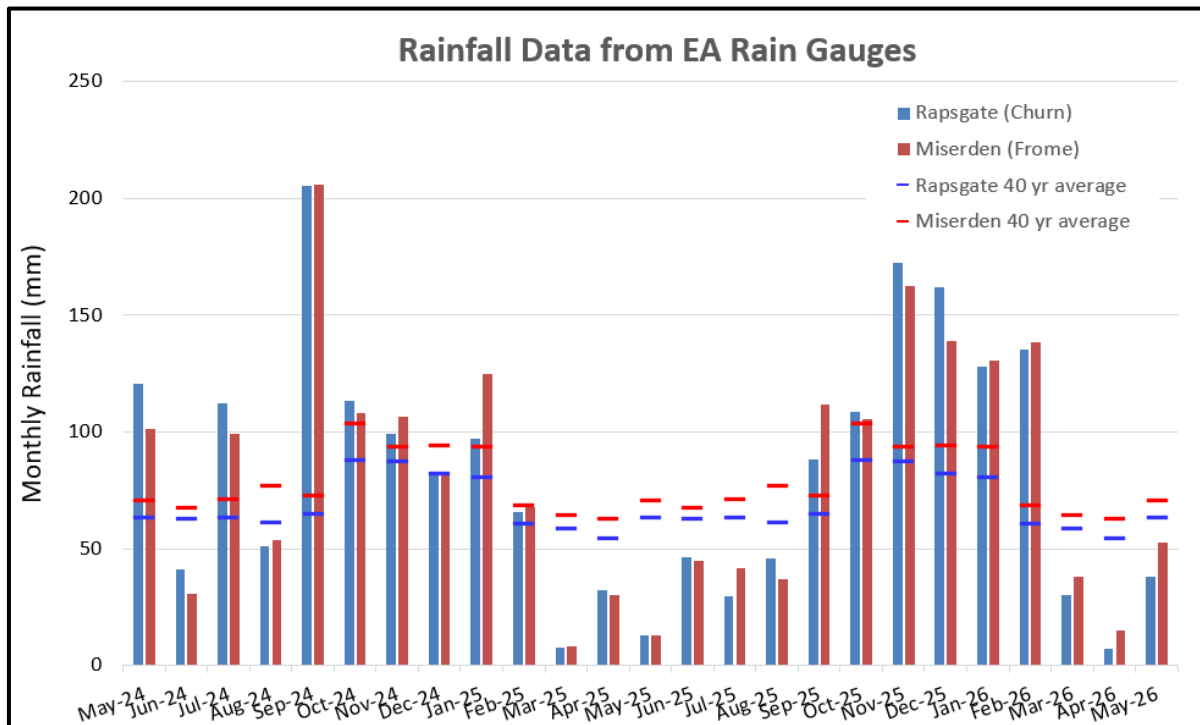
Spring 2026 in the upper Churn and Daglingworth catchments experienced three consecutive months of below average rainfall, as shown on the graph below. March 2026 was notably dry and followed by an exceptionally dry April, with May experiencing about 38 mm in the Churn and 52 mm in the Frome catchments, equating to 60% and 72% of their monthly averages, respectively. It is also noticeable from the graph that the transition from a wet Autumn/Winter to a dry Spring in 2026 is similar to that of 2025, with below average rainfall continuing throughout Summer 2025.

With both March, April and May experiencing below average rainfall, and unseasonably hot weather at the end of May, soils across the Churn catchment and the rest of the Cotswolds are now particularly dry. Without exceptionally heavy rainfall, no aquifer recharge is expected with the decline of groundwater levels and river flows set to continue into autumn.

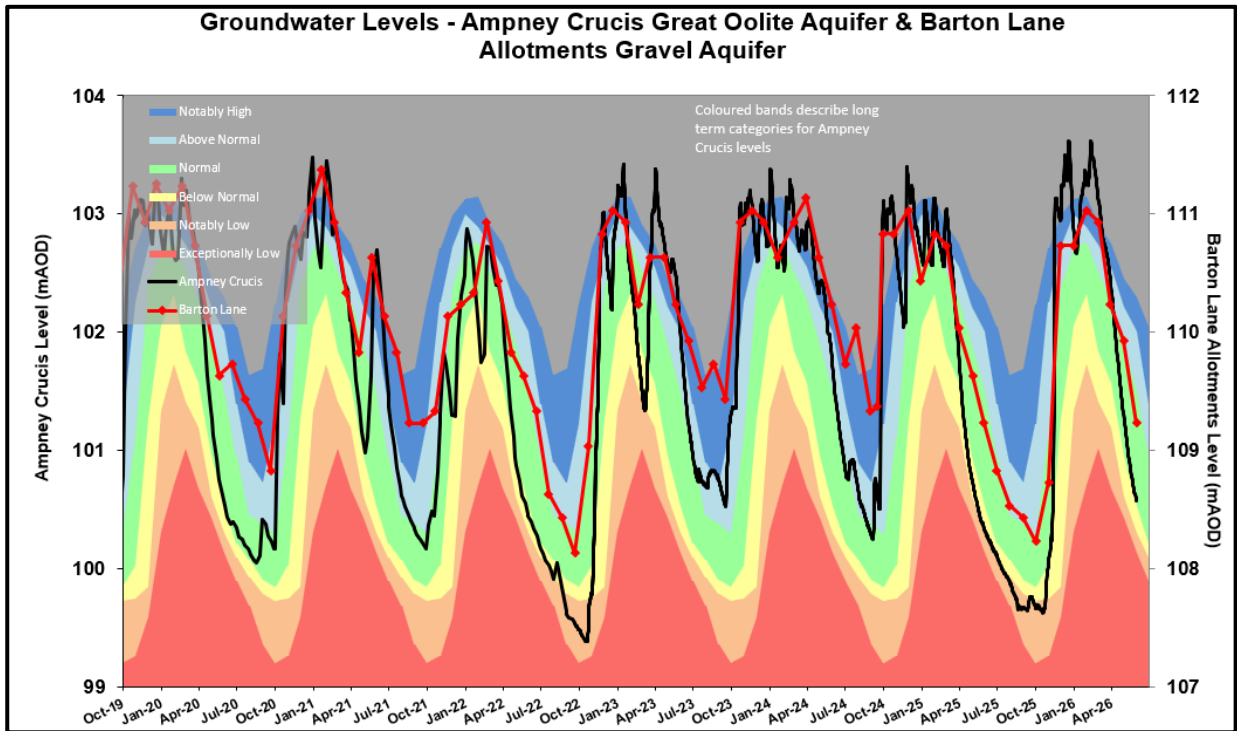
Although groundwater in the Great Oolite limestone aquifer reached exceptionally high levels in the 2025/26 winter, the below average rainfall in March, April and May resulted in a significant fall decline in levels. Despite this decline, groundwater levels at the end of May remained normal for the time of year, although they are very close to being below normal for the time of year, as

illustrated on the graph below. There are parts of the Great Oolite aquifer in the Churn catchment where groundwater levels are below normal for the time of year, evidencing variability in the catchment conditions. The end May levels plotted below are similar to, but slightly higher than, those at the end of May 2025.

The graph above includes groundwater levels measured monthly in the shallow Gravel aquifer in the Barton Lane Allotments Well. This illustrates the consistency in groundwater level patterns between the Gravel aquifer and the Great Oolite limestone aquifer, although the details are less clear due to the less frequent (monthly) monitoring. The end May groundwater level at Barton Lane Allotments is the same as that recorded at the end of May 2025, the joint lowest end May levels in the 7 year record.

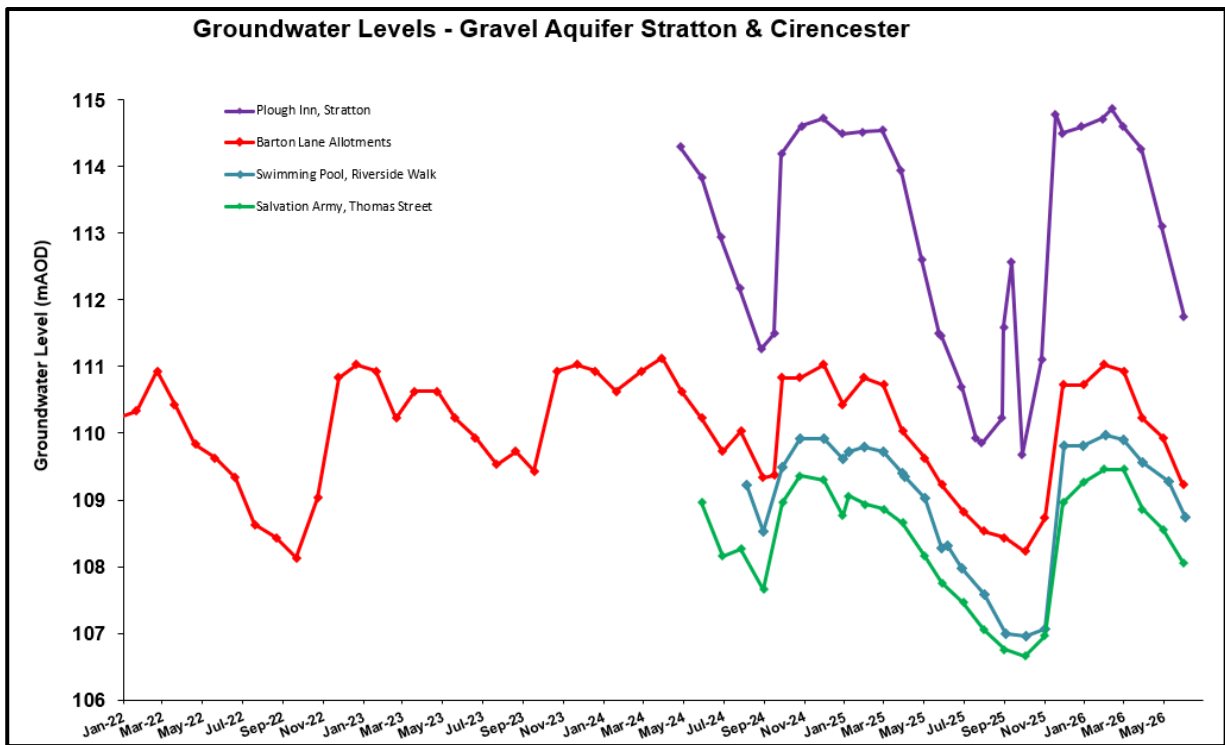
As shown on the graph above, very similar groundwater level trends in the Gravel aquifer continue to be measured in the shallow wells at Barton Lane allotments, the Swimming Pool and the Salvation Army in Cirencester, and the Plough Inn in Stratton. Although the end May groundwater level at Barton Lane Allotments is the same as that recorded at the end of May 2025, the end May 2026 levels in the other shallow wells slightly higher than those recorded in 2025, consistent with the pattern of Great Oolite limestone aquifer levels. It has been evident from ongoing monitoring that groundwater levels in the Plough Inn well have a larger range between its minimum and maximum levels, and also that groundwater levels fall more rapidly compared with the other shallow wells. It is now also becoming apparent that the rates of groundwater level decline in the Great Oolite limestone aquifer are similar to those in the Gravel aquifer at the Plough Inn, and that groundwater levels in other parts of the Gravel aquifer fall more slowly. This indicates that the Gravel aquifer has potential to release stored groundwater more slowly and sustain flow in those parts of the waterways where there is a groundwater-stream connection.

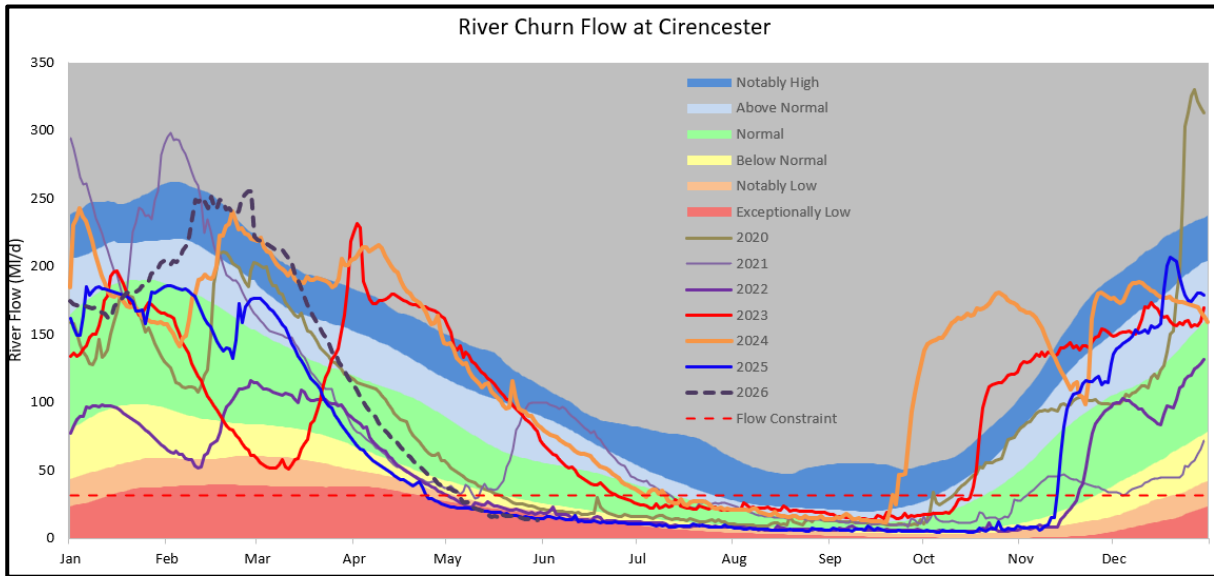
With the notably dry March, exceptionally dry April and 60% to 70% of the monthly average rainfall in May, both groundwater levels and river flows in the Churn have declined further. At the end of April, data from the Environment Agency (EA) Cirencester gauging station showed the flow was just below 39 million litres per day (ML/d), equivalent to 0.45 cubic metres per second (m^3/s), while at the end of May the flow had decreased to just over 13 ML/d, equivalent to 0.16 m^3/s , a reduction of 66%. This is another significant reduction with the end May flow now exceptionally low for the time of year, as illustrated on the graphs below. The expanded plot, focusing on low Spring/Summer flows since 2020 and significant years earlier in the 21st century, shows that the end May 2026 flow is very similar to, but slightly lower than in 2025, but the plot also highlights that the end May 2026 flow in the Churn is the 2nd lowest end May flow since records began in 1980. Only the end May flow of 2011 has been lower.

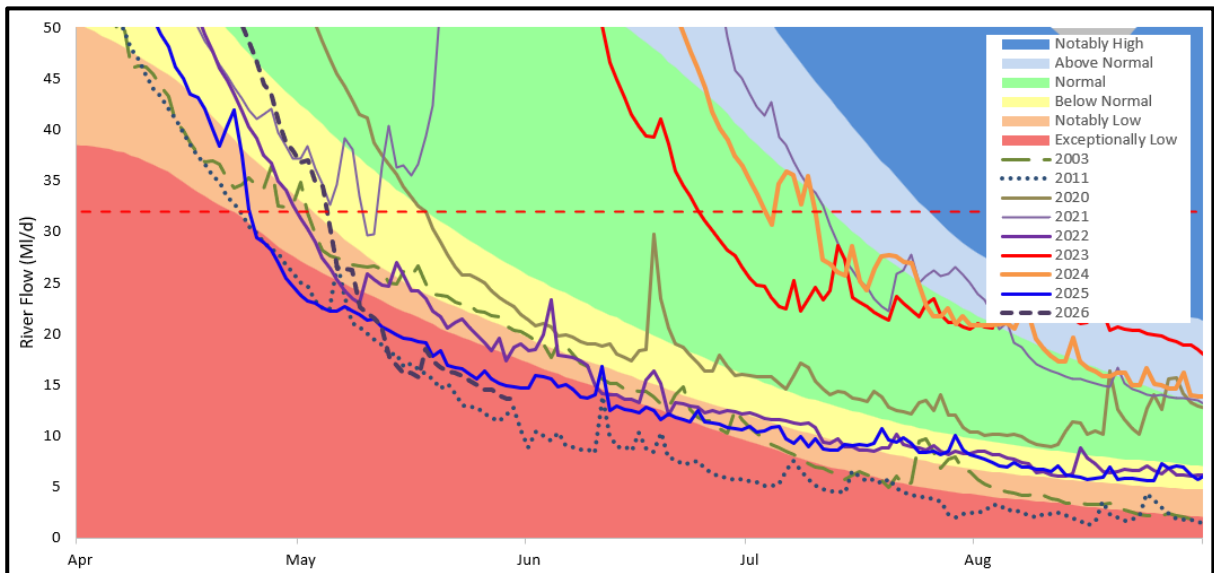
The graph below is an expanded plot to show low flows in the River Churn during Spring/Summer since 2020, together with significant years earlier in the 21st century.

With the end of May flow in the Churn at the EA gauging station at 13 ML/d, this is below the 32 ML/d flow trigger at which groundwater abstraction by Thames Water at Baunton for public water supply must cease. Thames Water has confirmed that Baunton has ceased abstracting to supply customers in the area, with more distant water sources being used in its place. Nevertheless, some pumping of groundwater from Baunton into the River Churn is likely to take place every week to enable water to be supplied to customers in an emergency.

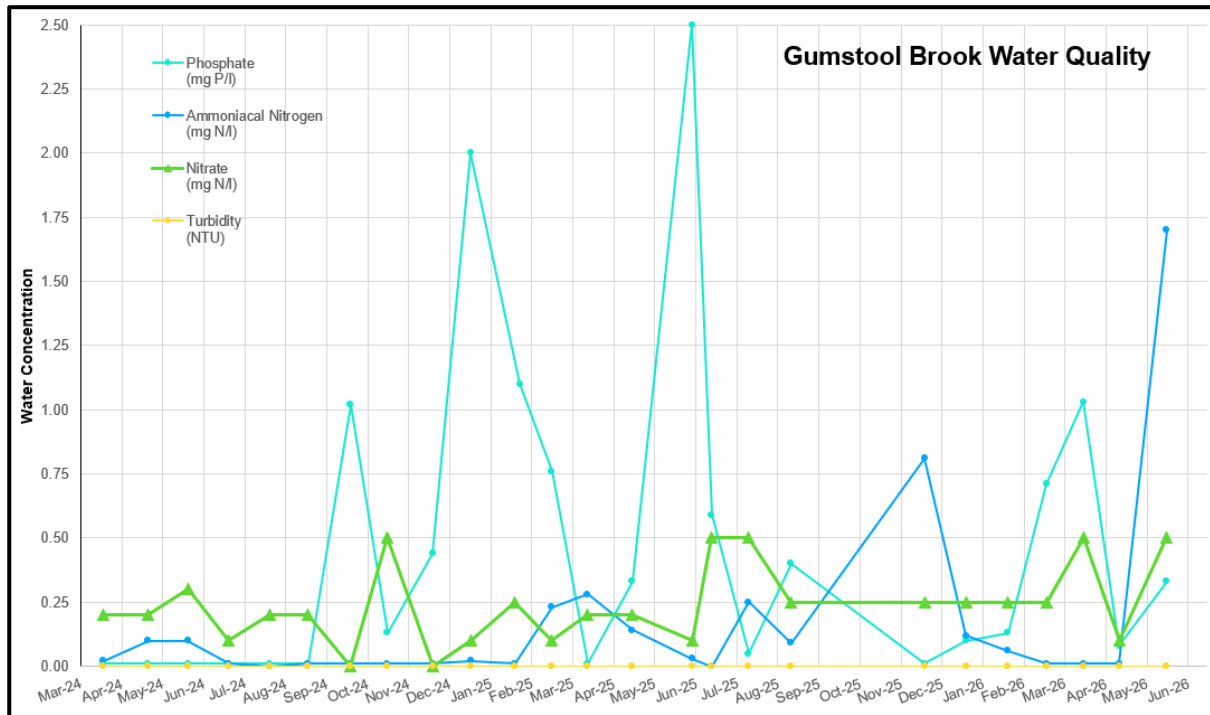
Monitoring of river water quality covers the nutrients, ammonia, nitrate and phosphate, and turbidity, a measure of how clear the water is. All measurements to date have shown intermittent spikes, with phosphate (PO_4) concentration spikes being the most obvious and frequent, as shown on the graph for the Gumstool Brook below, with similar spikes having also occurred in the

Churn. Some spikes of high nitrate (NO₃) also occur in the Churn and Gumstool Brook, with much less frequent spikes in ammonia concentrations. In the Gumstool Brook, concentrations of nitrate, ammonia and PO₄ in April 2026 were all low, having decreased since March. In the end May sample, concentrations of all these nutrients increased again, most notably ammonia reaching the highest concentration recorded since monitoring began in Spring 2024. In contrast, nutrient concentrations in May remained low, despite having increased slightly since April. These water quality trends have occurred while river flows have decreased progressively, with very low flows and significant vegetation growth in the Gumstool Brook by the end of May, although the factors that influence water quality remain uncertain. These factors potentially include increased river flows reducing nutrient concentrations by dilution, increased runoff transporting nutrients into the river, changes in nutrient sources during the year, as well as antecedent river flows and rainfall events. It is possible that very low flows within the Gumstool Brook and high temperatures at the end of May could have resulted in ammonia formation in, and release from stream bed.

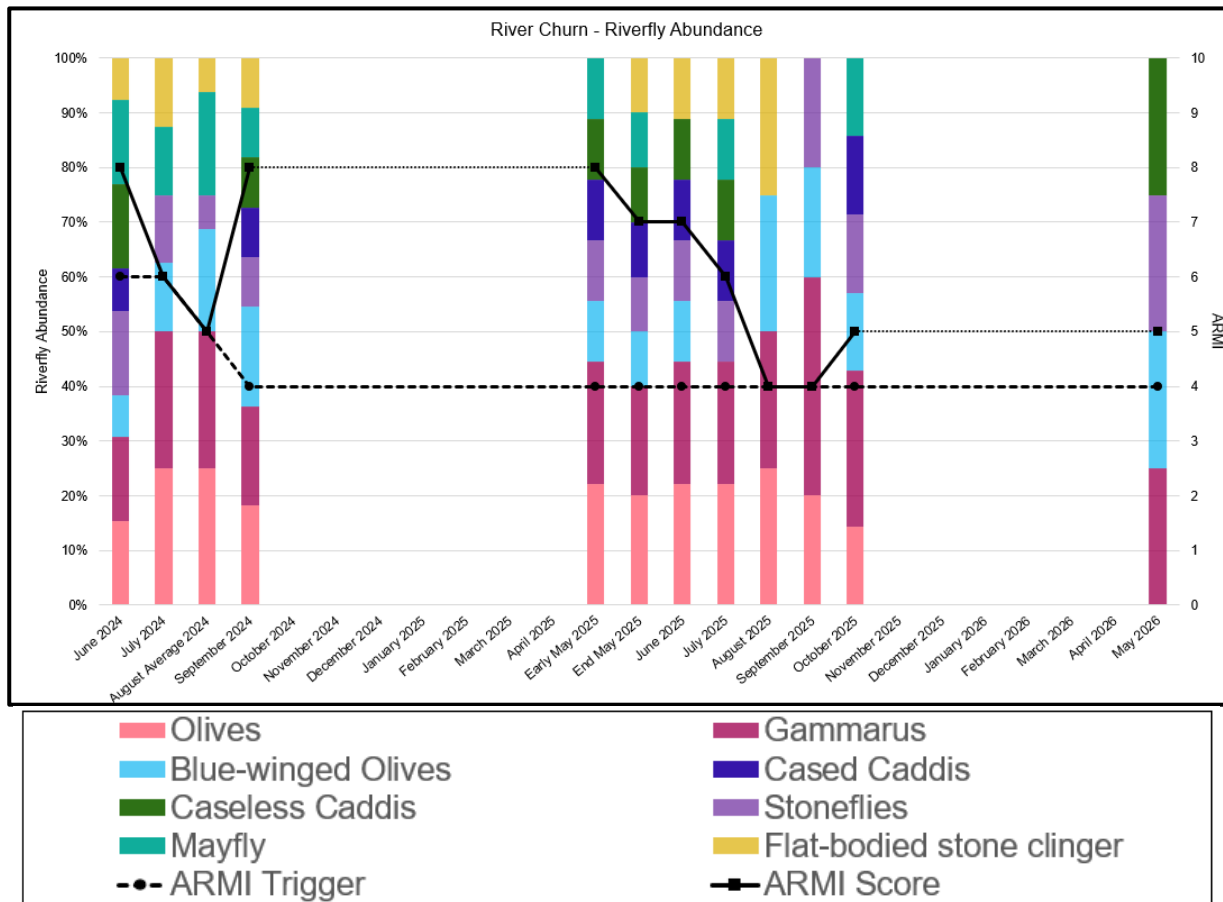
The available results for the River Churn are presented below, comparing the ARMI (Anglers Riverfly Monitoring Initiative) score, calculated from the riverflies identified and counted in the sample, with an ARMI trigger. Following August and September 2025 results, where the Churn ARMI score had decreased to the ARMI trigger level, the October results had a higher ARMI score. This indicates that following a deterioration in the ecological health of the Churn during the Summer, the river experienced its poorest health during the time of lowest minimum flows, but showed improving health in October as river flows began to increase.

From the May 2026 results below, it can be seen that the ARMI score (5) is above the trigger level set but is the same as that recorded in October 2025, although much lower than the ARMI score (7) recorded at the end of May 2025. Flow in the Churn at the end of May 2026 was very similar to that in recorded in May 2025, but the ARMI score suggests the aquatic health of the river is poorer

this year, reflected perhaps by the absence of mayfly larvae. In contrast, the May 2026 ARMI score (6) is significantly higher than the May 2025 score (2), which was below the trigger and, at the time, was considered to reflect the low flow in the Gumstool Brook in May 2025. With equally low flows and poor water quality in the Gumstool Brook in 2025 and 2026 (high phosphate and high ammonia, respectively), its better aquatic health in May 2026 is not intuitively expected, especially in the context of poorer aquatic health in the River Churn.

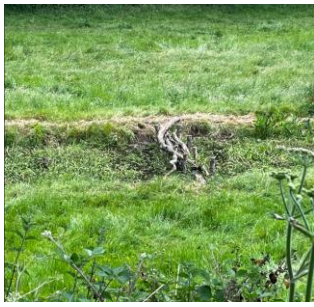
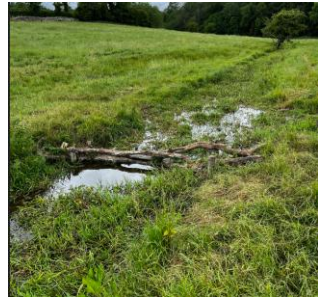
| <p>6a. Daglingworth Stream – Leaky Dam #1, upstream of Grove Hill Lane.</p> <p>The dam is in good condition. Vegetation has been removed from the stream and banks.</p> | | <p>6b. Daglingworth Stream Leaky Dam #2, upstream of Grove Hill Lane.</p> <p>The dam is in good condition. There is a low flow in the stream.</p> | |

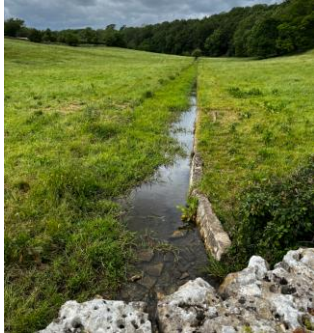
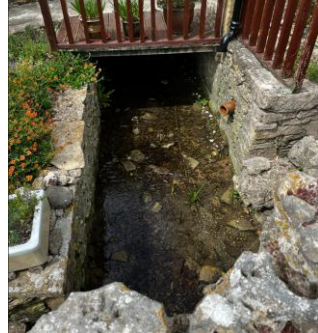
| <p>6c. Daglingworth Stream Grove Hill bridge.</p> <p>A low flow is observed that fills a small section of the channel in the field upstream of the Grove Hill bridge.</p> | | <p>7. Daglingworth Stream, Church Road</p> <p>The stream has a low flow in the culvert.</p> | |

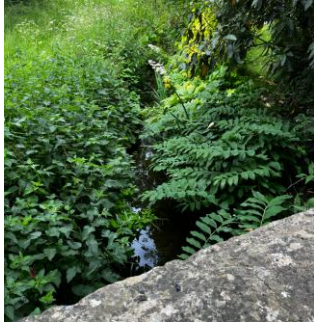
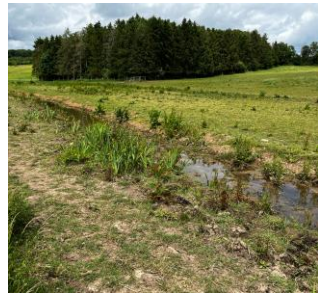
| <p>8. Daglingworth Stream at Lower End road bridge.</p> <p>There is a low flow observed in the channel and lots of vegetation present.</p> | | <p>9a. Wellhill Copse, Daglingworth Stream in equestrian fields.</p> <p>The stream has a low flow in the equestrian fields upstream of the stone wall.</p> | |

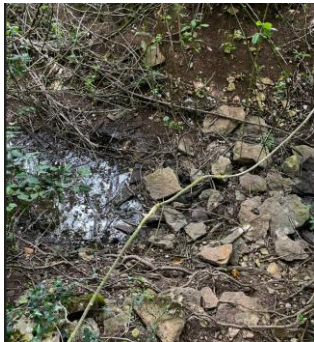
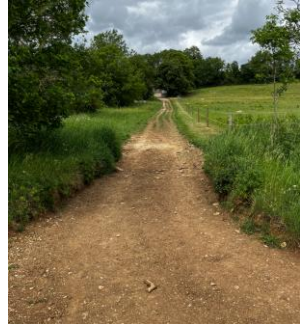
| <p>9b. Wellhill Copse, Daglingworth Stream near path stile.</p> <p>There is a very low flow in the stream.</p> | | <p>10. Daglingworth Place ford, Daglingworth Stream.</p> <p>The stream bed is dry through the ford.</p> | |

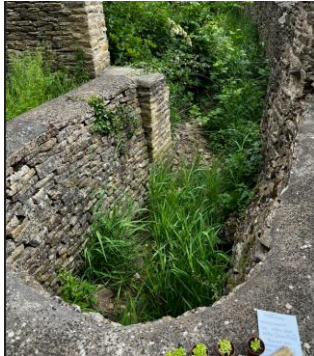
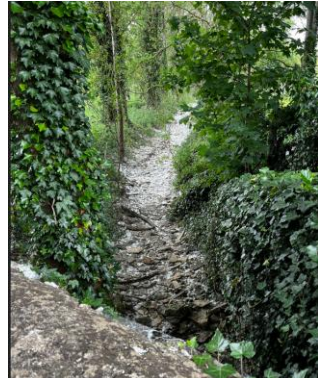
| <p>11. Grange Farm bridge, Daglingworth Stream.</p> <p>The stream channel is dry.</p> | | <p>12. School Hill bridge, Daglingworth Stream.</p> <p>The stream channel is dry.</p> | |

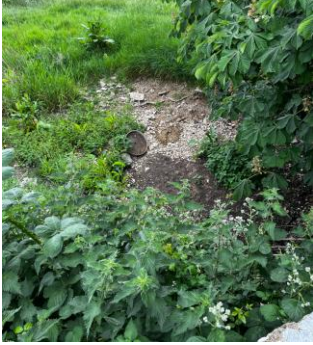
| <p>13. Stratton End (private road), Daglingworth Stream.</p> <p>The stream is dry upstream and downstream of the road bridge.</p> | | <p>14. Barn Way bridge, Daglingworth Stream.</p> <p>The stream channel is dry.</p> | |

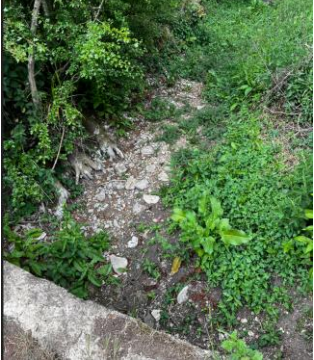
| <p>15. Daglingworth Stream, Plough Inn channel</p> | <p>No photo</p> <p>The stream bed is dry.</p> | <p>16. Footpath at Lower Stratton.</p> <p>The stream bed is dry.</p> | |

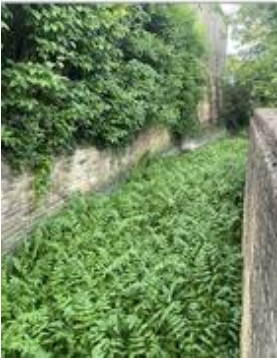
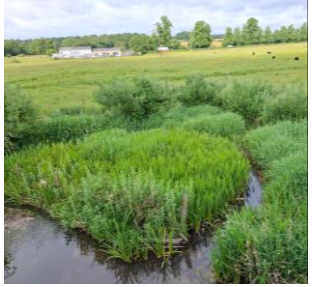
| <p>23. Balancing stream at Powell's school -towards Salvation Army building</p> <p>No water visible, large buildup of vegetation</p> | | <p>24 River Churn-Bomford Cottage, Stratton Water meadows beyond River Churn</p> <p>Meadows dry</p> | |

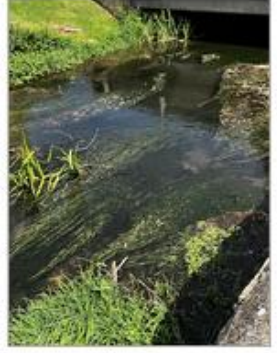
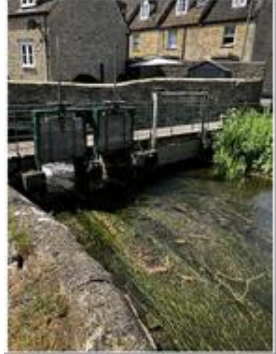
| <p>25a. River Churn at Gloucester St. bridge upstream of sluices</p> <p>Flowing slowly, some water Crowfoot</p> | | <p>25b. Glos st bridge sluices</p> <p>Flowing, lot of weeds in water</p> | |

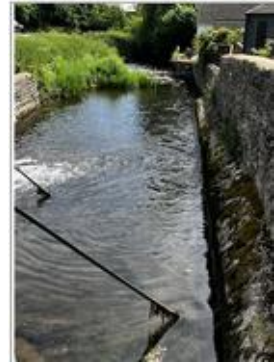
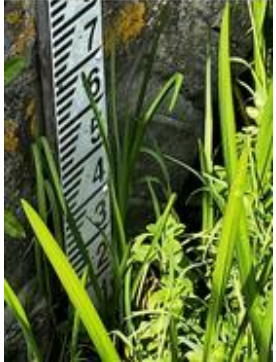
| <p>25c. River Churn downstream of Glos st sluices</p> | | <p>26a. River Churn at Glos St bridge measuring gauge</p> <p>The river level is below the bottom of the gauge.</p> | |

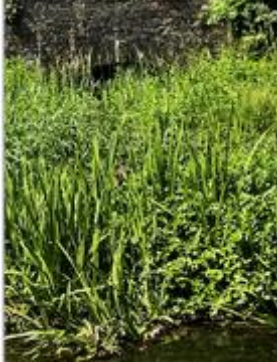
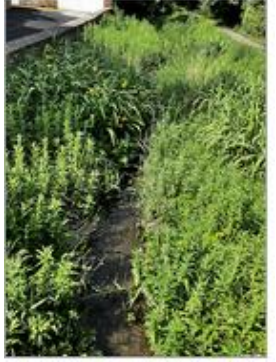
| <p>26b. Glos st bridge towards Mill Pound</p> <p>Buildup of vegetation hiding stream</p> | | <p>26c. Mill Pound downstream from Glos St bridge</p> <p>Flowing very slowly, much vegetation</p> | |

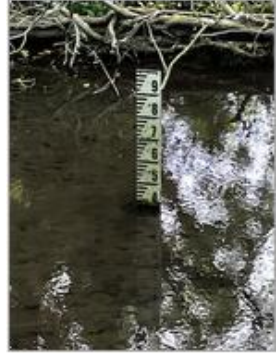
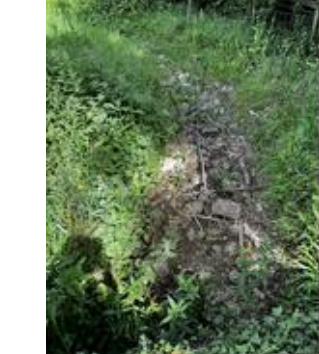
| <p>27. Gauge in Mill Pound at New Overflow</p> <p>Gauge showing 0.4m</p> | | <p>27. Mill Pound overflow (new)</p> <p>Totally dry</p> | |

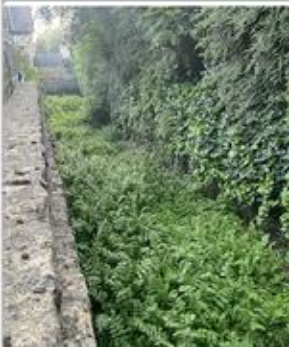
| <p>22a. Balancing Stream - Powell's school trash screen</p> <p>No flow visible but large buildup of vegetation</p> | | <p>28. Mill Pound overflow (old)</p> <p>Water visible in small puddle</p> | |

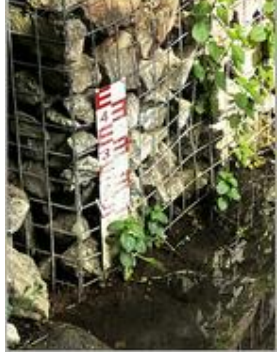
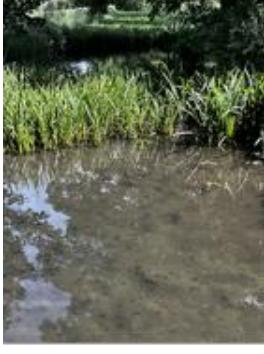
| <p>29a. Gumstool Brook gauge at foot bridge - water level below bottom of gauge</p> | | <p>29b. Mill Pound upstream of footbridge</p> <p>Very low water level and low flow, buildup of vegetation</p> | |

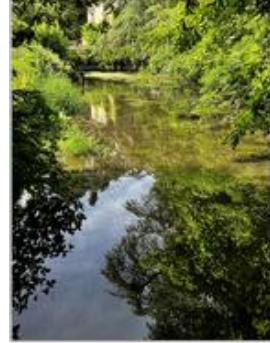
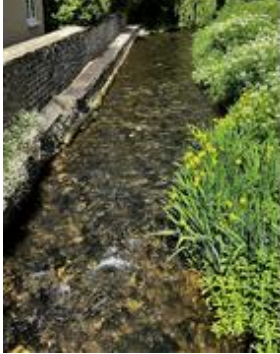
| <p>29c. Mill Pound downstream of footbridge</p> | | <p>31. River Churn upstream side of Gooseacre lane</p> <p>Flowing</p> | |

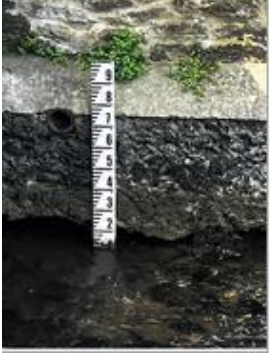
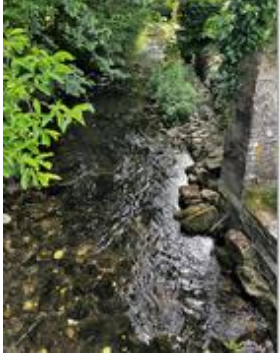
| <p>32a. River Churn gauge upstream side of Gooseacre lane</p> <p>showing 0.13m</p> | | <p>32b, River Churn downstream side of Gooseacre lane</p> <p>Flowing but level v low</p> | |

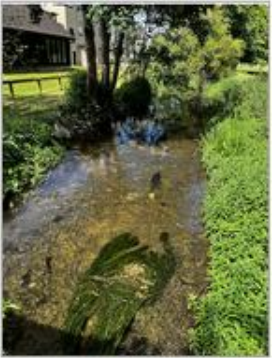
| <p>33a. River Churn upstream of Spitalgate Lane bridge</p> | | <p>33b. Bridge on upstream side of Spitalgate lane bridge</p> | |

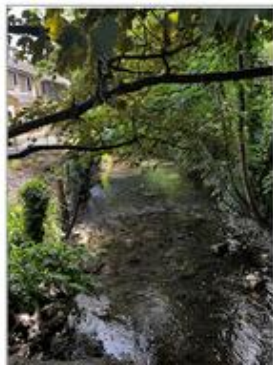
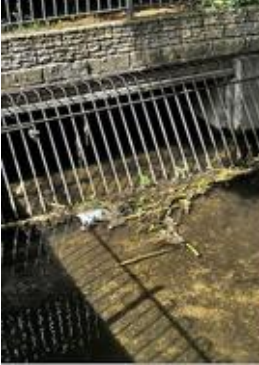
| <p>33c. River Churn downstream side of Spitalgate Lane bridge</p> | | <p>34a. River Churn at Hereward road trash screen</p> <p>Low level, not too much trash</p> | |

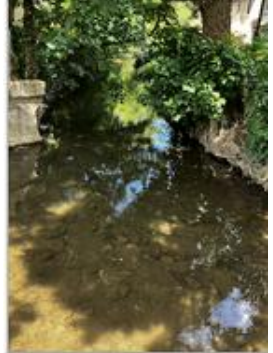
| <p>34b. River Churn upstream of Hereward Rd trash screen</p> | | <p>34c. River Churn downstream of Hereward Rd. Trash screen</p> | |

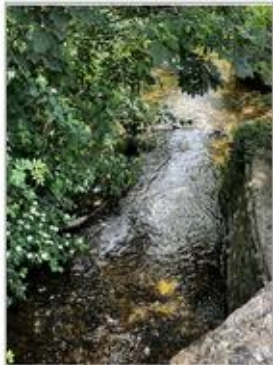
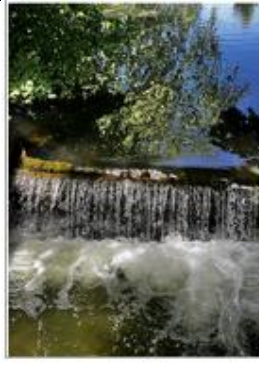
| <p>35. Stream in Abbey grounds - slow flow towards lake</p> | | <p>36a. Weir at stream outlet from Abbey lake</p> <p>Moderate flow out of lake</p> | |

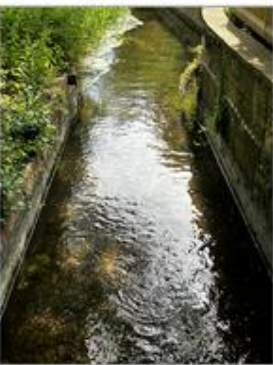
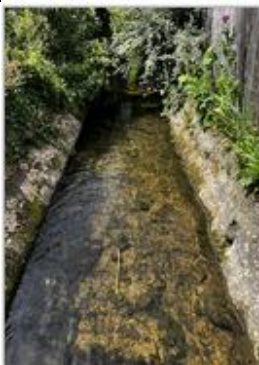
| <p>36b. Footbridge - downstream of stream outlet from Abbey Lake</p> | | <p>37. Abbey Lake outlet stream at Corinium Gate bridge</p> <p>Low flow level</p> | |

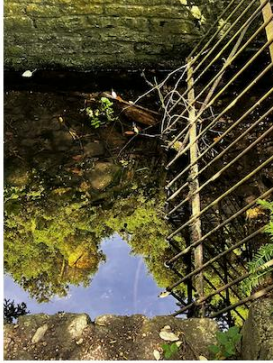
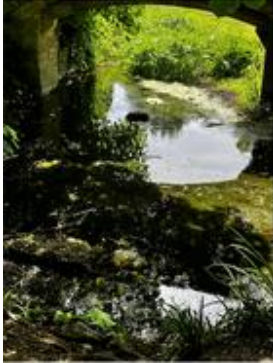
| <p>38a. Gumstool Brook culvert outlet in Abbey Grounds</p> <p>Some trash, very slow flow</p> | | <p>38b. Daglingworth Stream/Gumstool Brook in Abbey Ground towards Waterloo</p> <p>Water level low, dry stream bed exposed</p> | |

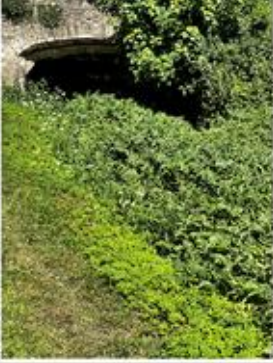
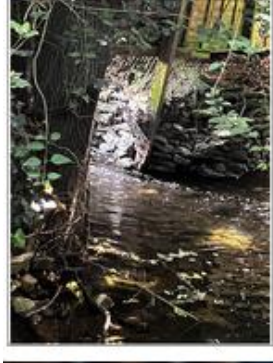
| <p>38c. Daglingworth Stream alongside Waterloo flats looking upstream</p> <p>Lot of vegetation, stream not visible</p> | | <p>39. Daglingworth Stream confluence with Abbey Lake outlet (Waterloo car park)</p> <p>Moderate flow</p> | |

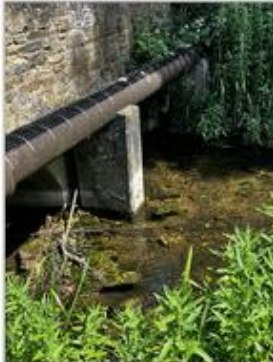
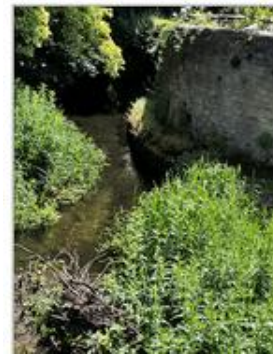
| <p>40a. Churn (West branch) on downstream side of London Rd bridge</p> <p>Low water level, gentle flow</p> | | <p>40b. Churn (West branch) on downstream side of London Rd bridge</p> | |

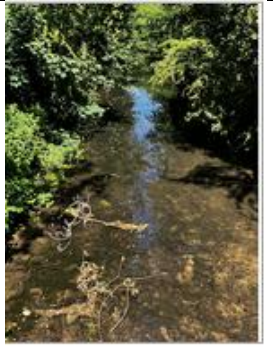
| <p>41. River Churn (East branch) upstream of old Beeches Road bridge</p> | | <p>42. River Churn (East branch) downstream of old Beeches Road bridge</p> | |

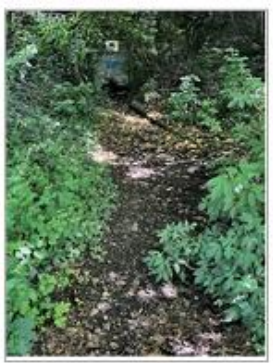
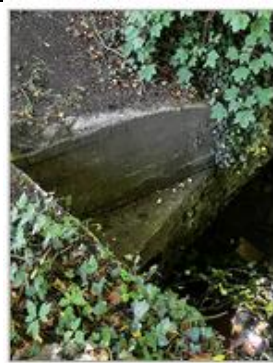
| <p>43a. River Churn (West branch) - Furness hole connection to East branch at New Mills</p> <p>Totally dry</p> | | <p>43b. River Churn (East branch) - New Mills overflow</p> <p>No water overflow from New Mills pond</p> | |
