# Citizen River

## Monitoring Report

### July 2026

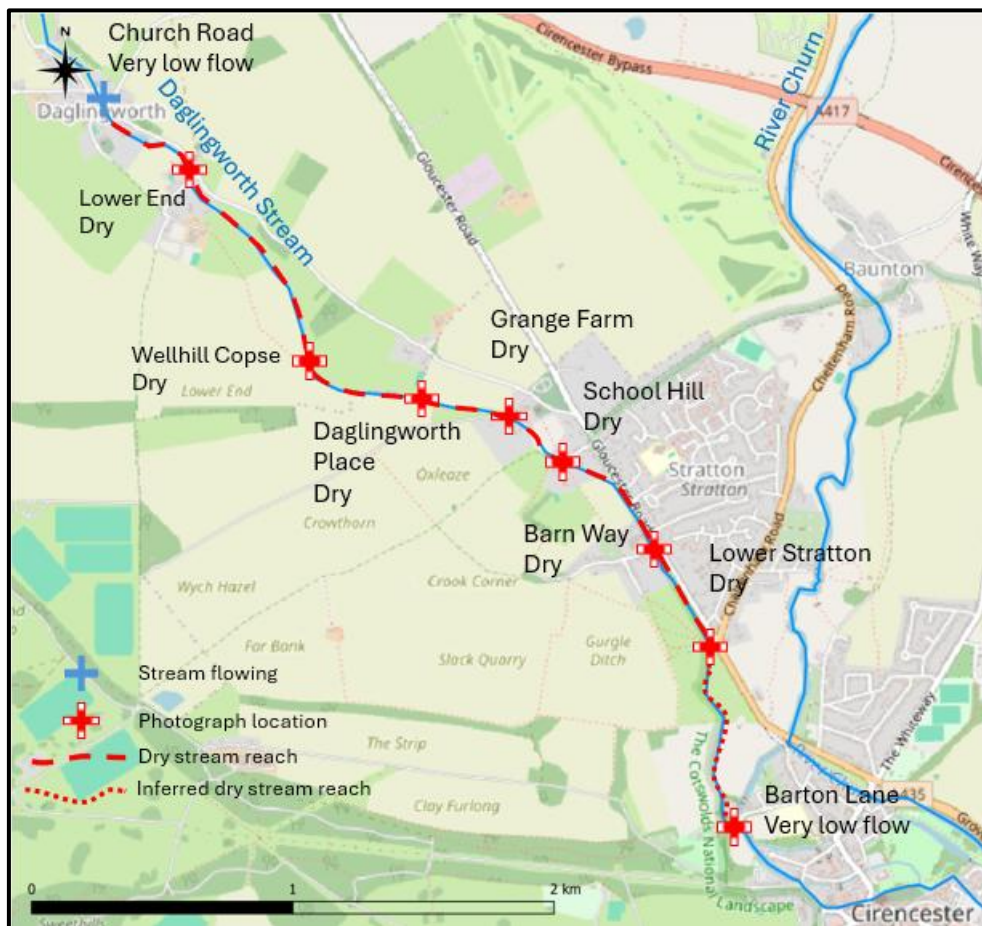
Following dry weather and declining groundwater levels in March and April, the Daglingworth Stream ceased to flow just upstream of Daglingworth Place. At the end of July however, the stream has ceased to flow between Church Road and Lower End in Daglingworth, as illustrated on the map below. This means that there was no flow in the Daglingworth Stream from this point downstream to Barton Lane at the northern edge of Cirencester, a distance of 3.7 km. This means that, since the end of June, a further 700 m of the Daglingworth Stream has ceased to flow.

The extent of no flow in the Daglingworth Stream at the end of July differs from the end of July 2025. Last year, the stream ceased to flow upstream of Wellhill Copse with low flows persisting at Lower End in Daglingworth, but at the end July 2026 there was no flow at Lower End with only very low at Church Road further upstream in Daglingworth village. Compared with the end of July 2025, an additional 700 m to 1.2 km of the Daglingworth Stream was dry at the end of July 2026, despite groundwater levels being higher this year. This situation is likely to be influenced by the almost complete absence of rain, significantly higher temperatures, increased evaporation and exceptionally dry soils in July 2026 compared with July 2025. As a result, in July 2026, there was

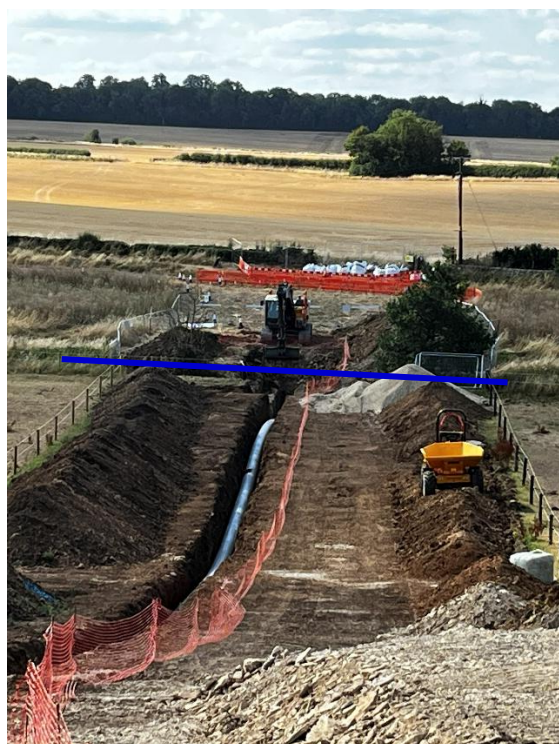
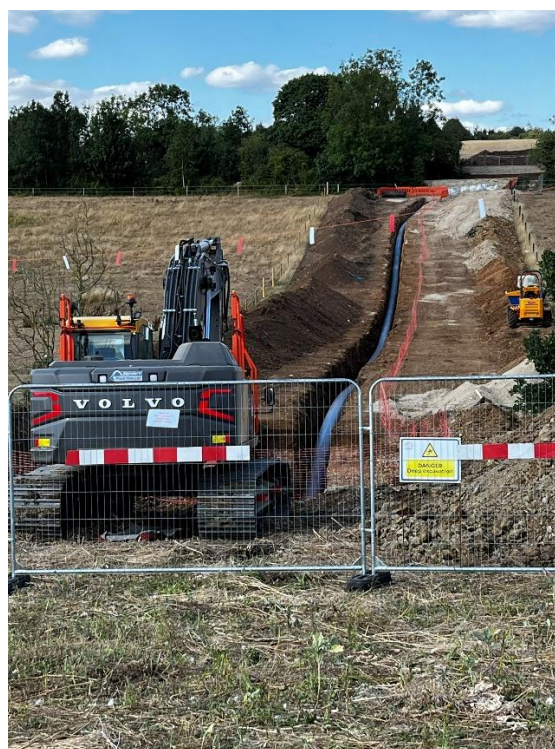
During July, it was identified that a new water pipeline is being constructed by Thames Water from their Gloucester Road reservoir into northern Cirencester. Its route crosses the currently dry Daglingworth Stream near Daglingworth Place. Photographic monitoring of the construction method and progress is being carried out, which will extend to cover the reinstatement of the stream and surrounding floodplain. The photographs below show the status of construction on 31<sup>st</sup> July. The LH photo taken from the Daglingworth Road looking south towards the stream, and the RH near to the stream bed looking north towards the Daglingworth Road. The route of the Daglingworth stream is shown as a blue line on the LH photo.

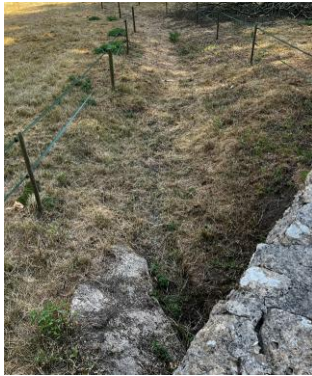
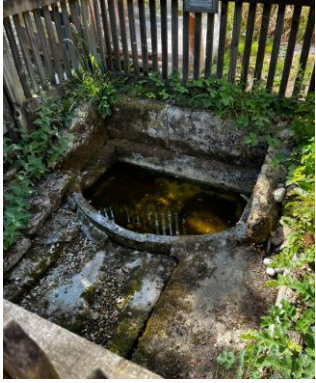
| <p>1a. Daglingworth Stream upper source north of Duntisbourne Abbots.</p> <p>The stream bed is dry on both sides of the road.</p> | | <p>1b. Duntisbourne Abbots village spring.</p> <p>The spring has some brown water present but there is no flow from the spring.</p> | |

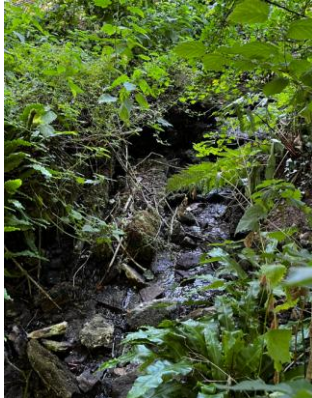
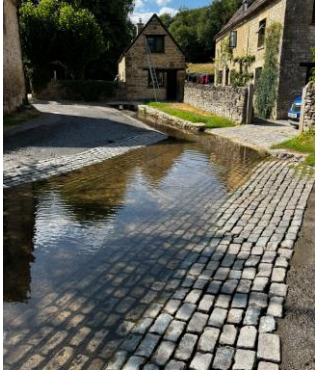
| <p>2. Duntisbourne Abbots, Daglingworth Stream downstream of inferred confluence of spring sources.</p> <p>There is a very low flow of clear water from the spring and in the channel.</p> | | <p>3. Duntisbourne Leer ford, Daglingworth Stream.</p> <p>There is a low flow across the ford that extends to ~9 cobbles on northeast side.</p> | |

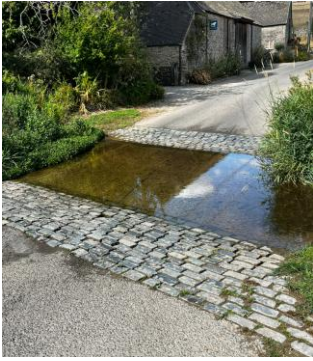
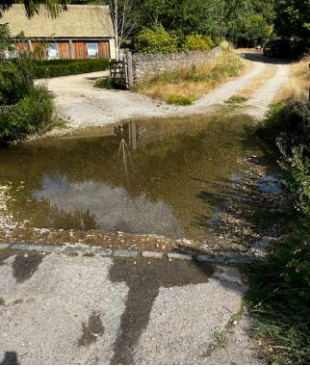
| <p>4. Middle Duntisbourne ford, Daglingworth Stream.</p> <p>A low flow is observed that extends to 12 bricks of the cobbled area of the south-west channel edge.</p> | | <p>5. Duntisbourne Rouse ford, Daglingworth Stream.</p> <p>There is a low flow across the ford, which is well inside the SW boundary cobbles.</p> | |

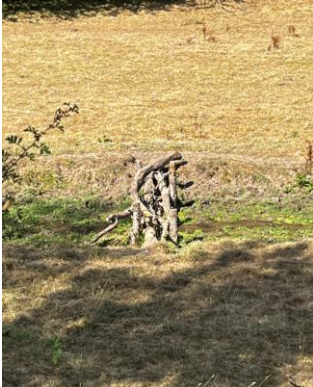
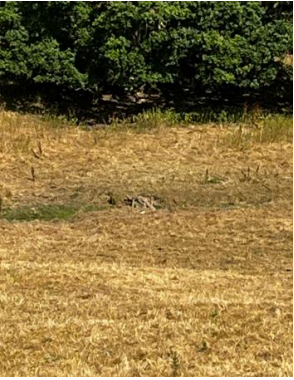
- Both of the woody debris leaky dams upstream of Daglingworth look to be in good condition. The stream has a low flow with the dams not restricting the flow.

| <p>6a. Daglingworth Stream – Leaky Dam #1, upstream of Grove Hill Lane.</p> <p>The dam is in good condition. There is a low flow in the stream. There are signs of cattle grazing the field.</p> | | <p>6b. Daglingworth Stream Leaky Dam #2, upstream of Grove Hill Lane.</p> <p>There are cattle grazing in the field so photos were taken from the field edge. The dam appears to be in good condition.</p> | |

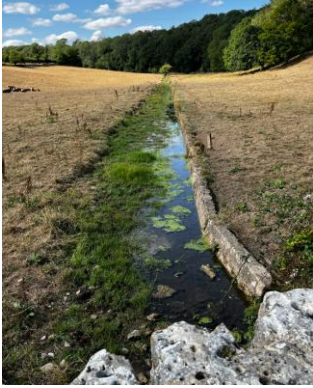
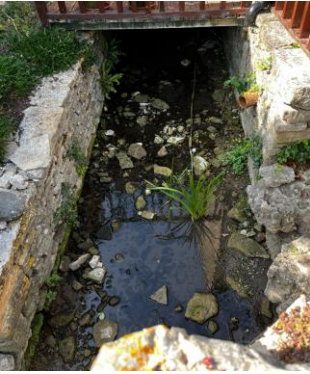
| <p>6c. Daglingworth Stream Grove Hill bridge.</p> <p>A low flow is observed that fills a small section of the channel in the field upstream of the Grove Hill bridge.</p> | | <p>7. Daglingworth Stream, Church Road</p> <p>The stream has a very low flow in the culvert.</p> | |

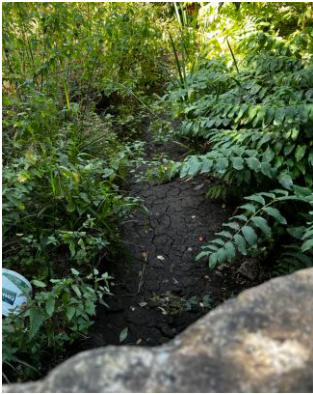
| <p>8. Daglingworth Stream at Lower End road bridge.</p> <p>There is no flow, and the stream bed has damp cracked mud.</p> | | <p>9a. Wellhill Copse, Daglingworth Stream in equestrian fields.</p> | <p>No Picture</p> |

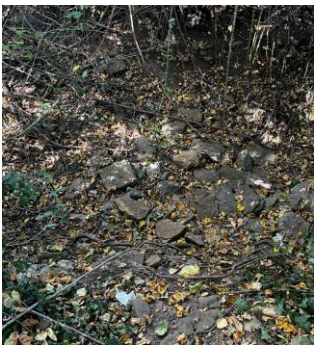
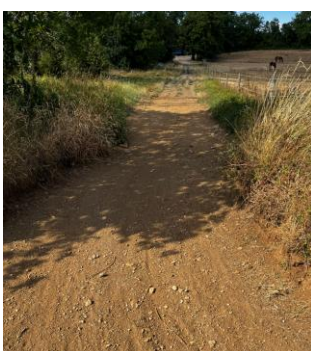
| <p>9b. Wellhill Copse,<br/>Daglingworth Stream<br/>near path stile.</p> <p>The stream bed is dry.</p> | | <p>10. Daglingworth<br/>Place ford,<br/>Daglingworth<br/>Stream.</p> <p>The stream bed<br/>through the ford is<br/>very dry and dusty.</p> | |

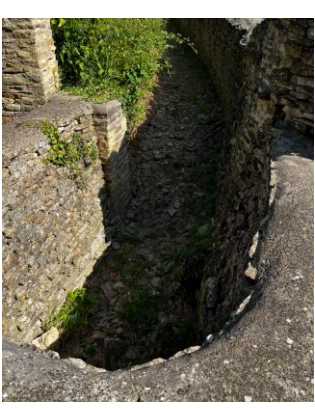
| <p>11. Grange Farm<br/>bridge, Daglingworth<br/>Stream.</p> <p>The stream channel is<br/>dry. There is little<br/>vegetation present.</p> | | <p>12. School Hill<br/>bridge, Daglingworth<br/>Stream.</p> <p>The stream channel<br/>is dry.</p> | |

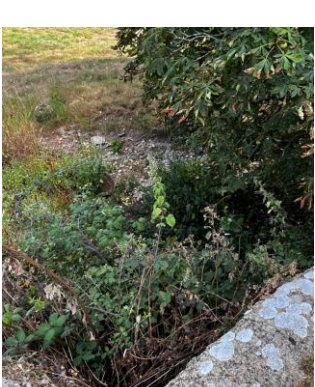
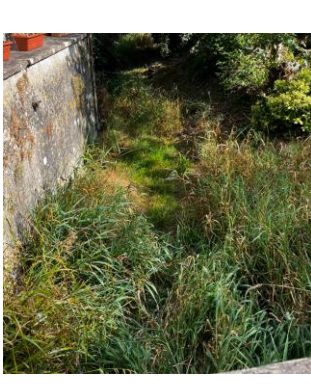
| <p>13. Stratton End<br/>(private road),<br/>Daglingworth Stream.</p> <p>The stream is dry<br/>upstream and<br/>downstream of the<br/>road bridge. There is<br/>significant vegetation<br/>present in the stream<br/>bed.</p> | | <p>14. Barn Way bridge,<br/>Daglingworth<br/>Stream.</p> <p>The stream channel<br/>is dry. There is lots of<br/>vegetation present.</p> | |

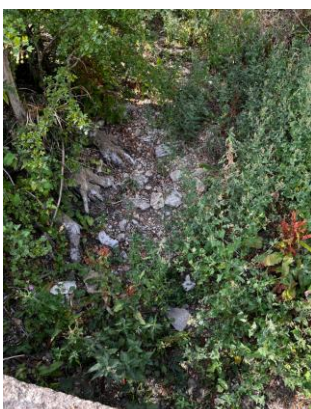
| <p>15. Daglingworth<br/>Stream, Plough Inn<br/>channel</p> <p>The channel is dry,<br/>and there is some<br/>vegetation present.</p> | | <p>16. Footpath at<br/>Lower Stratton.</p> <p>The stream bed is<br/>dry. There is lots of<br/>vegetation present.</p> | |

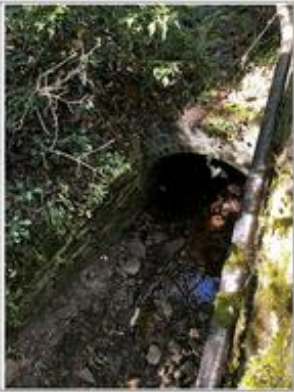
| | | <p>17a. Daglingworth stream downstream of Bathurst estate boundary wall</p> <p>Dry in places, no flow</p> | |

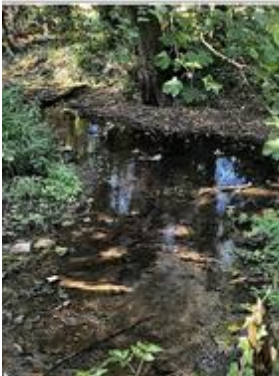
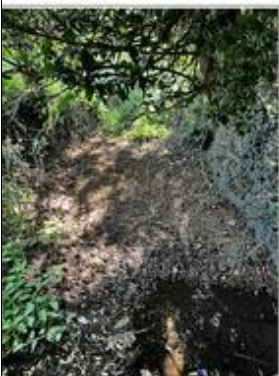
| <p>17b. Daglingworth stream downstream of Bathurst Estate boundary wall</p> <p>Dry in places, very low flow</p> | | <p>18. Gumstool Brook Balancing Stream</p> <p>The stream is dry apart from a small puddle by entrance from sluice.</p> | |

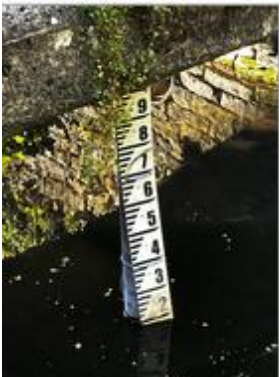
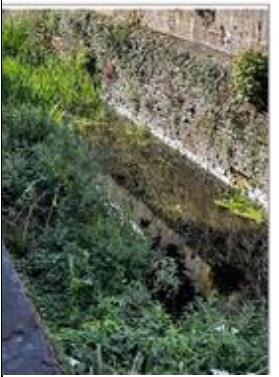
| <p>19. Gumstool Brook - gauge alongside swimming pool</p> <p>Reading 0.18m</p> | | <p>20. Gumstool Brook - alongside riverside walk</p> <p>Very low flow, great deal of vegetation</p> | |

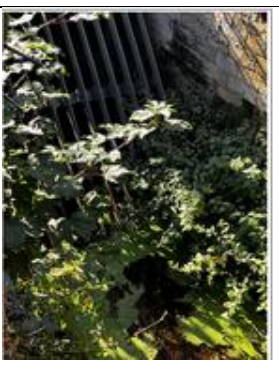
| <p>21. Gumstool brook at culvert trash screen</p> <p>Very low flow</p> | | <p>22a. Balancing stream at Powell's School - at trash screen</p> | |

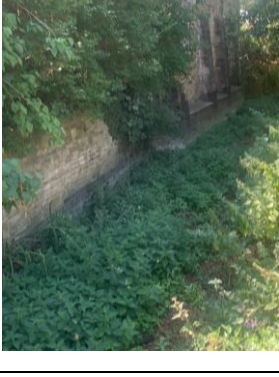
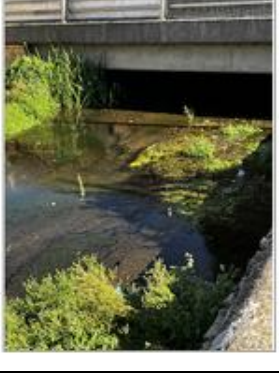
| <p>23. Balancing stream at Powell's School towards Salvation Army building</p> <p>Dry stream bed with vegetation covering the channel</p> | | <p>25a. River Churn at Gloucester St. bridge upstream of sluices</p> <p>Low flow, lots of weed present</p> | |

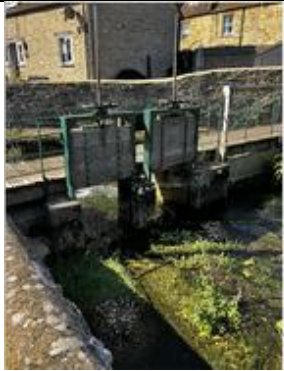
| <p>25b. Glos St bridge sluices</p> <p>Most flow entering into left hand sluice.</p> | | <p>25c. River Churn at Glos St bridge measuring gauge</p> <p>Water level is below gauge.</p> | |

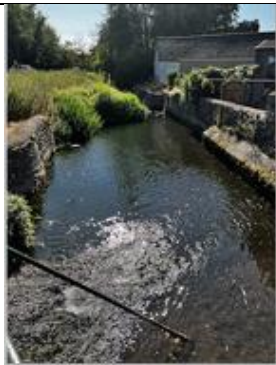
| <p>25d. River churn downstream of Glos St sluices</p> <p>Low flow</p> | | <p>25e. Glos St bridge towards Mill Pound</p> <p>Lots of vegetation present at entrance to the Barton Mill Pound.</p> | |

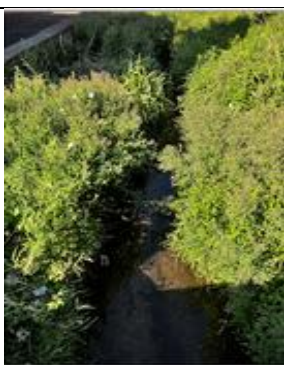
| <p>26. Barton Mill Pound downstream from Glos St bridge</p> <p>Stream has low flow and lots of vegetation present.</p> | | <p>27a. Gauge in Mill Pound</p> <p>Gauge showing below 0.4m</p> | |

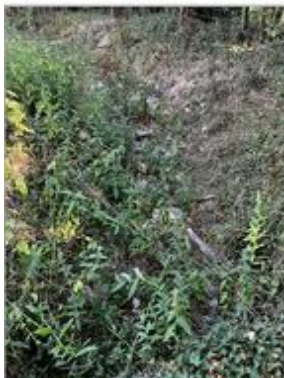
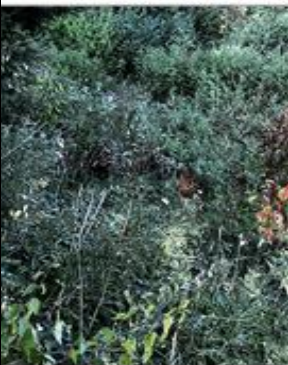
| <p>27b. Mill Pound overflow (new)</p> <p>Completely dry</p> | | <p>28. Mill Pound overflow (old)</p> <p>No visible water</p> | |

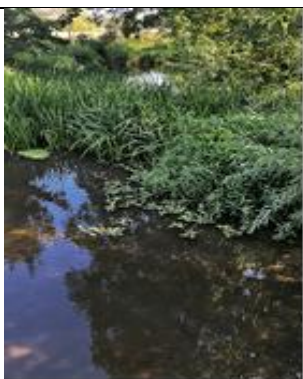
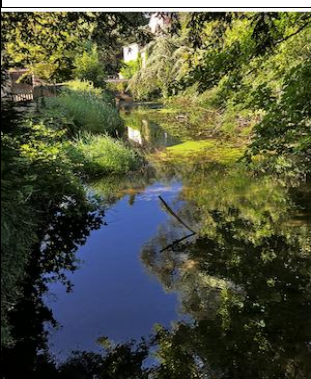
| <p>29a. Mill Pound upstream of footbridge</p> <p>Very shallow and a lot of vegetation present.</p> | | <p>29b. Mill Pound downstream of footbridge</p> <p>Very low flow</p> | |

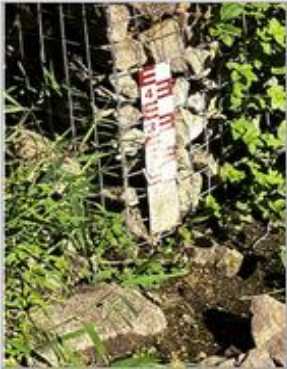
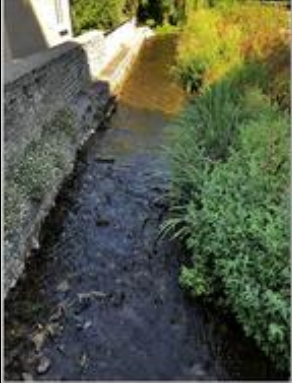
| <p>29c. Gauge by footbridge in Mill Pound</p> <p>High and dry!</p> | | <p>31. River Churn upstream side of Gooseacre lane</p> <p>Low flow</p> | |

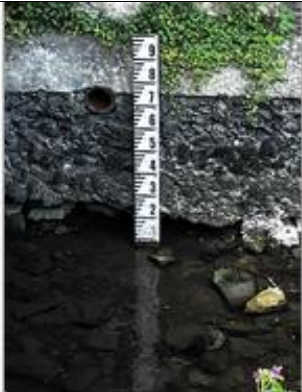
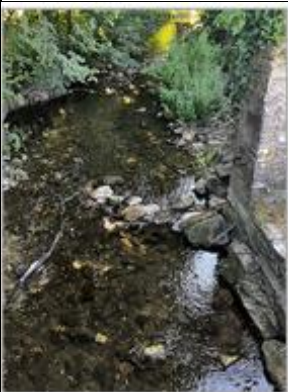
| <p>32a. River Churn gauge upstream side of Gooseacre lane</p> <p>Gauge showing 0.8m</p> | | <p>32b. River Churn downstream side of Gooseacre lane</p> <p>Low flow</p> | |

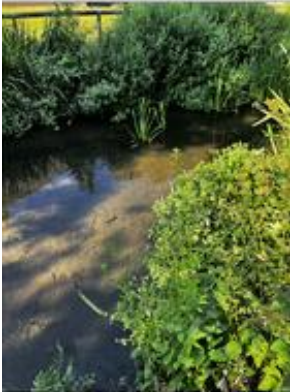
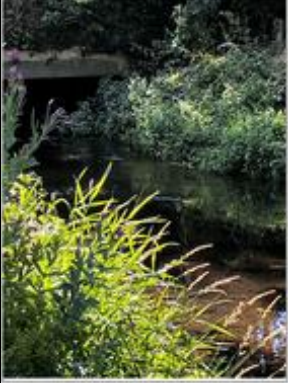
| <p>33a. River Churn upstream of Spitalgate Lane bridge</p> <p>Low flow</p> | | <p>33b. River Churn looking downstream towards Spitalgate lane bridge</p> <p>Much vegetation, low flow</p> | |

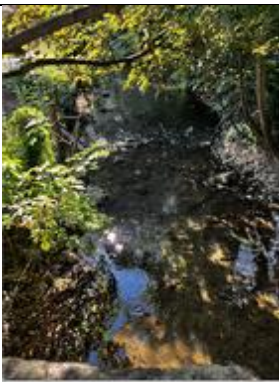
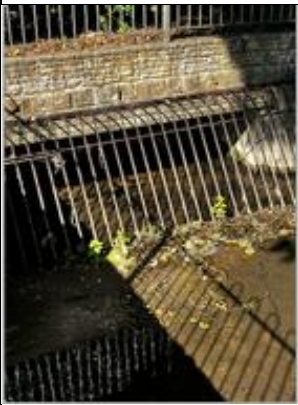
| <p>33c. River Churn downstream of Spitalgate Lane bridge</p> <p>Low flow</p> | | <p>34a. Hereward Rd trash screen</p> <p>Low water level, some trash</p> | |

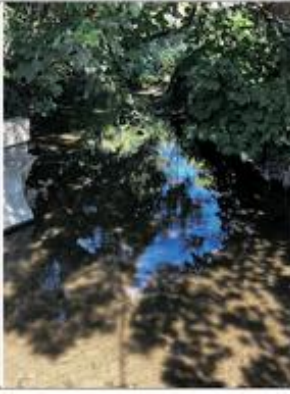
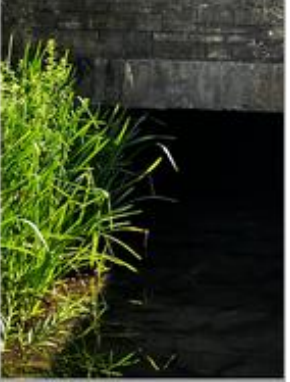
| <p>34b. River Churn upstream of Hereward Rd. trash screen</p> | | <p>34c. River Churn - bridge downstream of Hereward rd. Trash screen</p> | |

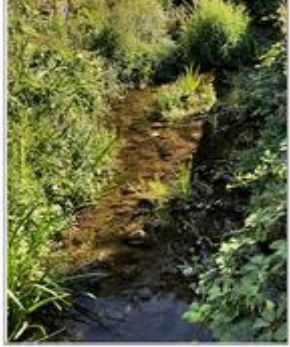
| <p>34d. River Churn on other side of Hereward Road bridge</p> <p>Low water level, low flow</p> | | <p>35. Stream flowing into Abbey Grounds &amp; lake</p> <p>Low flow</p> | |

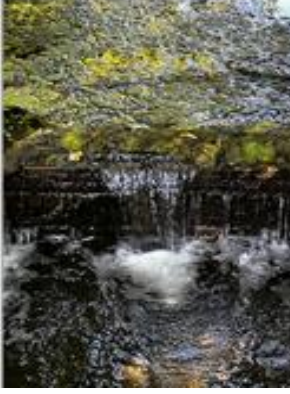
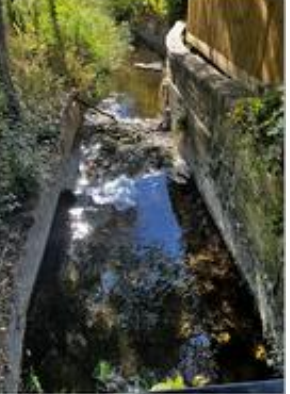
| <p>36a. Weir at stream outlet from Abbey lake</p> <p>Low flow with a lot of algae in lake and smelling bad!</p> | | <p>36b. Footbridge at stream outlet from Abbey Lake</p> <p>Low flow</p> | |

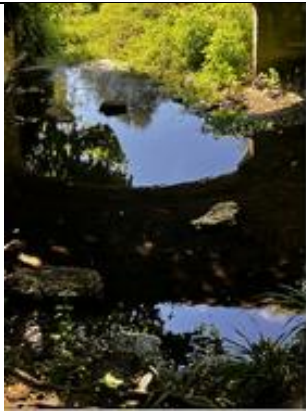
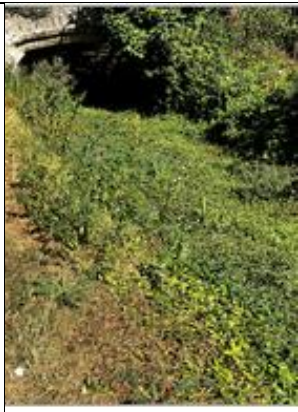
| <p>38. Gumstool Brook in Abbey Ground towards Waterloo</p> <p>Dry areas, with pools of water</p> | | <p>39a. Gumstool Brook alongside Waterloo flats looking upstream</p> <p>No stream visible, much vegetation</p> | |

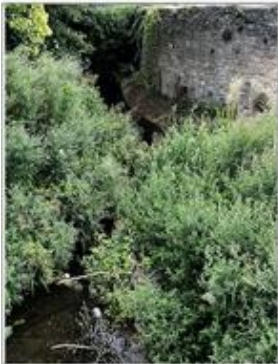
| <p>40b. River Churn on downstream side of London Rd bridge</p> <p>Low level, much vegetation</p> | | <p>41a. River Churn upstream of old Beeches road bridge</p> <p>Very dry in places, pools of water, no obvious flow</p> | |

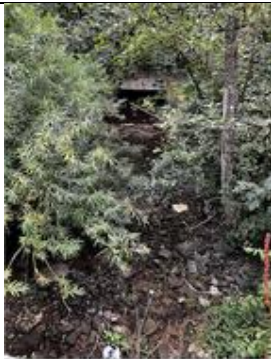
| <p>41b. River Churn downstream of old Beeches road bridge</p> <p>Dry areas with no obvious flow</p> | | <p>44. Weir at City Bank glade</p> <p>Weir not really visible, slow flow</p> | |

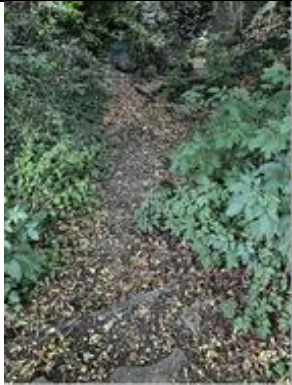
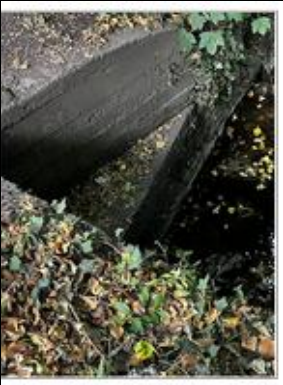
| <p>43a. River Churn – Furness hole</p> <p>Totally dry</p> | | <p>43b. River Churn - new Mills overflow</p> <p>No flow from overflow</p> | |

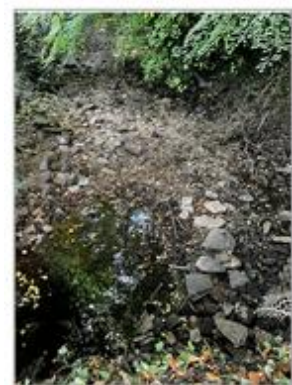
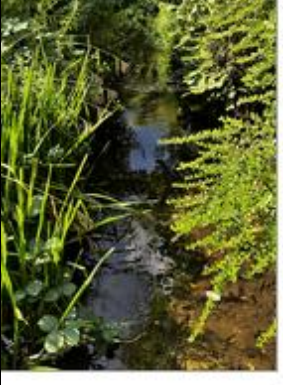
| <p>43c. River Churn - New Mills downstream</p> <p>Mostly dry river bed with ponded water immediately downstream of the sluices</p> | | <p>45. River Churn at City Bank park footbridge</p> <p>Low flow, vegetation</p> | |

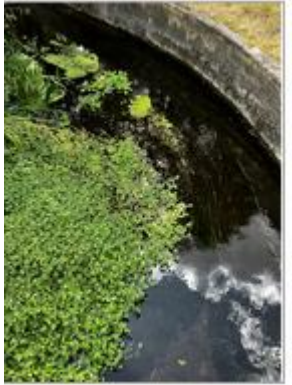
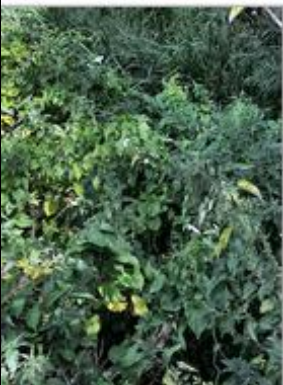
| <p>46. River Churn at Watermoor Point car park</p> <p>Low flow, duckweed and other vegetation</p> | | <p>47. River Churn at Cricklade road opposite Aldi</p> <p>River is not really visible, much vegetation</p> | |

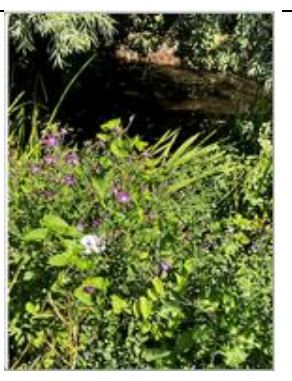
| <p>48. River Churn at Cricklade road opposite Tesco</p> <p>Not much visibility of river owing to extensive vegetation</p> | | | |
