# Citizen River Monitoring Report August 2026

Friends of Gumstool Brook is a group of local people interested in Cirencester's Gumstool Brook and its associated streams. Visit our website at <https://gumstool.org.uk>

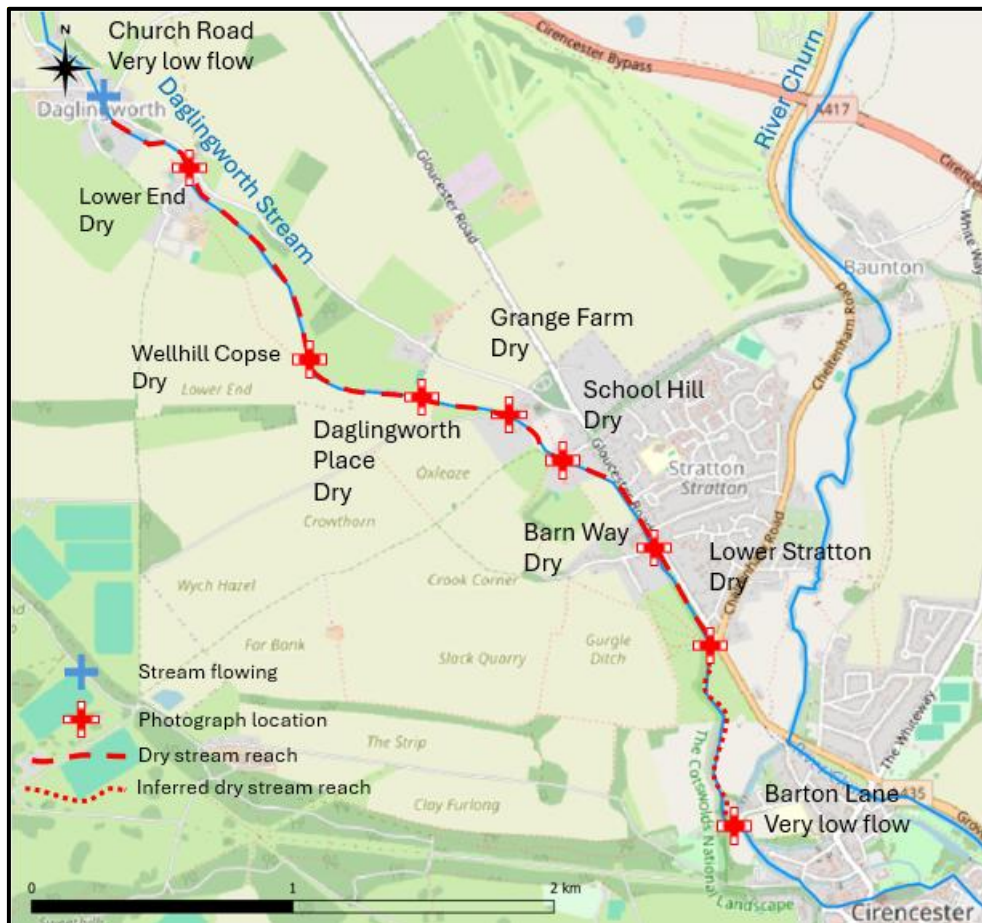
Following dry weather and declining groundwater levels in March and April, the Daglingworth Stream ceased to flow just upstream of Daglingworth Place. At the end of July however, the stream ceased to flow between Church Road and Lower End in Daglingworth, as illustrated on the map below. This means that there was no flow in the Daglingworth Stream from this point downstream to Barton Lane at the northern edge of Cirencester, a distance of 3.7 km. This situation remains unchanged at the end of August.

The extent of no flow in the Daglingworth Stream at the end of July was greater than that at the end of July 2025, with an additional 700 m to 1.2 km of the stream dry at the end of July 2026, despite groundwater levels being higher this year. By the end of August 2025, however, the extent of no flow in the Daglingworth Stream had extended further upstream and was very similar to the current situation at the end of August 2026. It is worth noting an additional detail from late August 2025, when residents in Daglingworth reported that the stream had dried up at the northern edge of the village, although there was some flow at the end of August 2025 following rainfall. This drying up at the northern edge of the village had not been noted previously in the period back to 1996 and was not observed by the same residents during August 2026. The differences between July 2025 and 2026 are likely to be influenced by the almost complete absence of rain, much higher temperatures, increased evaporation and exceptionally dry soils in July 2026. As a result, in July 2026, there was no benefit to river flow from any rainfall runoff and reduced benefit from groundwater baseflow, potentially because of greater evapotranspiration and exceptionally dry soils. Conversely, the similarities in the extent of dry stream bed at the end of August 2025 and 2026 is likely to reflect the effects of rainfall that occurred at the end of both months.

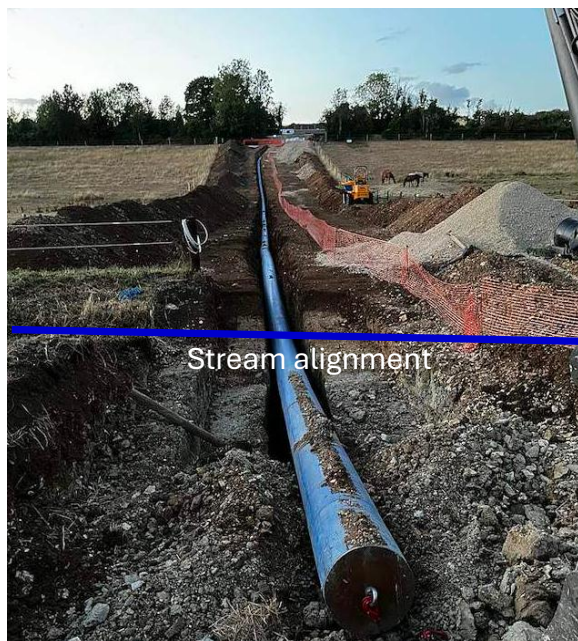
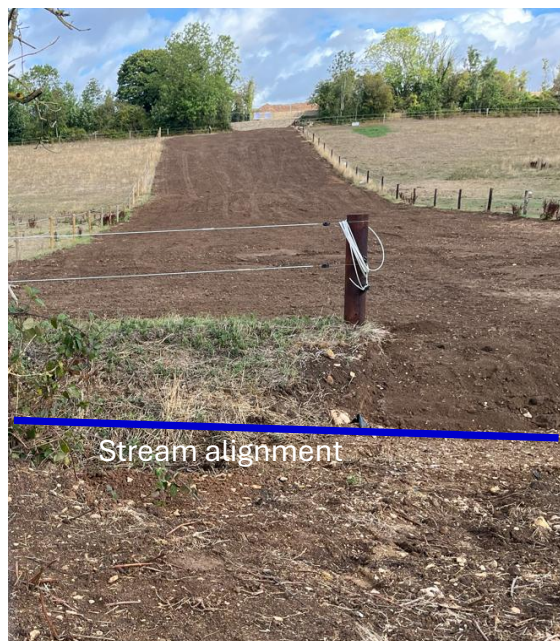
During July, it was identified that a new water pipeline is being constructed by Thames Water from their Gloucester Road reservoir into northern Cirencester, with its route crossing the Daglingworth Stream near Daglingworth Place. Photographic monitoring during construction of this crossing has been carried out, recording that the works in this area are now largely completed with the Daglingworth Stream having been reinstated. Monitoring will continue to record how the reinstated stream and floodplain respond as flow recommences during recovery from this year's drought. The photograph on the left below shows the pipeline during construction and, on the right, following completion on 30<sup>th</sup> August, with the topsoil reinstated over the pipeline route in this area. Both photographs are looking North across the Daglingworth Stream, with its approximate alignment shown by the blue line.

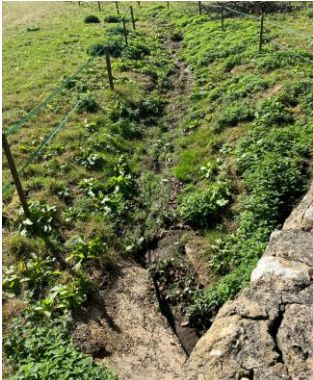
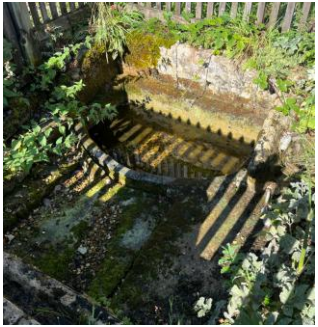
| <p>1a. Daglingworth Stream upper source north of Duntisbourne Abbots.</p> <p>The stream bed is dry on both sides of the road, with indication of recent flow – probably from road drains.</p> | | <p>1b. Duntisbourne Abbots village spring.</p> <p>There is some clear water present in the spring but no visible flow from the spring.</p> | |

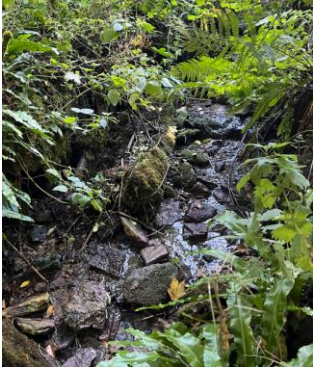
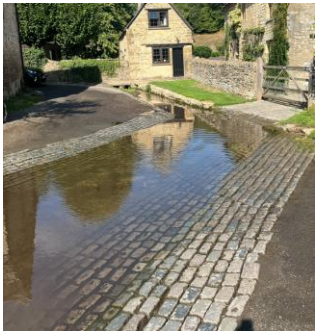
| <p>2. Duntisbourne Abbots, Daglingworth Stream downstream of inferred confluence of spring sources.</p> <p>There is a very low flow of clear water from the spring and in the channel.</p> | | <p>3. Duntisbourne Leer ford, Daglingworth Stream.</p> <p>There is a low flow across the ford that extends to ~9 cobbles on northeast side.</p> | |

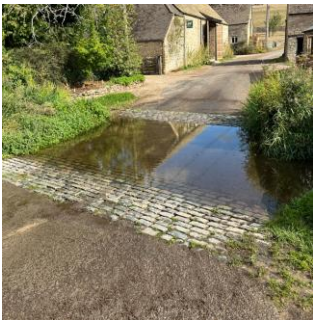
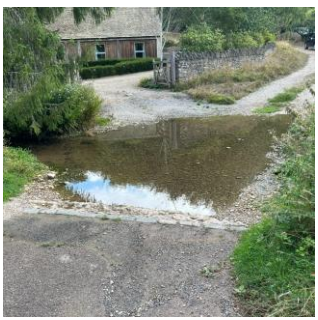
| <p>4. Middle Duntisbourne ford, Daglingworth Stream.</p> <p>A low flow is observed that extends to 9 bricks of the cobbled area of the south-west channel edge.</p> | | <p>5. Duntisbourne Rouse ford, Daglingworth Stream.</p> <p>There is a low flow across the ford, which is well inside the SW boundary cobbles.</p> | |

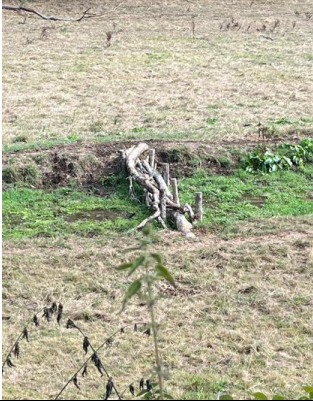
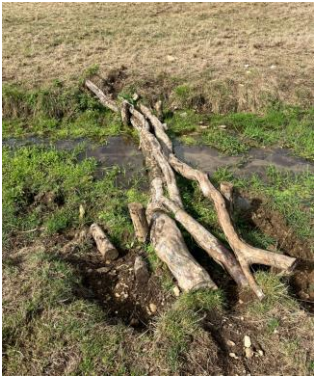
| <p>6a. Daglingworth Stream – Leaky Dam #1, upstream of Grove Hill Lane.</p> <p>The dam is in good condition. There is a low flow in the stream. There are signs of cattle grazing the field.</p> | | <p>6b. Daglingworth Stream Leaky Dam #2, upstream of Grove Hill Lane.</p> <p>The dam is in good condition. There is a low flow in the stream. Cattle grazing in the field have disturbed the stream banks.</p> | |

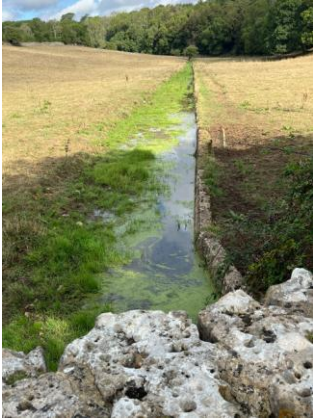
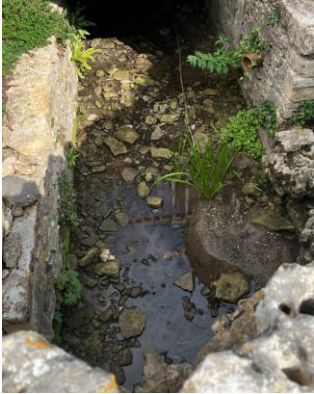
| <p>6c. Daglingworth Stream Grove Hill bridge.</p> <p>A low flow is observed that fills a section of the channel in the field upstream of the Grove Hill bridge.</p> | | <p>7. Daglingworth Stream, Church Road</p> <p>The stream has a very low flow in the culvert.</p> | |

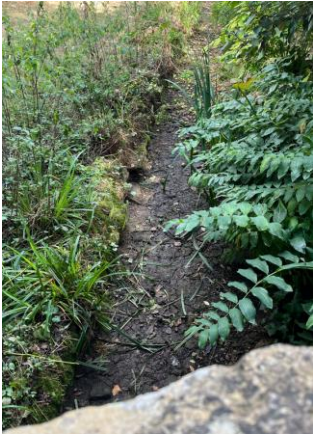
| <p>8. Daglingworth Stream at Lower End road bridge.</p> <p>There is no flow, and the stream bed has damp cracked mud.</p> | | <p>9a. Wellhill Copse, Daglingworth Stream in equestrian fields.</p> | <p>No Picture</p> |

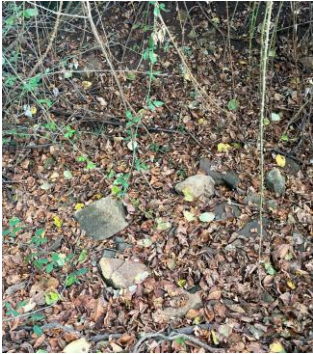
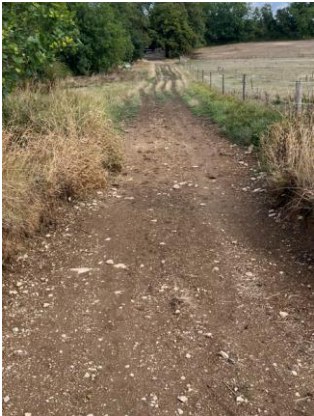
| <p>9b. Wellhill Copse, Daglingworth Stream near path stile.</p> <p>The stream bed is dry.</p> | | <p>10. Daglingworth Place ford, Daglingworth Stream.</p> <p>The stream bed through the ford is very dry and dusty.</p> | |

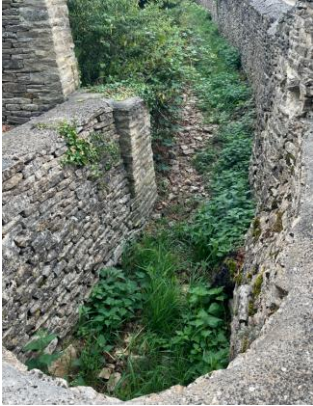
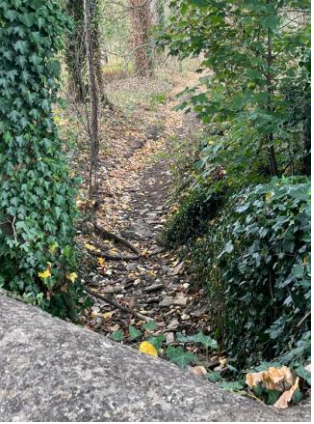
| <p>11. Grange Farm bridge, Daglingworth Stream.</p> <p>The stream channel is dry. There is vegetation present.</p> | | <p>12. School Hill bridge, Daglingworth Stream.</p> <p>The stream channel is dry.</p> | |

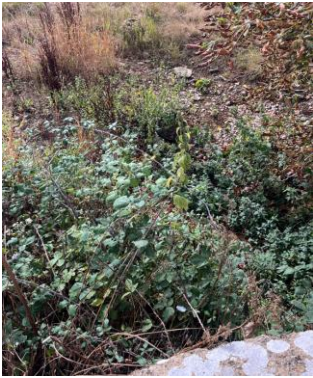
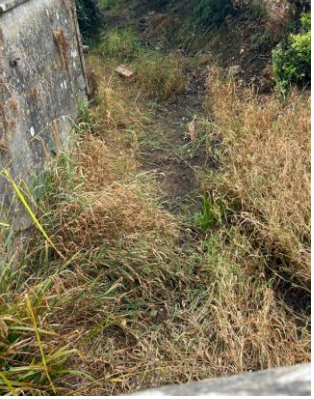
| <p>13. Stratton End (private road), Daglingworth Stream.</p> <p>The stream is dry upstream and downstream of the road bridge. There is significant vegetation present in the stream bed.</p> | | <p>14. Barn Way bridge, Daglingworth Stream.</p> <p>The stream channel is dry, but with signs of recent flow (probably from surface water run off)</p> | |

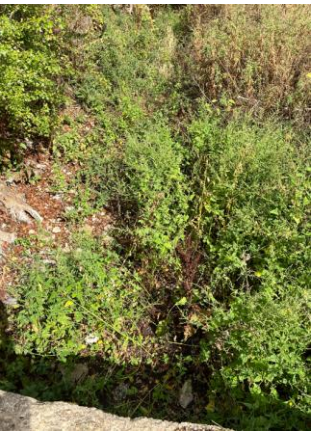
| <p>15. Daglingworth Stream, Plough Inn channel</p> <p>The channel is dry, and there is some vegetation present.</p> | | <p>16. Footpath at Lower Stratton.</p> <p>The stream bed is dry. There is lots of vegetation present.</p> | |

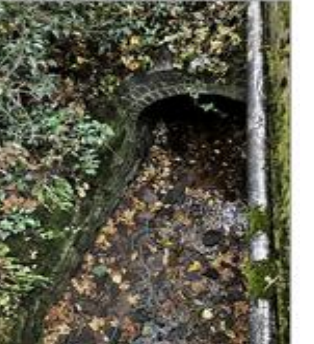
| | | <p>17a. Daglingworth stream downstream of Bathurst estate boundary wall</p> <p>Dry in places, no flow</p> | |

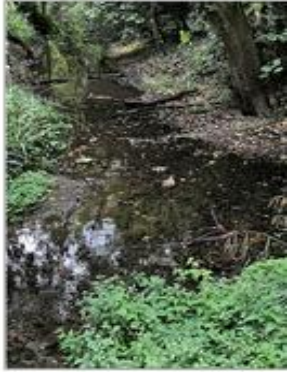
| <p>17b. Daglingworth stream downstream of Bathurst Estate boundary wall</p> <p>Dry in places, very low flow</p> | | <p>18. Gumstool Brook Balancing Stream</p> <p>The stream is dry apart from a small puddle by entrance from sluice.</p> | |

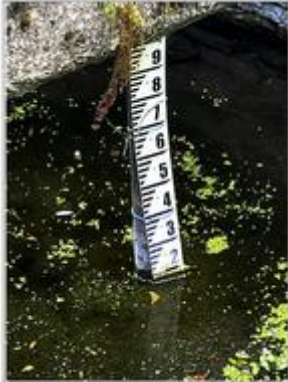
| <p>19. Gumstool Brook - gauge alongside swimming pool</p> <p>Reading just below 0.2m</p> | | <p>20. Gumstool Brook - alongside riverside walk</p> <p>Very low flow, great deal of vegetation and duck weed</p> | |

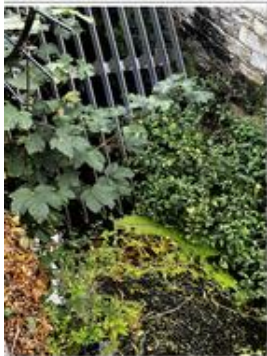
| <p>21. Gumstool brook at culvert trash screen</p> <p>Very low flow and a lot of vegetation</p> | | <p>22a. Balancing stream at Powell's school - at trash screen</p> | <p>No Picture</p> |

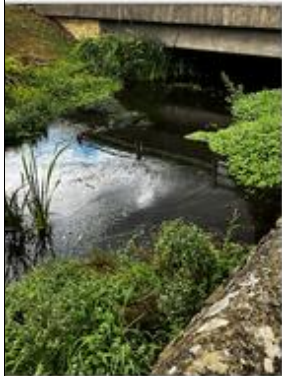
| <p>23. Balancing stream at Powell's school towards Salvation Army building</p> | <p>No Picture</p> | <p>25a. River Churn at Gloucester St. bridge upstream of sluices</p> <p>Low flow, lots of weed present</p> | |

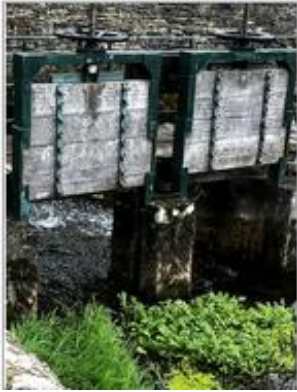
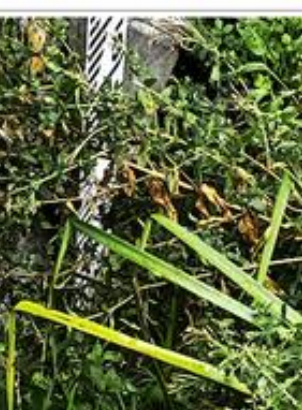
| <p>25b. Glos St bridge sluices</p> <p>Flow passing through both sluices.</p> | | <p>25c. River Churn at Glos St bridge measuring gauge</p> <p>Water level is below gauge but obscured by weeds</p> | |

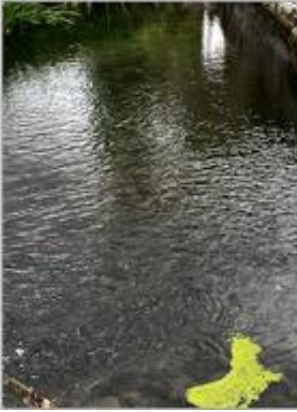
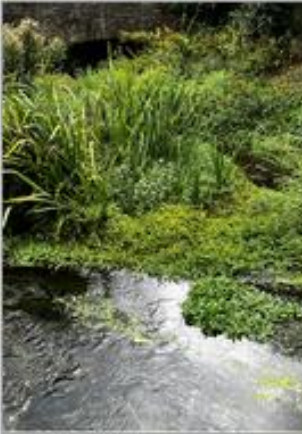
| <p>25d. River churn downstream of Glos St sluices</p> <p>Low flow</p> | | <p>25e. Glos St bridge towards Mill Pound</p> <p>Lots of vegetation present at entrance to the Barton Mill Pound.</p> | |

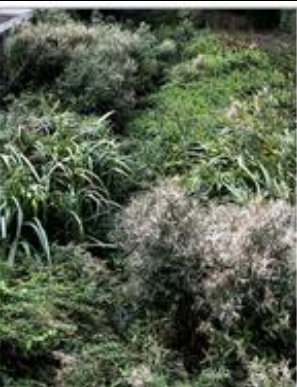
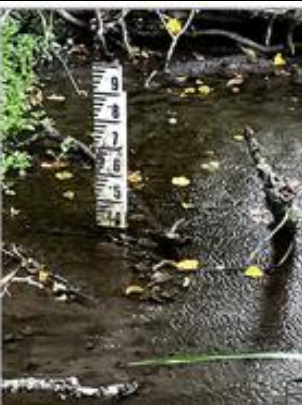
| <p>26. Barton Mill Pound downstream from Glos St bridge</p> <p>Stream has low flow and lots of vegetation present.</p> | | <p>27a. Gauge in Mill Pound</p> <p>Gauge showing below 0.4m</p> | |

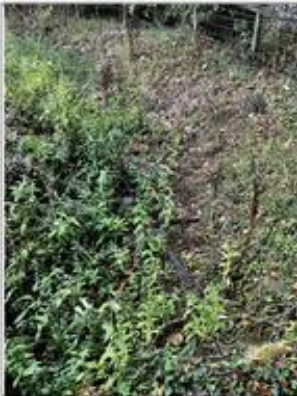
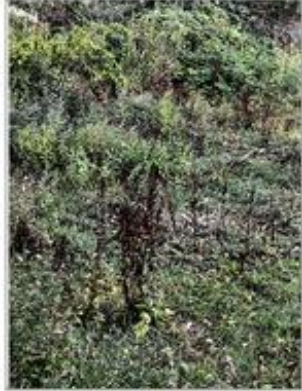
| <p>27b. Mill Pound overflow (new)</p> <p>Completely dry</p> | | <p>28. Mill Pound overflow (old)</p> <p>No visible water</p> | |

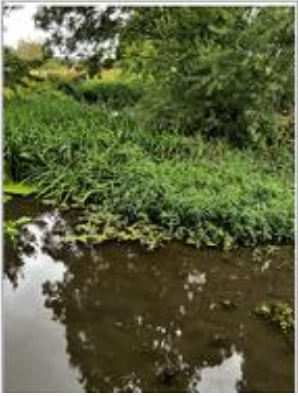
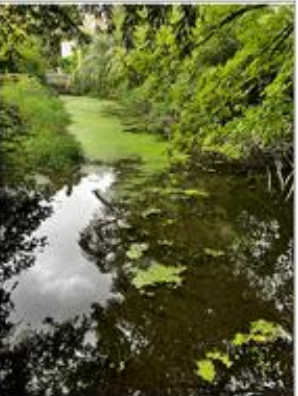
| <p>29a. Mill Pound<br/>upstream of footbridge</p> <p>Very shallow and a lot of<br/>vegetation present.</p> | | <p>29b. Mill Pound<br/>downstream of<br/>footbridge</p> <p>Very low flow, much<br/>weed and duck weed</p> | |

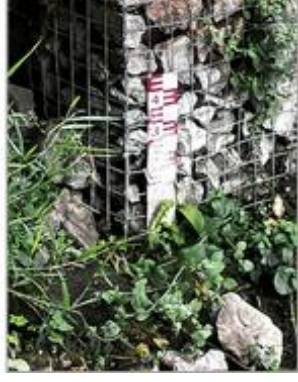
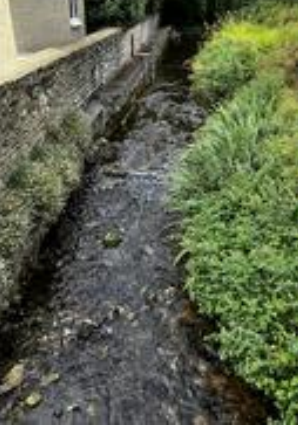
| <p>29c. Gauge by<br/>footbridge in Mill Pound</p> <p>High and dry! Numbers<br/>not very visible,<br/>potentially sun bleached</p> | | <p>31. River Churn<br/>upstream side of<br/>Gooseacre lane</p> <p>Low flow</p> | |

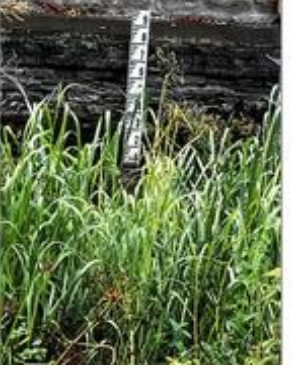
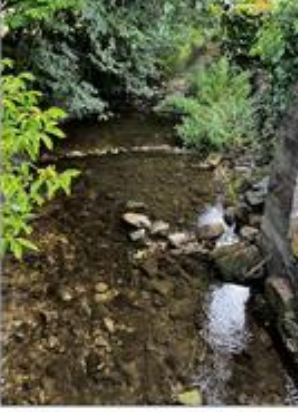
| <p>32a. River Churn gauge<br/>upstream side of<br/>Gooseacre lane</p> <p>Gauge showing 0.09m</p> | | <p>32b. River Churn<br/>downstream side of<br/>Gooseacre lane</p> <p>Low flow, small weir<br/>now visible</p> | |

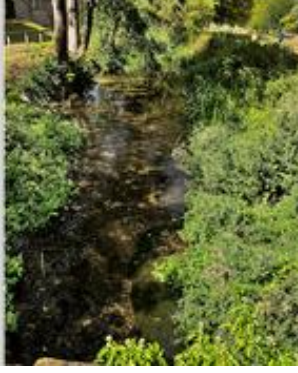
| <p>33a. River Churn<br/>upstream of Spitalgate<br/>Lane bridge</p> <p>Low flow</p> | | <p>33b. River Churn<br/>looking downstream<br/>towards Spitalgate<br/>lane bridge</p> <p>Much vegetation, low<br/>flow</p> | |

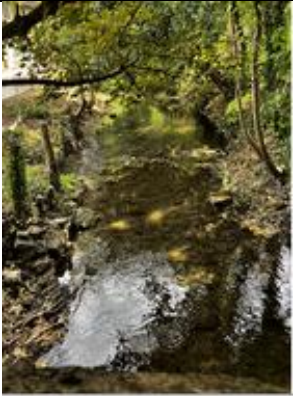
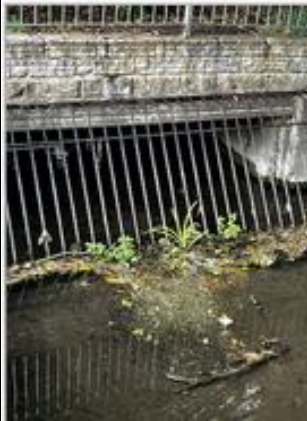
| <p>33c. River Churn downstream of Spitalgate Lane bridge</p> <p>Low flow</p> | | <p>34a. Hereward Rd trash screen</p> <p>Low water level, some trash</p> | |

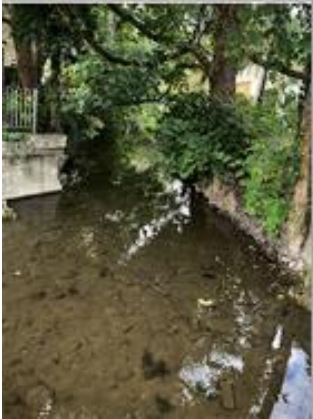
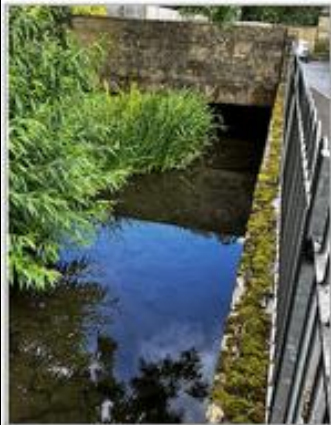
| <p>34b. River Churn upstream of Hereward Rd. trash screen</p> | | <p>34c. River Churn - bridge downstream of Hereward Rd. Trash screen</p> | |

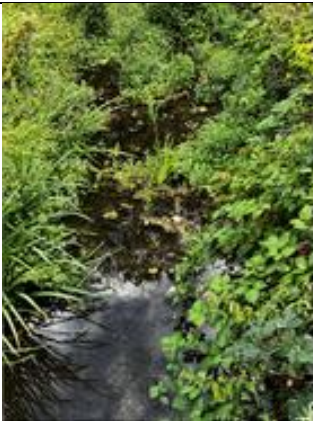
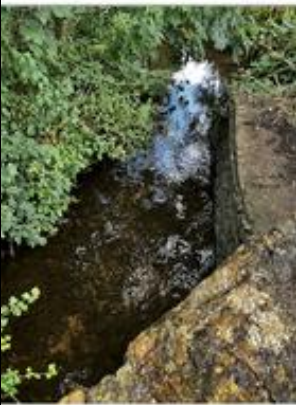
| <p>34d. River Churn on other side of Hereward Road bridge</p> <p>Low water level, low flow</p> | | <p>35. Stream flowing into Abbey Grounds &amp; lake</p> <p>Low flow</p> | |

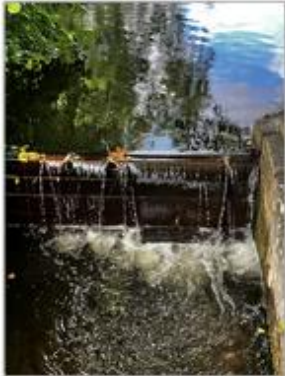
| <p>36a. Weir at stream outlet from Abbey lake</p> <p>Low flow but surface algae not now in evidence</p> | | <p>36b. Footbridge at stream outlet from Abbey Lake</p> <p>Low flow</p> | |

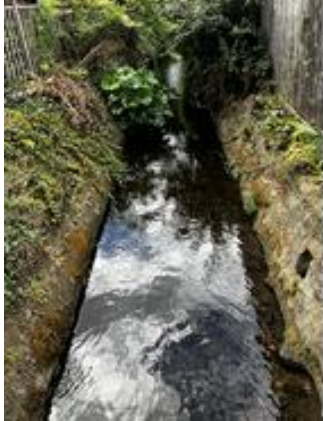
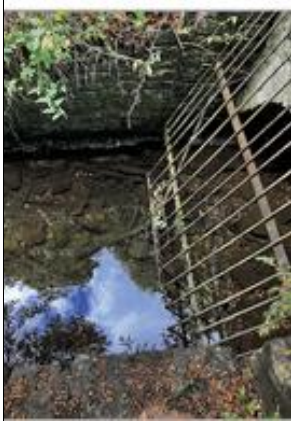
| <p>37. Abbey lake outlet stream at Corinium Gate bridge</p> <p>Low flow</p> | | <p>38a. Gumstool culvert outlet in Abbey Grounds</p> <p>Almost static water, but very low flow visible further downstream</p> | |

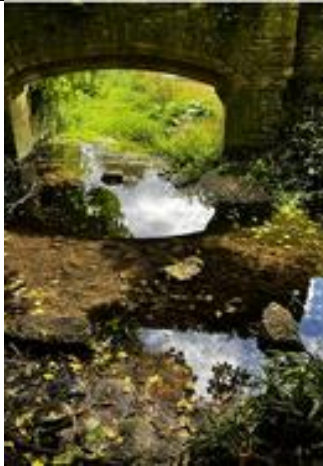
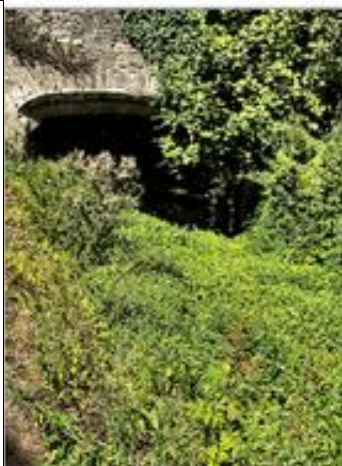
| <p>38. Gumstool Brook in Abbey Ground towards Waterloo</p> <p>Dry areas, with pools of water</p> | | <p>39a. Gumstool Brook alongside Waterloo flats looking upstream</p> <p>No stream visible, much vegetation</p> | |

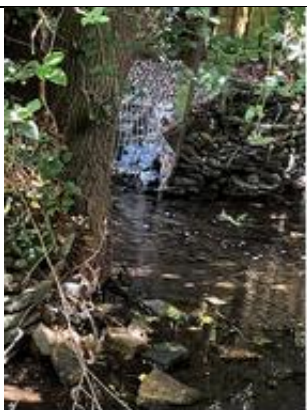
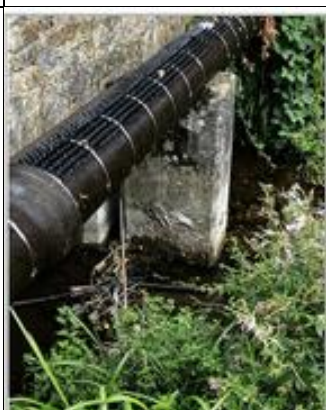
| <p>39b. Gumstool Brook confluence with Abbey lake outlet (Waterloo carpark)</p> <p>Very low flow</p> | | <p>40a. River Churn East on downstream side of London Rd bridge</p> <p>Stream only just visible, much vegetation</p> | |

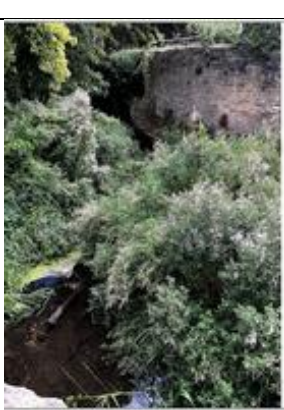
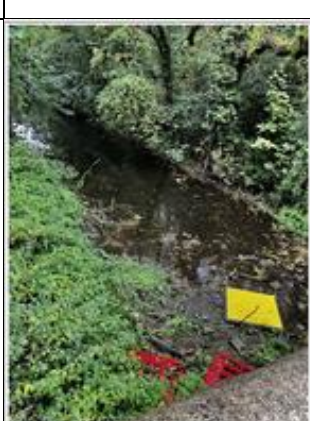
| <p>40b. River Churn on downstream side of London Rd bridge</p> <p>Low level, much vegetation</p> | | <p>41a. River Churn upstream of old Beeches road bridge</p> <p>Very dry in places, pools of water, no obvious flow</p> | |

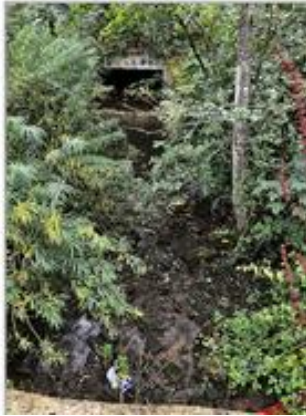
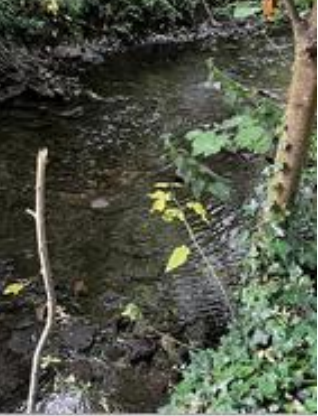
| <p>41b. River Churn downstream of old Beeches road bridge</p> <p>Dry areas with no obvious flow</p> | | <p>44. Weir at City Bank glade</p> <p>Weir not really visible, slow flow</p> | |

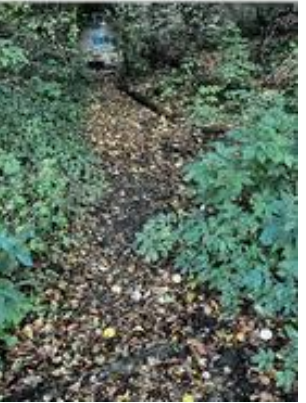
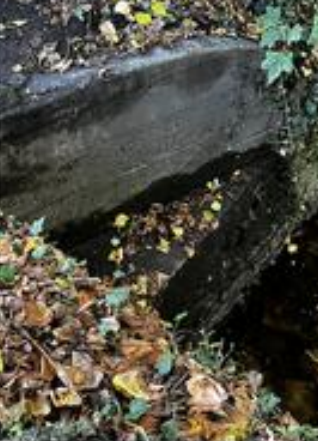
| <p>43a. River Churn – Furness hole</p> <p>Totally dry</p> | | <p>43b. River Churn - new Mills overflow</p> <p>No flow from overflow</p> | |

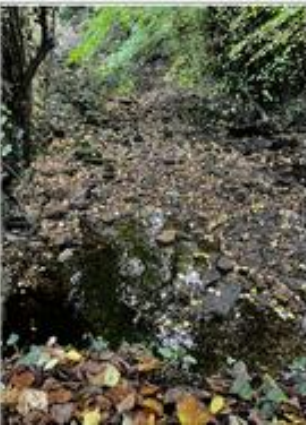
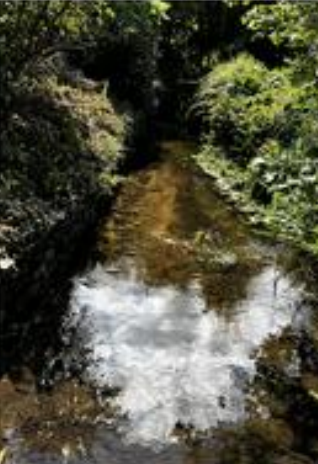
| <p>43c. River Churn - New Mills downstream</p> <p>Mostly dry river bed with ponded water immediately downstream of the sluices</p> | | <p>45. River Churn at City Bank park footbridge</p> <p>Low flow, vegetation</p> | |

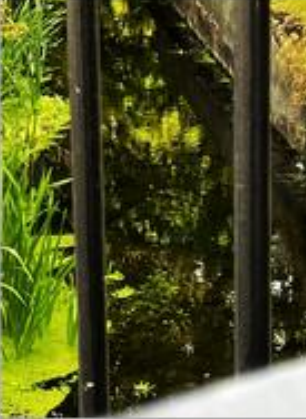
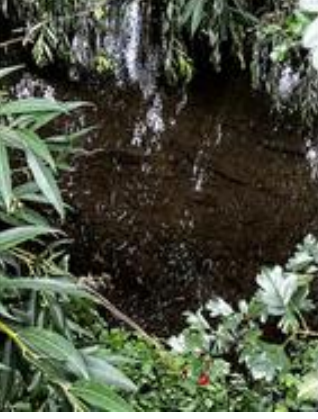
| <p>46. River Churn at Watermoor Point car park</p> <p>Low flow, duckweed and other vegetation</p> | | <p>47. River Churn at Cricklade road opposite Aldi</p> <p>River is not really visible, much vegetation</p> | |

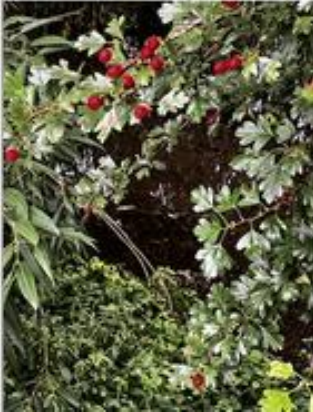
| <p>48. River Churn at Cricklade road opposite Tesco</p> <p>Not much visibility of river owing to extensive vegetation</p> | | | |
