# Citizen River

## Monitoring Report

### September 2026

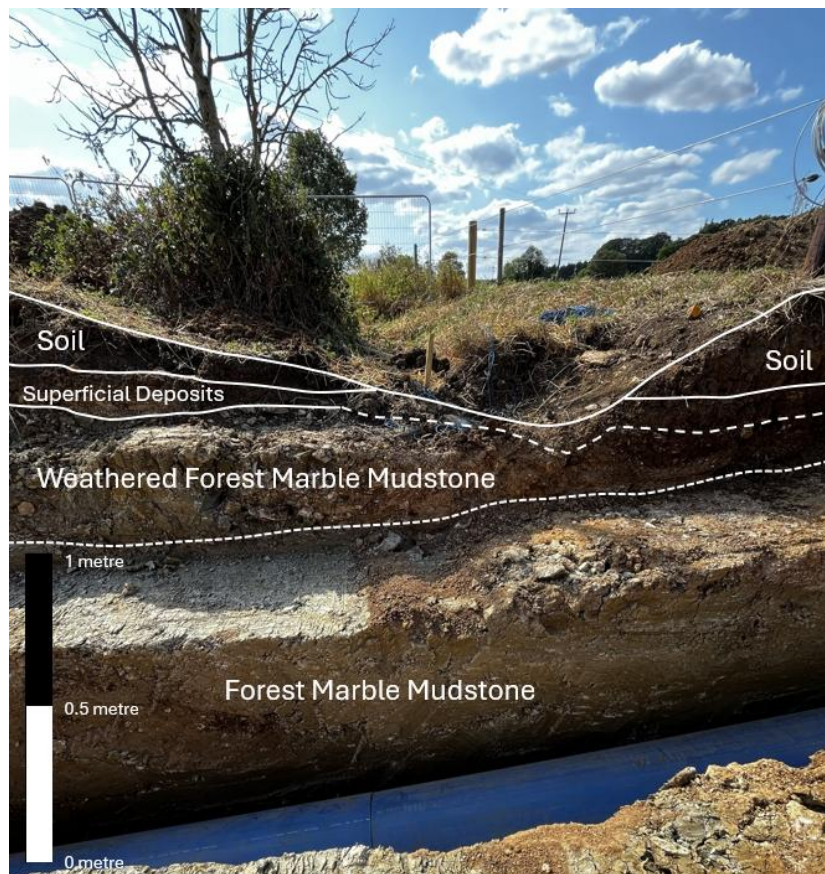
During July, a new water pipeline was being constructed by Thames Water from their Gloucester Road reservoir into northern Cirencester, with its route crossing the Daglingworth Stream near Daglingworth Place. Photographic monitoring during construction of the stream crossing enabled the geology in the pipeline trench to be inferred, as shown in the photograph below.

The geology inferred beneath the stream in this location shows that the bedrock comprises of Forest Marble Mudstone, overlain by very thin gravels, that also contain sand and possibly clay, with a thin soil on the stream channel edges. Although the top of the Forest Marble Mudstone is weathered and will have higher permeability, the underlying mudstone will have a lower permeability. As result, in this particular reach of the Daglingworth Stream, the lower permeability mudstone will prevent any significant interaction between groundwater in the deeper limestone aquifer and the stream. Owing to the geological variations along the Daglingworth Stream the limestone aquifer does underlie the stream further upstream and downstream, which means that when groundwater levels in the aquifer are high enough, groundwater can interact with the stream flow.

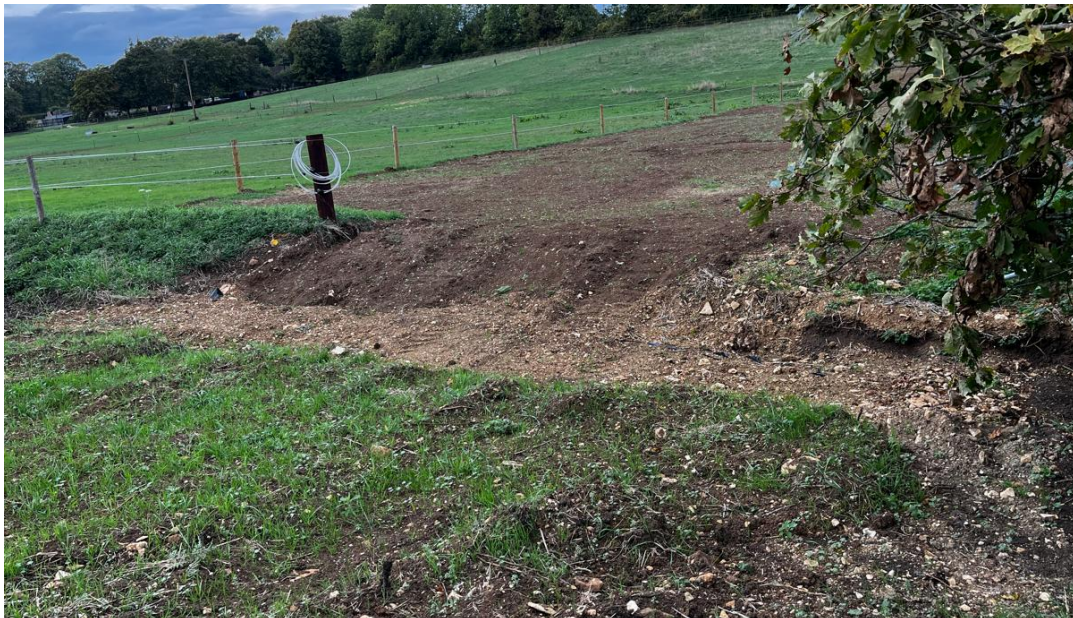
Photographic monitoring of the pipeline crossing has continued throughout the construction works and will continue to record how the reinstated stream and floodplain respond as groundwater levels rise and stream flow recommences. The photograph below shows the dry stream bed adjacent to Daglingworth Place on 29<sup>th</sup> September. It is noticeable in the photograph that the stream bed has a lighter coloured material compared with the local topsoil. This could well reflect the original soil and sediment characteristics because the planned construction method was to remove the stream bed material, keeping it as intact as possible and placing it back in the same sequence.

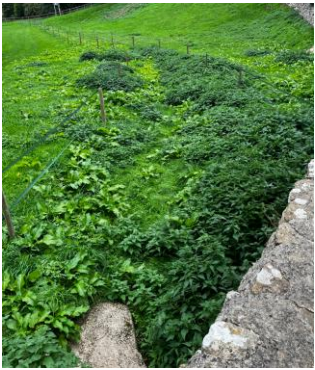
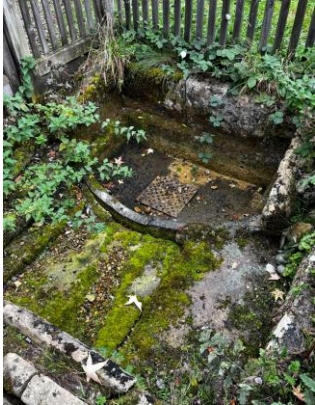
| <p>1a. Daglingworth Stream upper source north of Duntisbourne Abbots.</p> <p>The stream bed is dry on both sides of the road. There is extensive vegetation present.</p> | | <p>1b. Duntisbourne Abbots village spring.</p> <p>The spring is dry.</p> | |

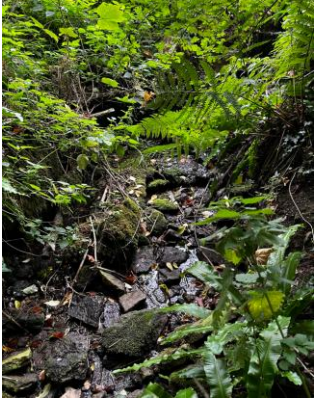
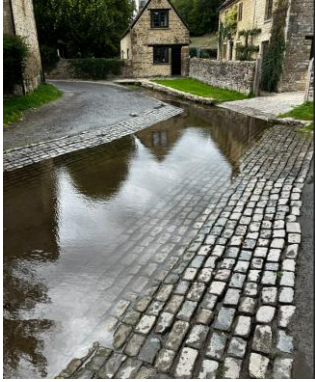
| <p>2. Duntisbourne Abbots, Daglingworth Stream downstream of inferred confluence of spring sources.</p> <p>There is a very low flow of clear water from the spring and in the channel.</p> | | <p>3. Duntisbourne Leer ford, Daglingworth Stream.</p> <p>There is a very low flow across the ford that extends to ~9 cobbles on northeast side.</p> | |

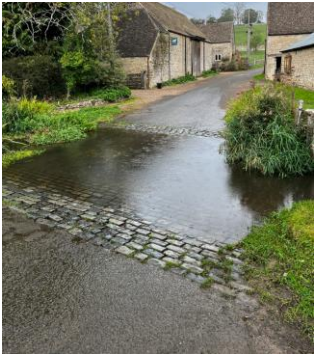
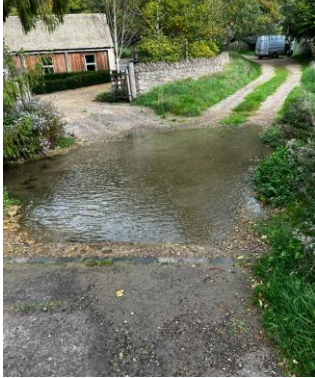
| <p>4. Middle Duntisbourne ford, Daglingworth Stream.</p> <p>A low flow is observed that extends to 7 bricks of the cobbled area of the south-west channel edge.</p> | | <p>5. Duntisbourne Rouse ford, Daglingworth Stream.</p> <p>There is a low flow across the ford, which is well inside the SW boundary cobbles.</p> | |

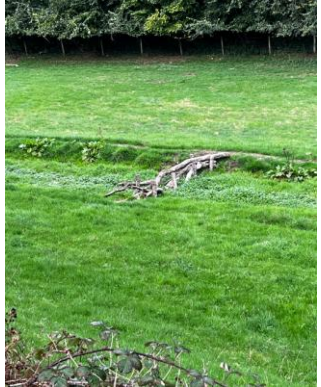
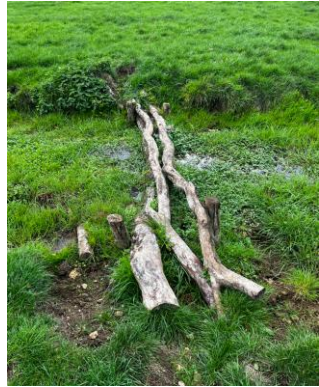
| <p>6a. Daglingworth Stream – Leaky Dam #1, upstream of Grove Hill Lane.</p> <p>The dam is in good condition. There is a low flow in the stream.</p> | | <p>6b. Daglingworth Stream Leaky Dam #2, upstream of Grove Hill Lane.</p> <p>The dam is in good condition. There is a low flow in the stream.</p> | |

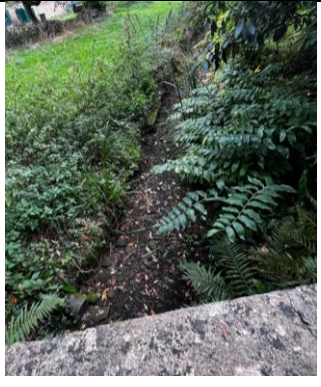
| <p>8. Daglingworth Stream at Lower End road bridge.</p> <p>There is no flow, and the stream bed is dry.</p> | | <p>9a. Wellhill Copse, Daglingworth Stream in equestrian fields.</p> | <p>No Picture</p> |

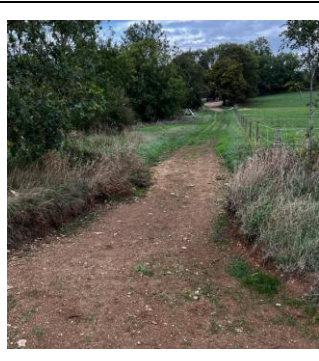
| <p>9b. Wellhill Copse, Daglingworth Stream near path stile.</p> | <p>No Picture</p> | <p>10. Daglingworth Place ford, Daglingworth Stream.</p> <p>The stream bed through the ford is very dry and dusty.</p> | |

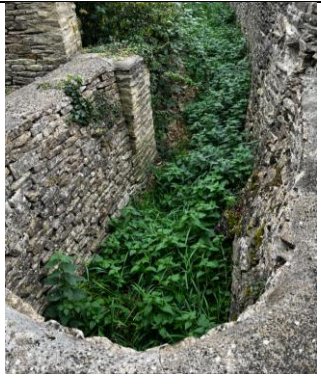
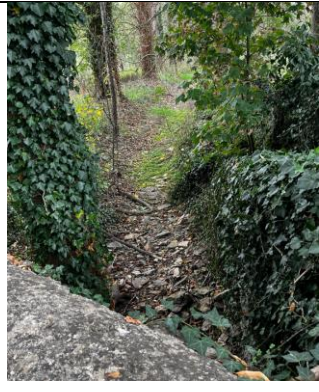
| <p>11. Grange Farm bridge, Daglingworth Stream.</p> <p>The stream channel is dry. There is a lot of vegetation present.</p> | | <p>12. School Hill bridge, Daglingworth Stream.</p> <p>The stream channel is dry.</p> | |

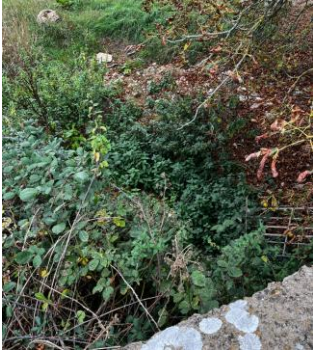
| <p>13. Stratton End (private road), Daglingworth Stream.</p> <p>The stream is dry upstream and downstream of the road bridge. There is significant vegetation in the stream bed.</p> | | <p>14. Barn Way bridge, Daglingworth Stream.</p> <p>The stream channel is dry with some vegetation present.</p> | |

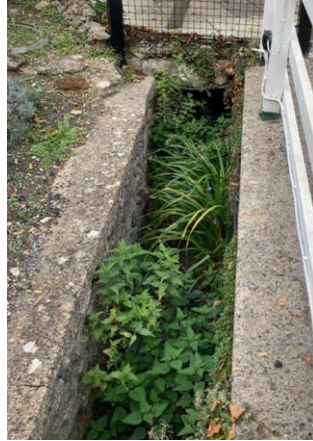
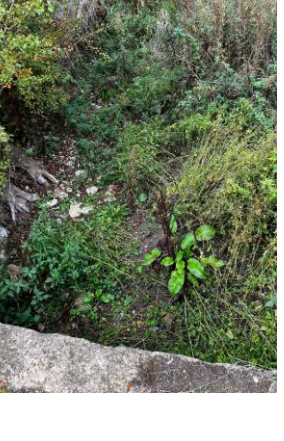
| <p>15. Daglingworth Stream, Plough Inn channel</p> <p>The channel is dry, and there is some vegetation present.</p> | | <p>16. Footpath at Lower Stratton.</p> <p>The stream bed is dry. There is lots of vegetation present.</p> | |

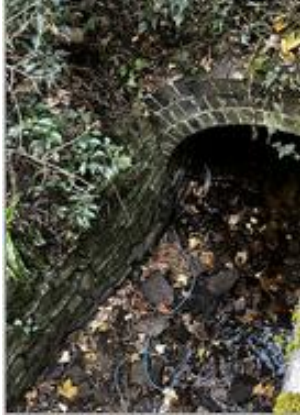
| <p>17a. Daglingworth Stream downstream of Bathurst estate boundary wall</p> <p>Dry in places, no flow</p> | | <p>17b. Daglingworth Stream downstream of Bathurst Estate boundary wall</p> <p>Dry in places, very low flow</p> | |

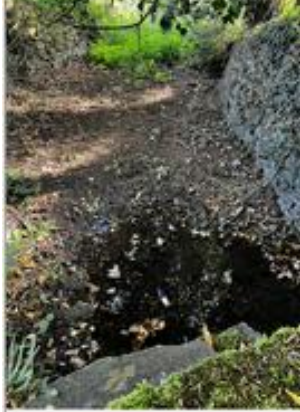
| <p>18. Gumstool Brook Balancing Stream</p> <p>The stream is dry apart from a small puddle by entrance from sluice.</p> | | <p>19. Gumstool Brook - gauge alongside swimming pool</p> <p>Reading just below 0.2m, lot of duckweed</p> | |

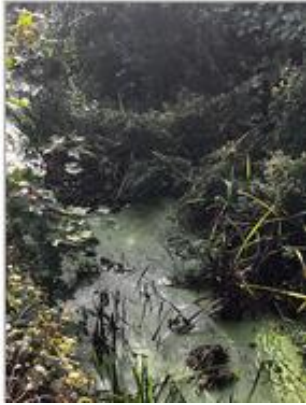
| <p>20. Gumstool Brook - alongside riverside walk</p> <p>Very low flow, great deal of vegetation and duckweed</p> | | <p>21. Gumstool brook at culvert trash screen</p> <p>Very low flow and a lot of vegetation</p> | |

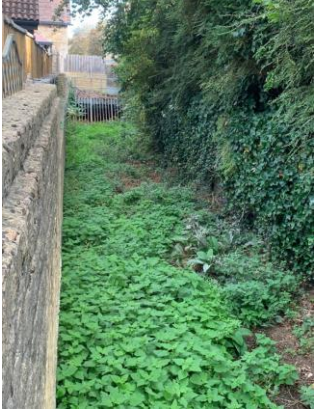
| <p>22a. Balancing stream at Powell's School - at trash screen</p> <p>Dry stream, almost completely covered by vegetation</p> | | <p>23. Balancing stream at Powell's school towards Salvation Army building</p> <p>Dry stream, completely covered by vegetation</p> | |

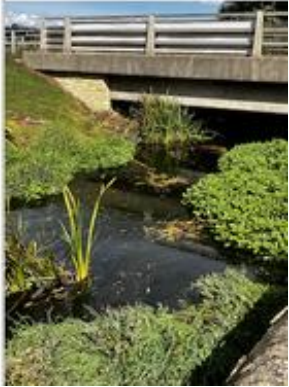
| <p>24. River Churn and Stratton Meadow at Bomford Cottage</p> <p>Low flow in Churn; Stratton Meadows dry</p> | | <p>25a. River Churn at Gloucester St. bridge upstream of sluices</p> <p>Low flow, lots of weed present</p> | |

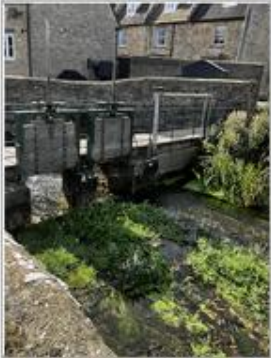
| <p>25b. Glos St bridge sluices</p> <p>Most flow entering into both sluices. Lots of gravel and vegetation present above sluices.</p> | | <p>25c. River Churn at Glos St bridge measuring gauge</p> <p>Water level just below 0.1m</p> | |

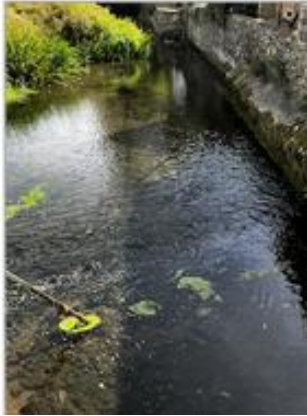
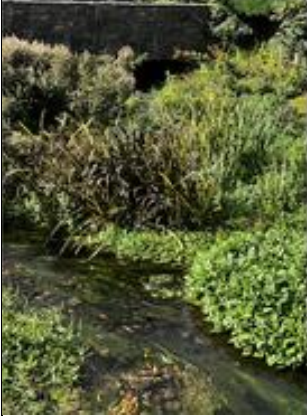
| <p>25d. River Churn downstream of Glos St sluices</p> <p>Low flow</p> | | <p>25e. Glos St bridge towards Mill Pound</p> <p>Lots of vegetation present at entrance to the Barton Mill Pound.</p> | |

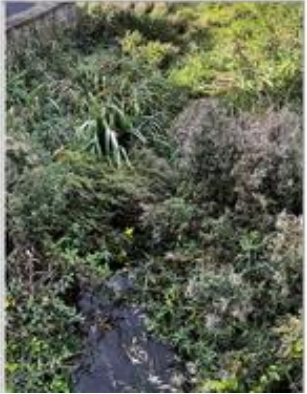
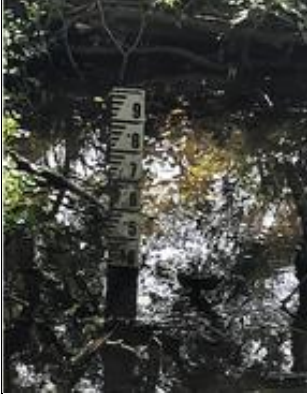
| <p>26. Barton Mill Pound downstream from Glos St bridge</p> <p>Stream has low flow and lots of vegetation present.</p> | | <p>27a. Gauge in Mill Pound</p> <p>Guage showing just below 0.4m</p> | |

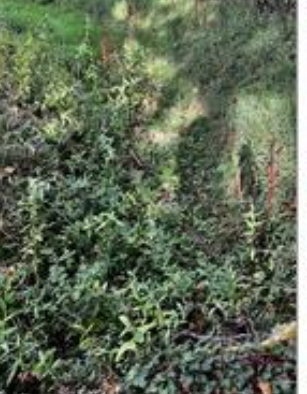
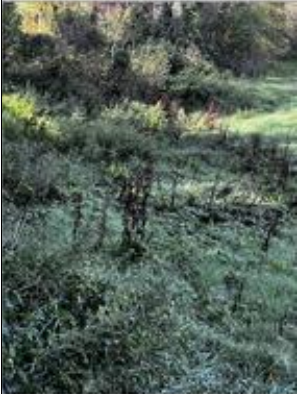
| <p>27b. Mill Pound overflow (new)</p> <p>Completely dry</p> | | <p>28. Mill Pound overflow (old)</p> <p>No visible water</p> | |

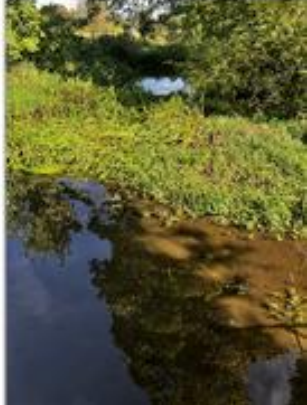
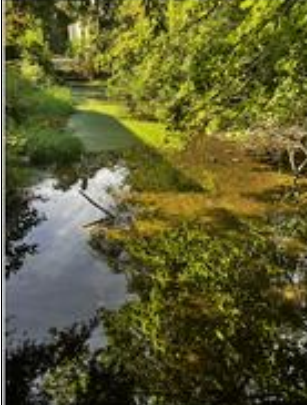
| <p>29a. Mill Pound upstream of footbridge</p> <p>Very shallow and a lot of vegetation present.</p> | | <p>29b. Mill Pound downstream of footbridge</p> <p>Very low flow, much weed and duck weed</p> | |

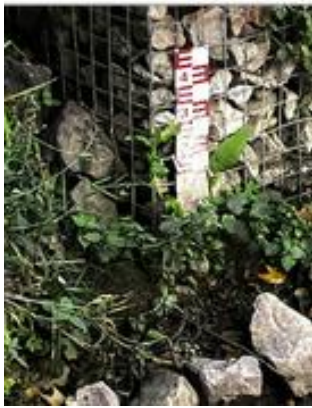
| <p>29c. Gauge by footbridge in Mill Pound</p> <p>High and dry!<br/>Numbers not very visible (sun bleached?)</p> | | <p>31. River Churn upstream side of Gooseacre Lane</p> <p>Low level and flow</p> | |

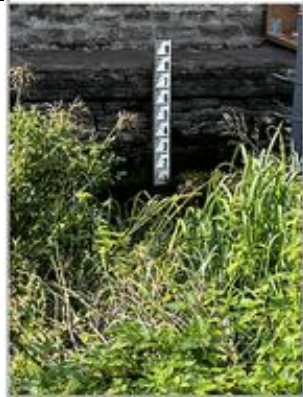
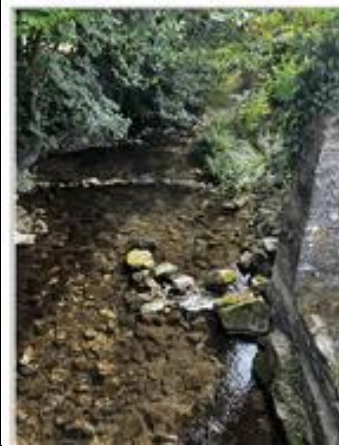
| <p>32a. River Churn gauge upstream side of Gooseacre lane</p> <p>Gauge showing 0.09m</p> | | <p>32b. River Churn downstream side of Gooseacre lane</p> <p>Low flow, small weir now visible</p> | |

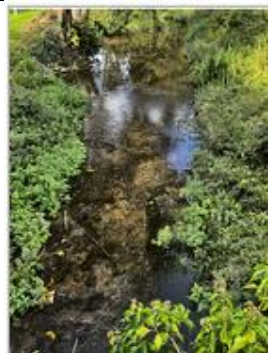
| <p>33a. River Churn upstream of Spitalgate Lane bridge</p> <p>Low flow</p> | | <p>33b. River Churn looking downstream towards Spitalgate Lane bridge</p> <p>Much vegetation masking water, low flow</p> | |

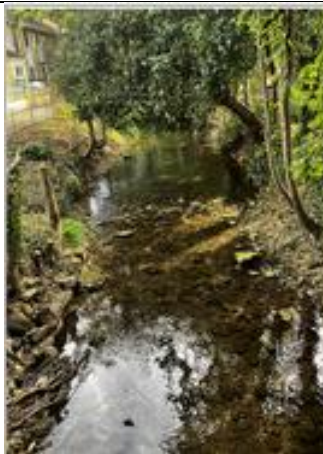
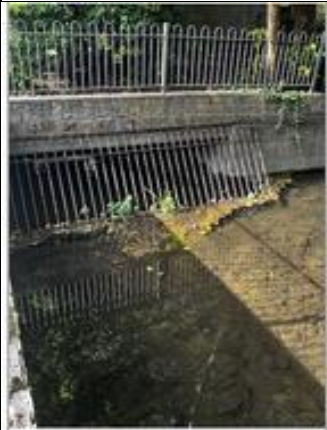
| <p>33c. River Churn downstream of Spitalgate Lane bridge</p> <p>Low flow</p> | | <p>34a. Hereward Rd trash screen</p> <p>Low water level, some trash</p> | |

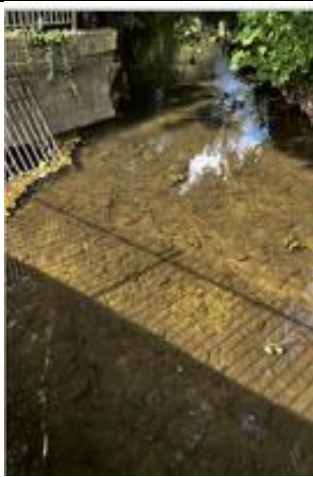
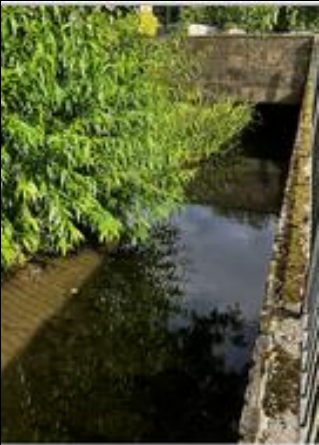
| <p>34b. River Churn upstream of Hereward Road trash screen, low level and flow</p> | | <p>34c. River Churn - bridge downstream of Hereward Road Trash screen</p> | |

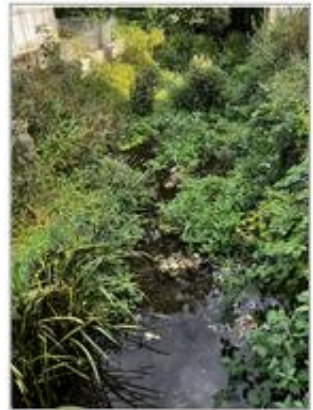
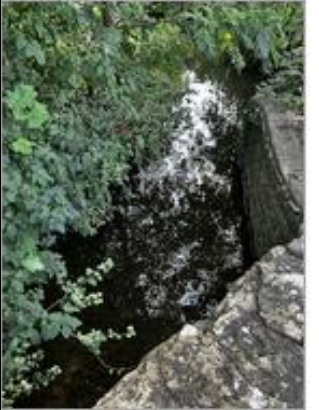
| <p>34d. River Churn on other side of Hereward Road bridge</p> <p>Low water level, low flow</p> | | <p>35. Stream flowing into Abbey Grounds &amp; lake</p> <p>Low flow</p> | |

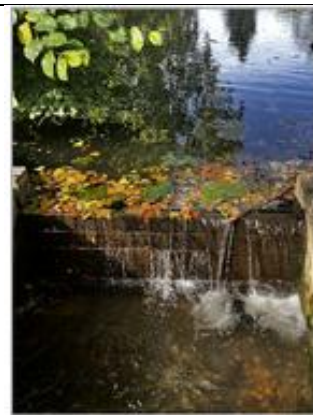
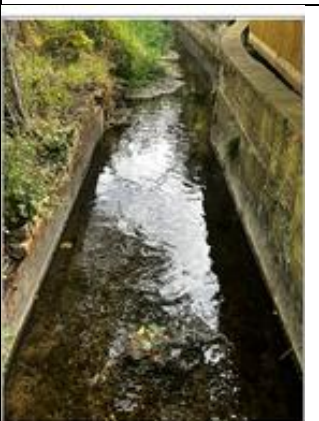
| <p>36a. Weir at stream outlet from Abbey Lake</p> <p>Low flow, surface algae again in evidence and leaves</p> | | <p>36b. Footbridge at stream outlet from Abbey Lake</p> <p>Low flow</p> | |

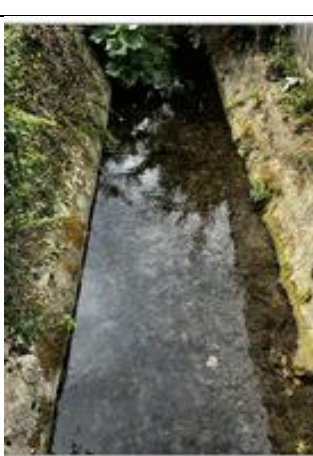
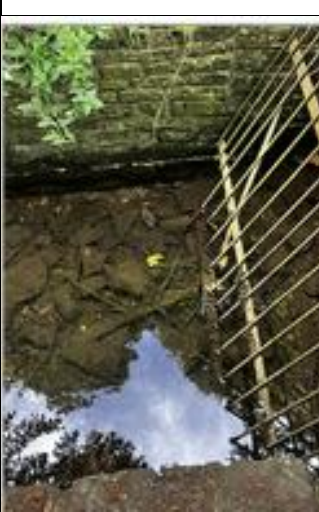
| <p>37. Abbey Lake outlet stream at Corinium Gate bridge</p> <p>Low flow</p> | | <p>38a. Gumstool culvert outlet in Abbey Grounds</p> <p>No flow, static water, (very low flow visible further downstream)</p> | |

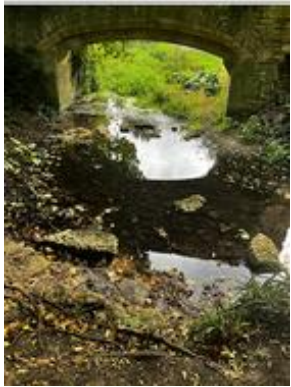
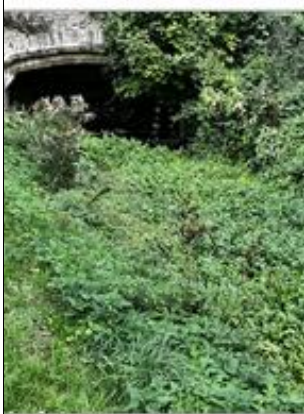
| <p>38. Gumstool Brook in Abbey Ground towards Waterloo</p> <p>Dry areas, with pools of water and no obvious flow</p> | | <p>39a. Gumstool Brook alongside Waterloo flats looking upstream</p> <p>No stream visible, much vegetation</p> | |

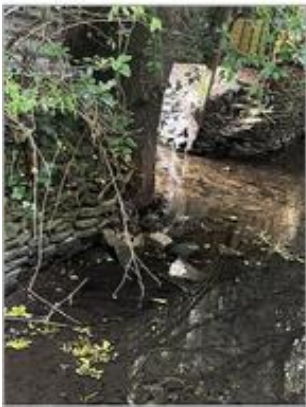
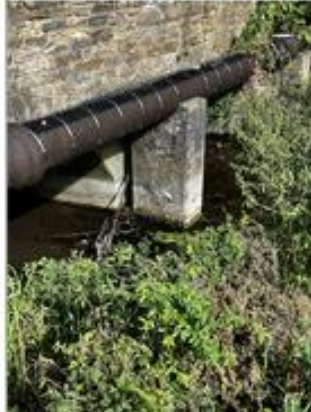
| <p>39b. Gumstool Brook confluence with Abbey Lake outlet (Waterloo car park)</p> <p>Very low flow</p> | | <p>40a. River Churn East on downstream side of London Rd bridge</p> <p>Stream only just visible, much vegetation</p> | |

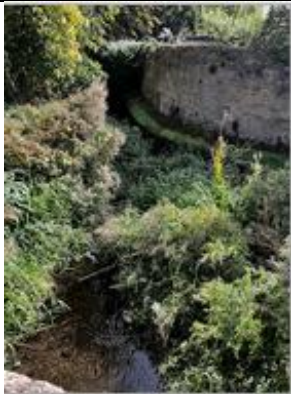
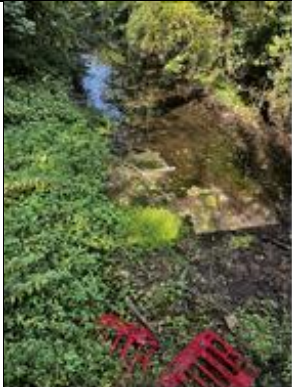
| <p>40b. River Churn on downstream side of London Rd bridge</p> <p>Low level, much vegetation</p> | | <p>41a. River Churn upstream of old Beeches Road bridge</p> <p>Very dry in places, pools of water, no obvious flow, rubbish visible</p> | |

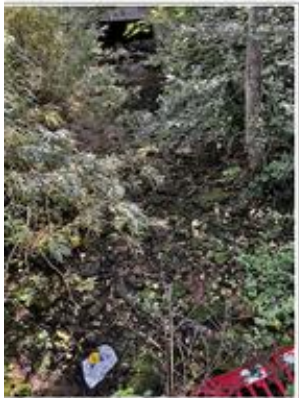
| <p>41b. River Churn downstream of old Beeches Road bridge</p> <p>Dry areas with no obvious flow, rubbish visible</p> | | <p>44. Weir at City Bank glade</p> <p>Weir not really visible, slow flow</p> | |

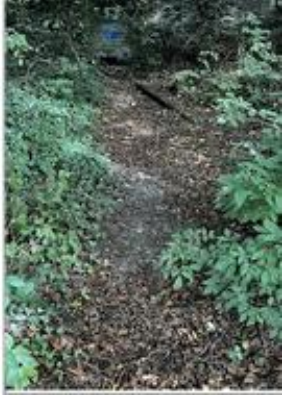
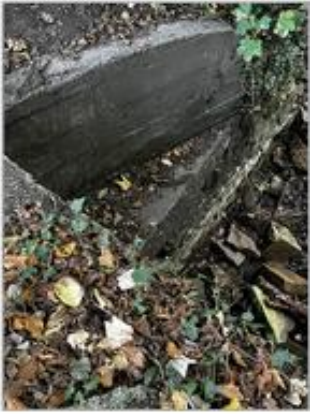
| <p>43a. River Churn – Furness hole</p> <p>Totally dry</p> | | <p>43b. River Churn - new Mills overflow</p> <p>No flow from overflow</p> | |

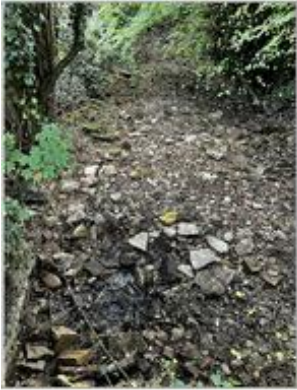
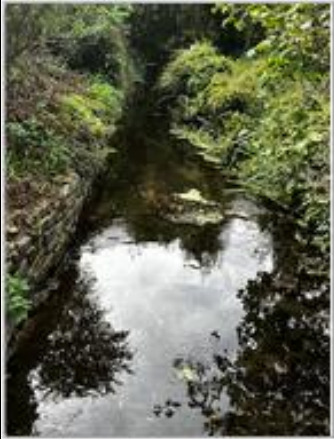
| <p>43c. River Churn - New Mills downstream</p> <p>Dry riverbed</p> | | <p>45. River Churn at City Bank Park footbridge</p> <p>Low flow, vegetation</p> | |

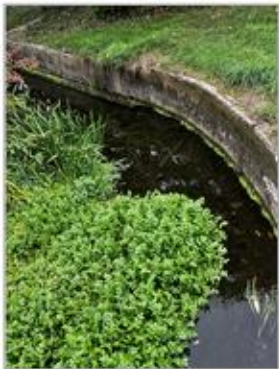
| <p>46. River Churn at Watermoor Point car park</p> <p>Low flow, duckweed and other vegetation</p> | | <p>47. River Churn at Cricklade Road opposite Aldi</p> <p>River more visible due to clearing work being done, still much vegetation</p> | |

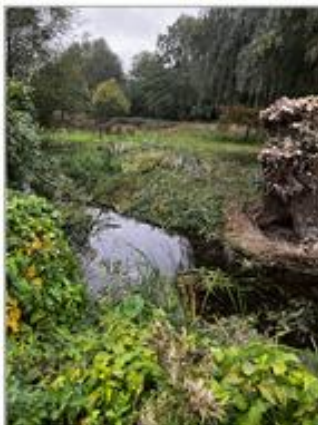
| <p>48. River Churn at Cricklade Road opposite Tesco</p> <p>Work going on to clear area between main road and river</p> | | | |
